Profile/Photo Observation Report

Date:	10/10/2021	Weather:		Coding:	PACP 7.0
Pipe Length (ft):	393.6	Owner:	City of Hobart	Pre Clean:	Heavy Cleaning
P.O.#:	YES502259	Surveyor:	S. Bucklin	PSR:	P-704-015-014
Customer:	City of Hobart	Clean Date:	10/09/2021	Shape:	C

Street:	East Home Avenue	Flow Control:	Not Controlled
City:	Hobart, IN	Year Renewed:	
Location:	Local rural streets with light traffic, t	Tape/Media #:	
Purpose:	Routine Assessment	Dia/Height:	12"
Use:	Sanitary Sewage Pipe	Material:	VCP
Drain Area:		Lining:	
Category:	NA		
Comment:			
Location Details:		Direction of Survey:	Upstream
US MH:	M-704-014	DS MH:	M-704-015
		Total Length Surveyed (ft):	393.6

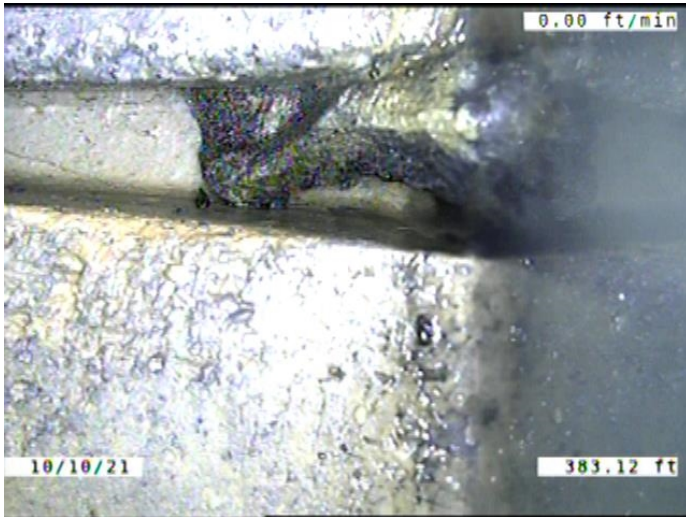
Code: **CM**
 Description: **Crack Multiple**

Distance (ft): **383.1**
 Structural Grade: **3**
 O&M Grade: **0**
 Clock Start/From: **9**
 Clock To: **3**
 1st Value:
 2nd Value:
 Value Percent:
 Continuous Index:
 Within 8" of Joint: **YES**
 Remarks:

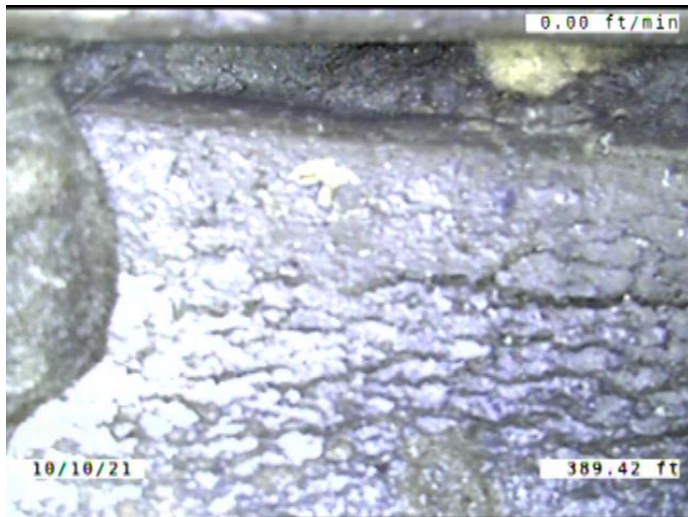
Code: **FM**
 Description: **Fracture Multiple**

Distance (ft): **385.1**
 Structural Grade: **4**
 O&M Grade: **0**
 Clock Start/From: **9**
 Clock To: **3**
 1st Value:
 2nd Value:
 Value Percent:
 Continuous Index:
 Within 8" of Joint: **YES**
 Remarks:

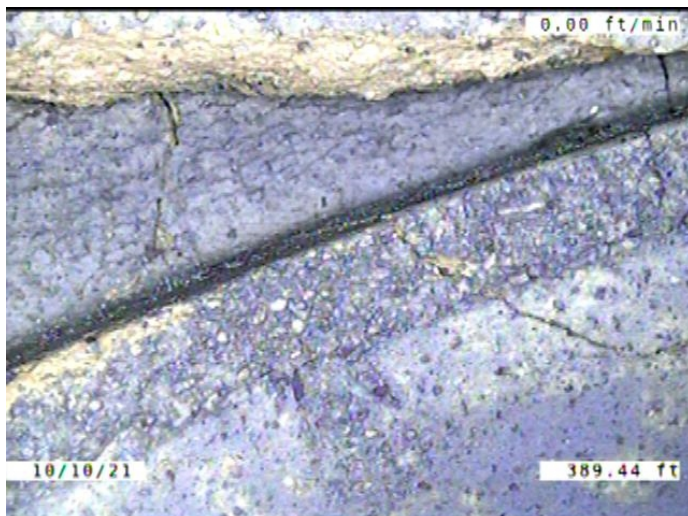
Code: **JAL**
 Description: **Joint Angular Large**

Distance (ft): **389.4**
 Structural Grade: **4**
 O&M Grade: **0**
 Clock Start/From:
 Clock To:
 1st Value:
 2nd Value:
 Value Percent:
 Continuous Index:
 Within 8" of Joint: **NO**
 Remarks: **SOIL VISIBLE**

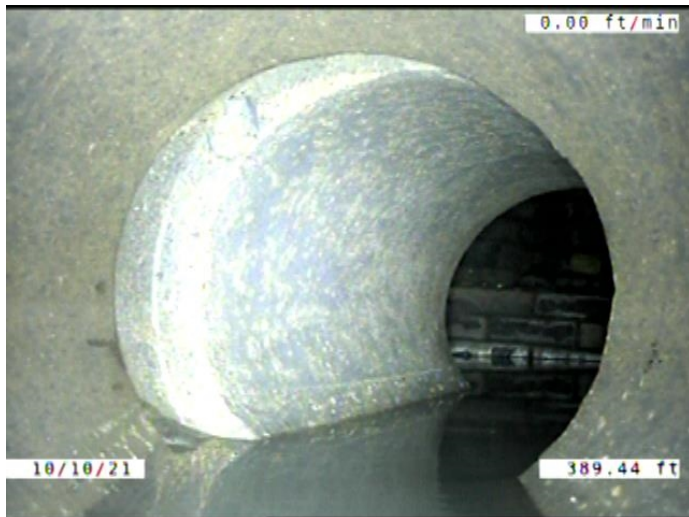
Code: **FM**
 Description: **Fracture Multiple**

Distance (ft): **389.4**
 Structural Grade: **4**
 O&M Grade: **0**
 Clock Start/From: **8**
 Clock To: **2**
 1st Value:
 2nd Value:
 Value Percent:
 Continuous Index:
 Within 8" of Joint: **YES**
 Remarks:

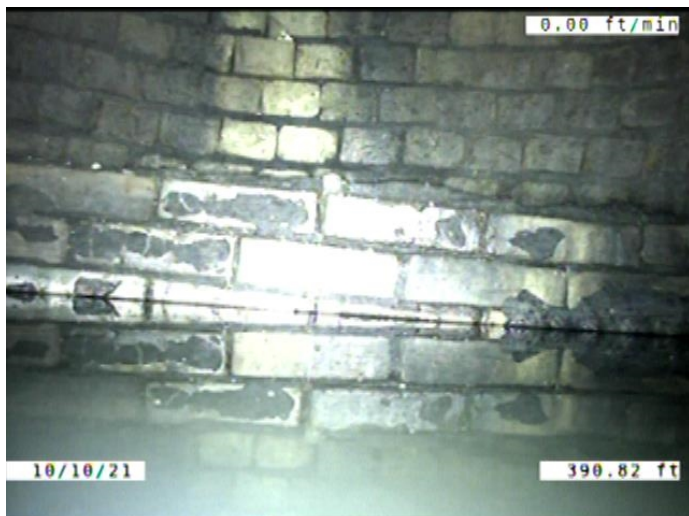
Code: **LR**
 Description: **Line Right**

Distance (ft): **389.4**
 Structural Grade: **0**
 O&M Grade: **4**
 Clock Start/From:
 Clock To:
 1st Value:
 2nd Value:
 Value Percent: **35.000**
 Continuous Index:
 Within 8" of Joint: **NO**
 Remarks:

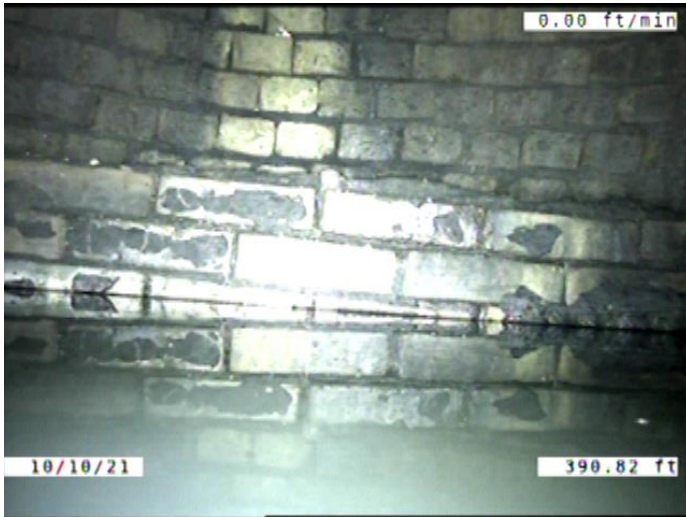
Code: **DSF**
 Description: **Deposits Settled Fine**

Distance (ft): **390.8**
 Structural Grade: **0**
 O&M Grade: **2**
 Clock Start/From: **5**
 Clock To: **7**
 1st Value:
 2nd Value:
 Value Percent: **5.000**
 Continuous Index: **F01**
 Within 8" of Joint: **YES**
 Remarks:

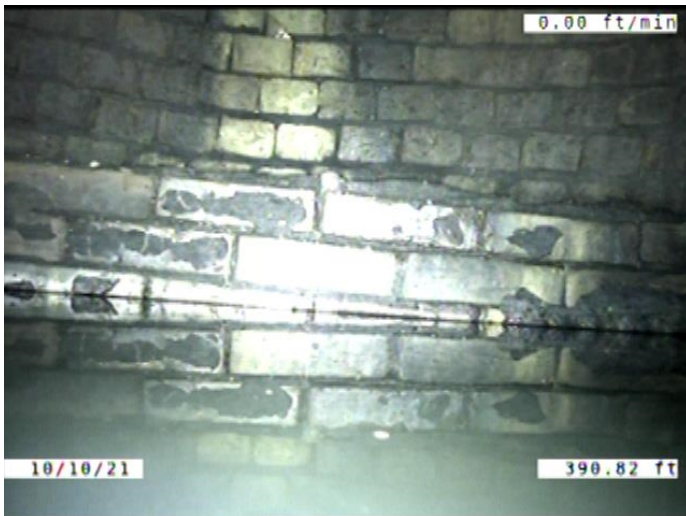
Code: **RFJ**
Description: **Roots Fine Joint**

Distance (ft): **390.8**
Structural Grade: **0**
O&M Grade: **1**
Clock Start/From: **9**
Clock To: **3**
1st Value:
2nd Value:
Value Percent:
Continuous Index: **F03**
Within 8" of Joint: **YES**
Remarks:

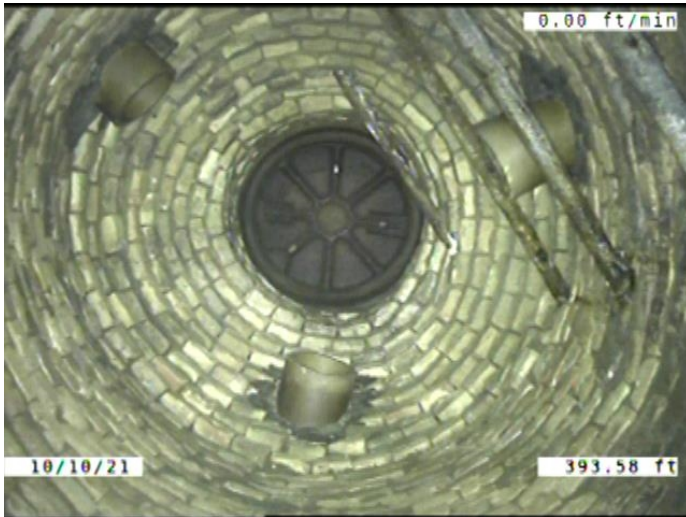
Code: **MWLS**
Description: **Miscellaneous Water Level Sag**

Distance (ft): **390.8**
Structural Grade: **2**
O&M Grade: **0**
Clock Start/From:
Clock To:
1st Value:
2nd Value:
Value Percent: **5.000**
Continuous Index: **F05**
Within 8" of Joint: **NO**
Remarks:
