Profile/Photo Observation Report

Date:	10/15/2021	Weather:		Coding:	PACP 7.0
Pipe Length (ft):	331.2	Owner:	City of Hobart	Pre Clean:	Heavy Cleaning
P.O.#:	YES502259	Surveyor:	S. Bucklin	PSR:	P-704-016-014
Customer:	City of Hobart	Clean Date:	10/12/2021	Shape:	C

Street:	North Michigan Avenue	Flow Control:	Not Controlled
City:	Hobart, IN	Year Renewed:	
Location:	Local rural streets with light traffic, t	Tape/Media #:	
Purpose:	Routine Assessment	Dia/Height:	8"
Use:	Sanitary Sewage Pipe	Material:	VCP
Drain Area:		Lining:	
Category:	NA		
Comment:			
Location Details:		Direction of Survey:	Downstream
US MH:	M-704-016	DS MH:	M-704-014
		Total Length Surveyed (ft):	331.2

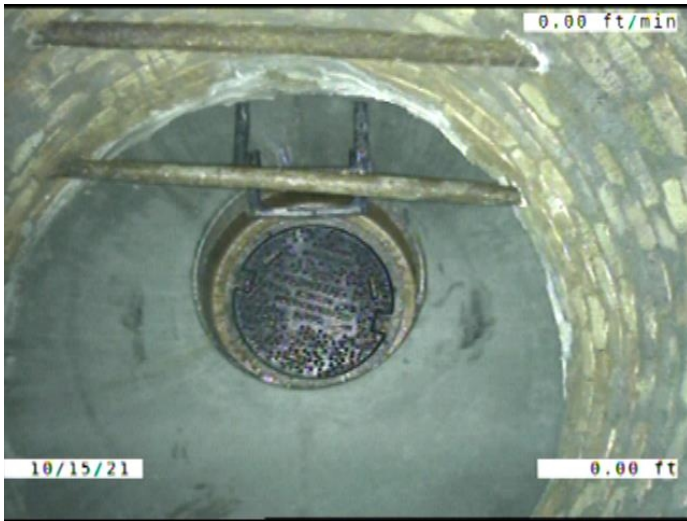
Code: **AMH**
Description: **Manhole**

Distance (ft): **.0**
Structural Grade: **0**
O&M Grade: **0**
Clock Start/From:
Clock To:
1st Value:
2nd Value:
Value Percent:
Continuous Index:
Within 8" of Joint: **NO**
Remarks: **M-704-016**

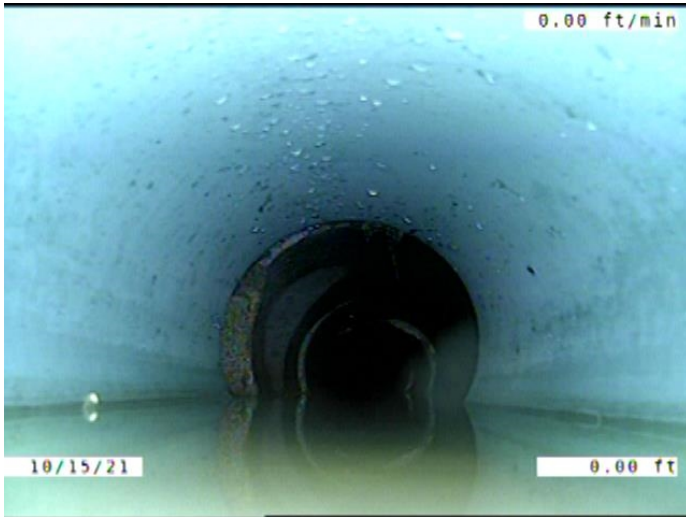
Code: **MWL**
 Description: **Miscellaneous Water Level**

Distance (ft): **.0**
 Structural Grade: **0**
 O&M Grade: **0**
 Clock Start/From:
 Clock To:
 1st Value:
 2nd Value:
 Value Percent: **10.000**
 Continuous Index:
 Within 8" of Joint: **NO**
 Remarks:

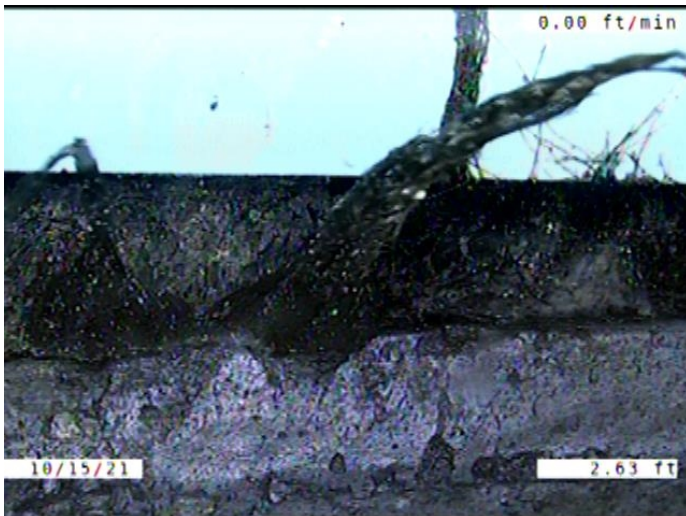
Code: **RFJ**
 Description: **Roots Fine Joint**

Distance (ft): **2.6**
 Structural Grade: **0**
 O&M Grade: **1**
 Clock Start/From: **8**
 Clock To: **4**
 1st Value:
 2nd Value:
 Value Percent:
 Continuous Index:
 Within 8" of Joint: **YES**
 Remarks:

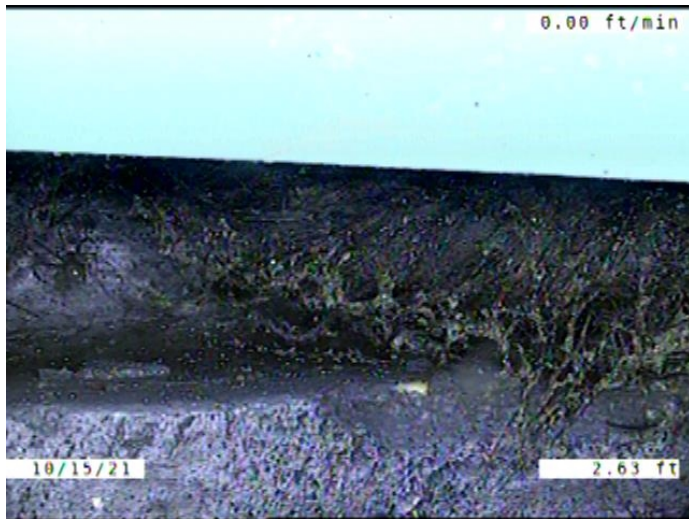
Code: **MMC**
Description: **Miscellaneous Material Change**

Distance (ft): **2.6**
Structural Grade: **0**
O&M Grade: **0**
Clock Start/From:
Clock To:
1st Value:
2nd Value:
Value Percent:
Continuous Index:
Within 8" of Joint: **NO**
Remarks: **PVC TO VCP**

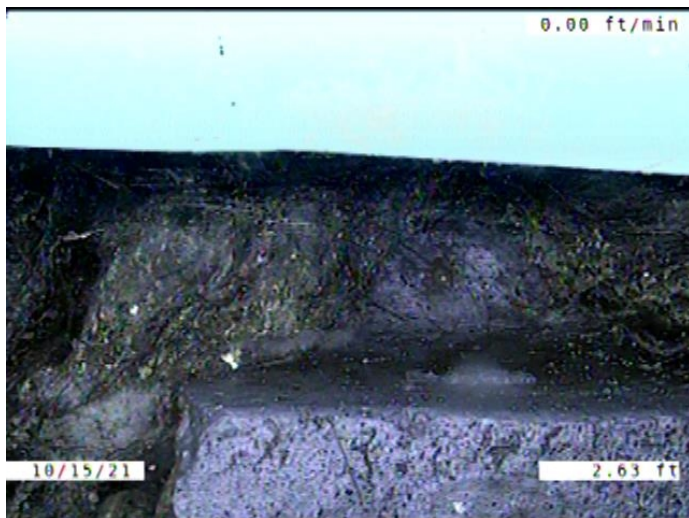
Code: **JAM**
Description: **Joint Angular Medium**

Distance (ft): **2.6**
Structural Grade: **3**
O&M Grade: **0**
Clock Start/From:
Clock To:
1st Value:
2nd Value:
Value Percent:
Continuous Index:
Within 8" of Joint: **NO**
Remarks:

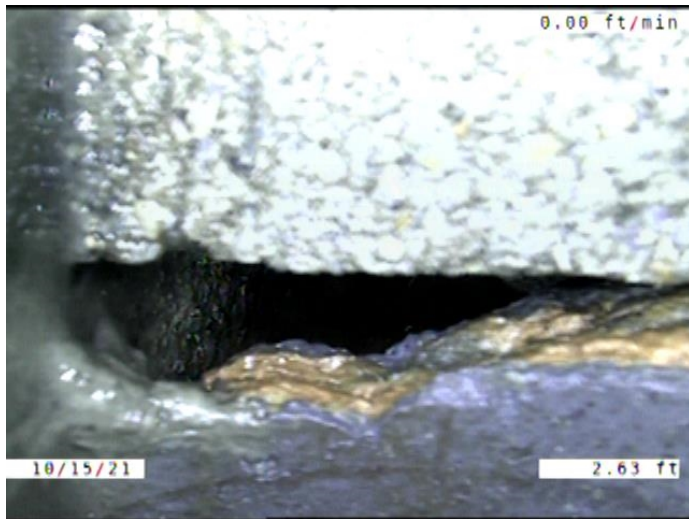
Code: **HVV**
Description: **Hole Void Visible**

Distance (ft): **2.6**
Structural Grade: **5**
O&M Grade: **0**
Clock Start/From: **8**
Clock To: **10**
1st Value:
2nd Value:
Value Percent:
Continuous Index:
Within 8" of Joint: **YES**
Remarks:

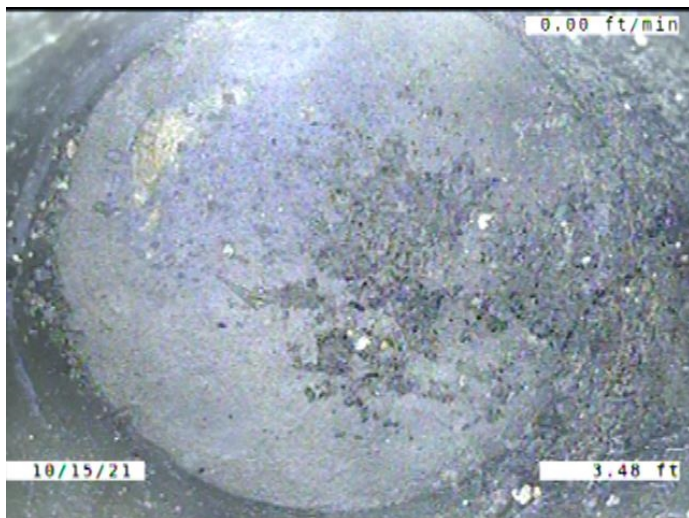
Code: **TFC**
Description: **Tap Factory Capped**

Distance (ft): **3.5**
Structural Grade: **0**
O&M Grade: **0**
Clock Start/From: **10**
Clock To:
1st Value: **4.000**
2nd Value:
Value Percent:
Continuous Index:
Within 8" of Joint: **YES**
Remarks:

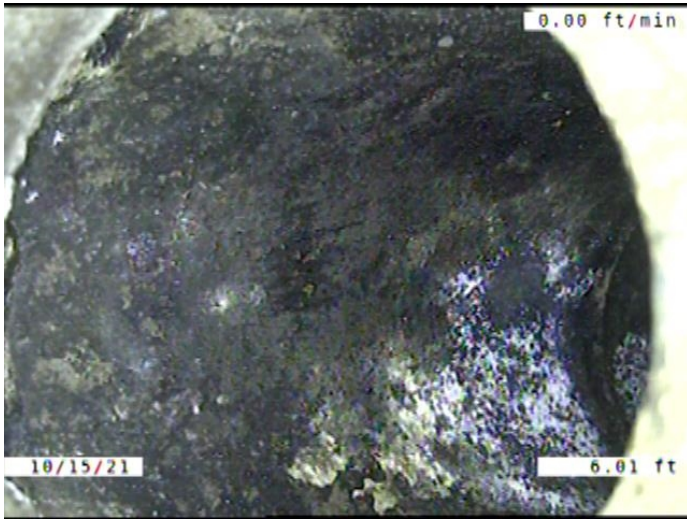
Code: **TBI**
Description: **Tap Break-in Intruding**

Distance (ft): **6.0**
Structural Grade: **0**
O&M Grade: **2**
Clock Start/From: **1**
Clock To:
1st Value: **4.000**
2nd Value: **1.000**
Value Percent:
Continuous Index:
Within 8" of Joint: **YES**
Remarks:

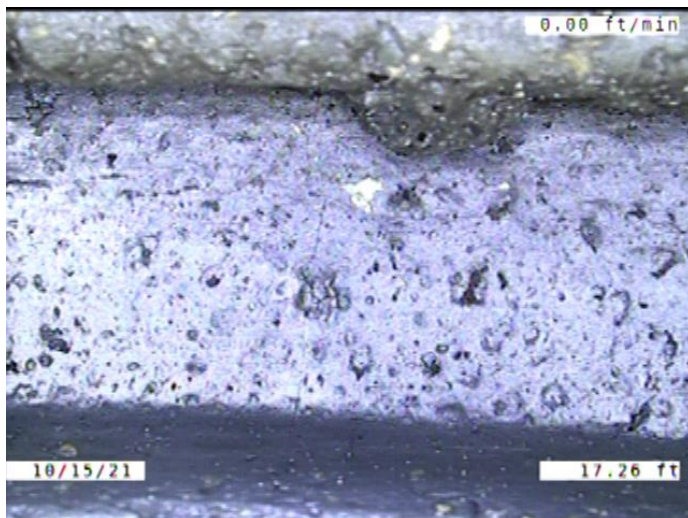
Code: **JSL**
 Description: **Joint Separated Large**

Distance (ft): **17.3**
 Structural Grade: **4**
 O&M Grade: **0**
 Clock Start/From:
 Clock To:
 1st Value:
 2nd Value:
 Value Percent:
 Continuous Index:
 Within 8" of Joint: **NO**
 Remarks:

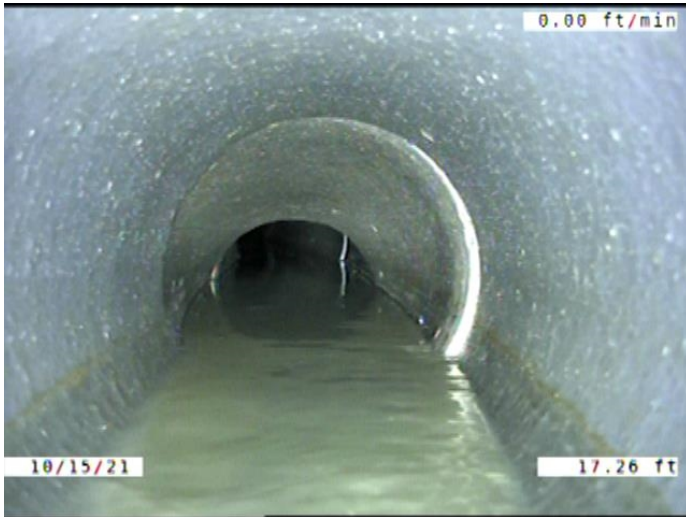
Code: **MWLS**
 Description: **Miscellaneous Water Level Sag**

Distance (ft): **17.3**
 Structural Grade: **2**
 O&M Grade: **0**
 Clock Start/From:
 Clock To:
 1st Value:
 2nd Value:
 Value Percent: **30.000**
 Continuous Index: **S01**
 Within 8" of Joint: **NO**
 Remarks:

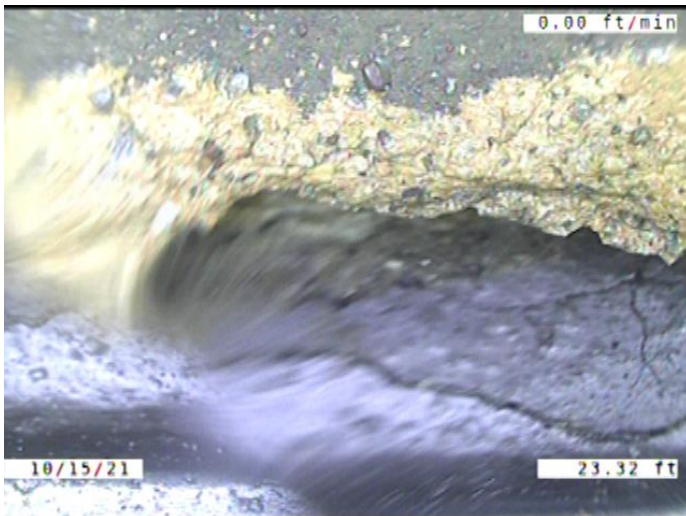
Code: **MCU**
 Description: **Miscellaneous Camera Underwater**

Distance (ft): **23.3**
 Structural Grade: **0**
 O&M Grade: **4**
 Clock Start/From:
 Clock To:
 1st Value:
 2nd Value:
 Value Percent:
 Continuous Index:
 Within 8" of Joint: **NO**
 Remarks: **Out at 23.4**

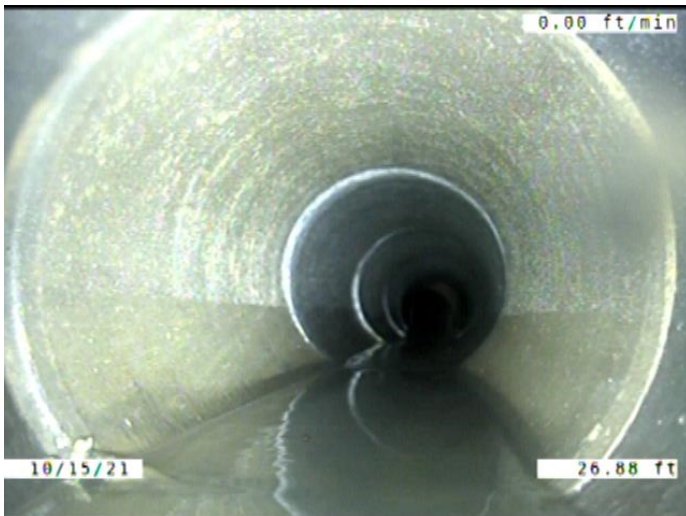
Code: **MWLS**
 Description: **Miscellaneous Water Level Sag**

Distance (ft): **26.9**
 Structural Grade: **2**
 O&M Grade: **0**
 Clock Start/From:
 Clock To:
 1st Value:
 2nd Value:
 Value Percent: **30.000**
 Continuous Index: **F01**
 Within 8" of Joint: **NO**
 Remarks:

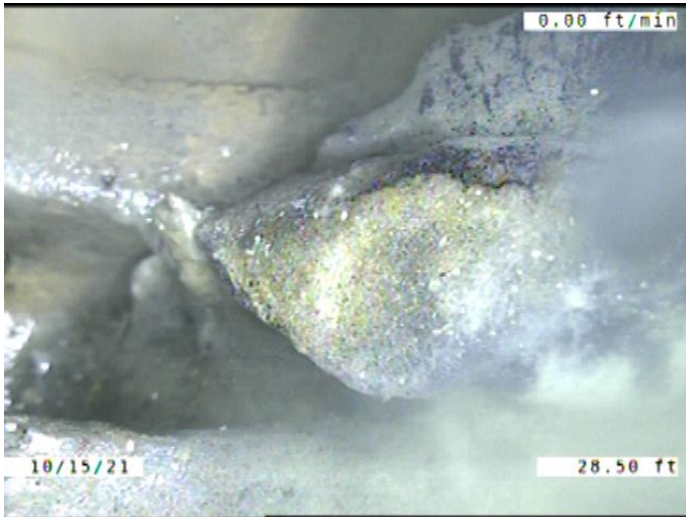
Code: **DAE**
 Description: **Deposits Attached Encrustation**

Distance (ft): **28.5**
 Structural Grade: **0**
 O&M Grade: **2**
 Clock Start/From: **6**
 Clock To: **8**
 1st Value:
 2nd Value:
 Value Percent: **5.000**
 Continuous Index:
 Within 8" of Joint: **YES**
 Remarks:

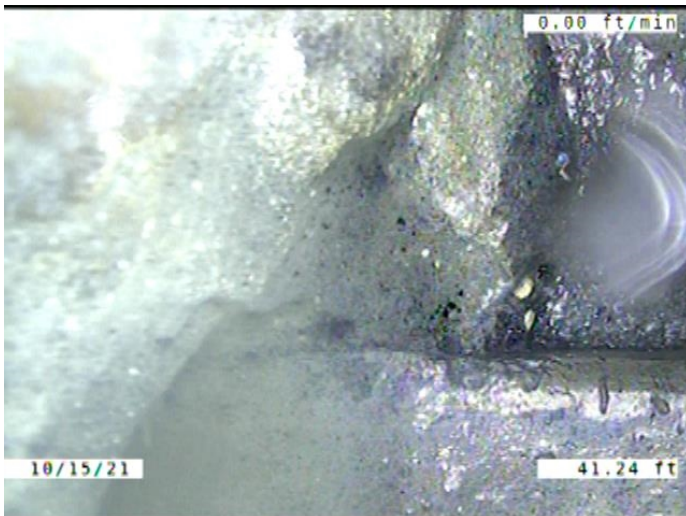
Code: **DAE**
 Description: **Deposits Attached Encrustation**

Distance (ft): **41.2**
 Structural Grade: **0**
 O&M Grade: **2**
 Clock Start/From: **3**
 Clock To: **6**
 1st Value:
 2nd Value:
 Value Percent: **5.000**
 Continuous Index:
 Within 8" of Joint: **YES**
 Remarks:

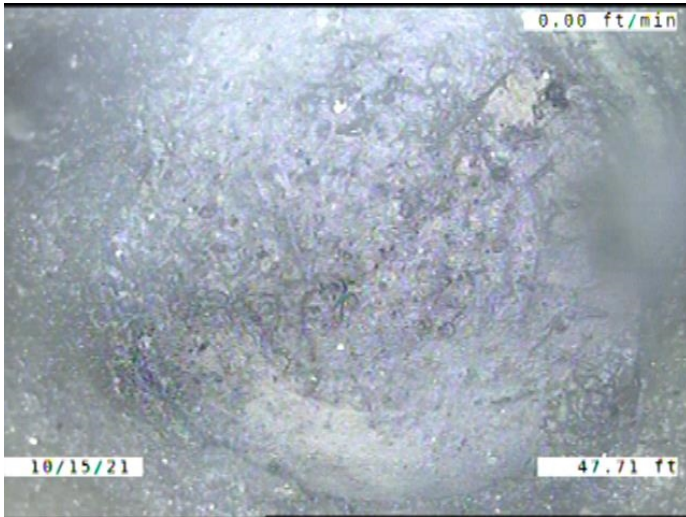
Code: **TFC**
Description: **Tap Factory Capped**

Distance (ft): **47.7**
Structural Grade: **0**
O&M Grade: **0**
Clock Start/From: **2**
Clock To:
1st Value: **6.000**
2nd Value:
Value Percent:
Continuous Index:
Within 8" of Joint: **YES**
Remarks:

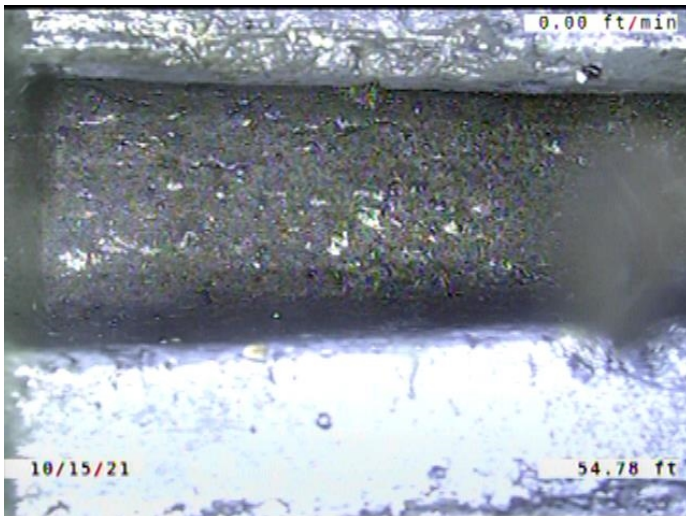
Code: **JAM**
Description: **Joint Angular Medium**

Distance (ft): **54.8**
Structural Grade: **3**
O&M Grade: **0**
Clock Start/From:
Clock To:
1st Value:
2nd Value:
Value Percent:
Continuous Index:
Within 8" of Joint: **NO**
Remarks:

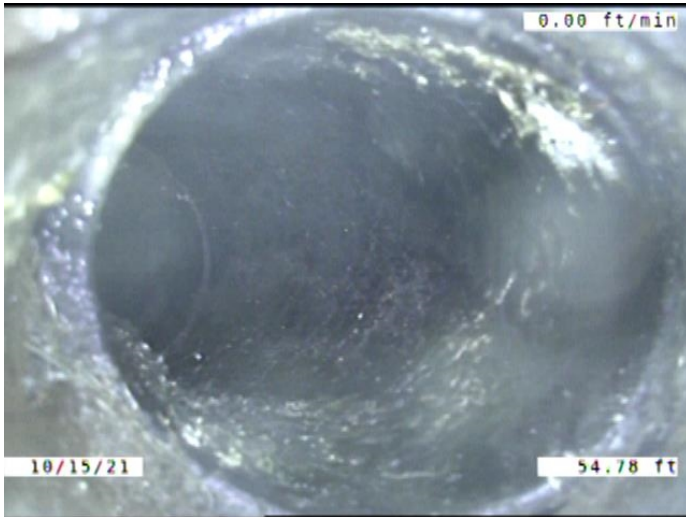
Code: **TF**
 Description: **Tap Factory**

Distance (ft): **54.8**
 Structural Grade: **0**
 O&M Grade: **0**
 Clock Start/From: **11**
 Clock To:
 1st Value: **4.000**
 2nd Value:
 Value Percent:
 Continuous Index:
 Within 8" of Joint: **YES**
 Remarks:

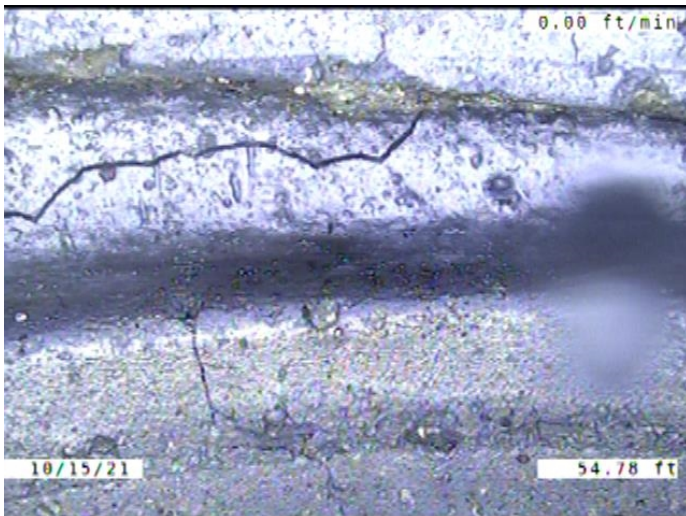
Code: **FM**
 Description: **Fracture Multiple**

Distance (ft): **54.8**
 Structural Grade: **4**
 O&M Grade: **0**
 Clock Start/From: **8**
 Clock To: **4**
 1st Value:
 2nd Value:
 Value Percent:
 Continuous Index:
 Within 8" of Joint: **YES**
 Remarks:

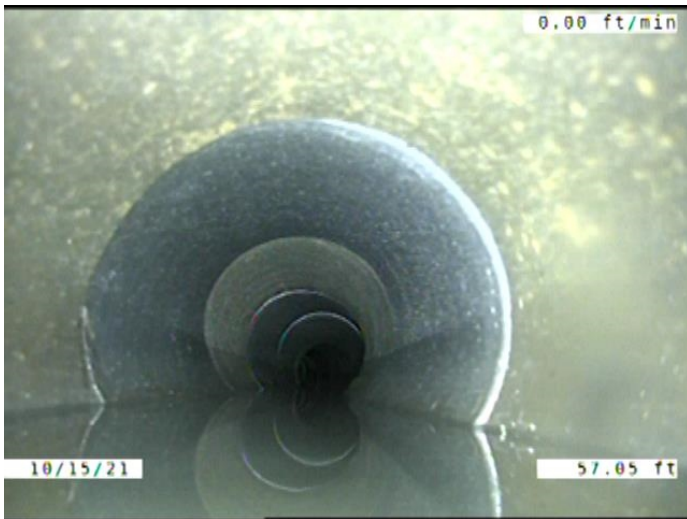
Code: **MWLS**
Description: **Miscellaneous Water Level Sag**

Distance (ft): **57.1**
Structural Grade: **2**
O&M Grade: **0**
Clock Start/From:
Clock To:
1st Value:
2nd Value:
Value Percent: **10.000**
Continuous Index:
Within 8" of Joint: **NO**
Remarks:

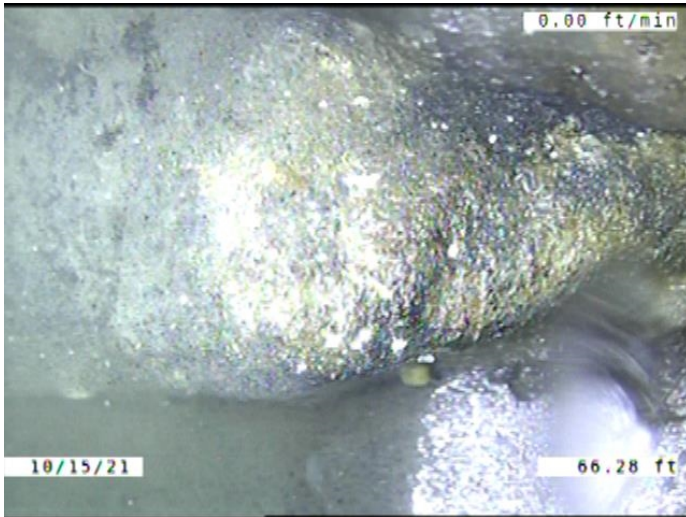
Code: **DAE**
 Description: **Deposits Attached Encrustation**

Distance (ft): **66.3**
 Structural Grade: **0**
 O&M Grade: **2**
 Clock Start/From: **3**
 Clock To: **6**
 1st Value:
 2nd Value:
 Value Percent: **5.000**
 Continuous Index:
 Within 8" of Joint: **YES**
 Remarks:

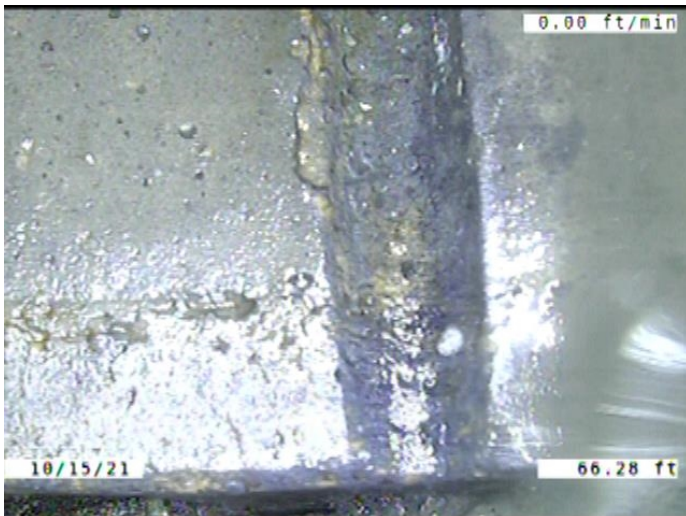
Code: **SZ**
 Description: **Surface Damage Other**

Distance (ft): **66.3**
 Structural Grade: **0**
 O&M Grade: **0**
 Clock Start/From: **8**
 Clock To: **9**
 1st Value:
 2nd Value:
 Value Percent:
 Continuous Index: **S02**
 Within 8" of Joint: **YES**
 Remarks: **GROOVE IN THE PIPE WALL**

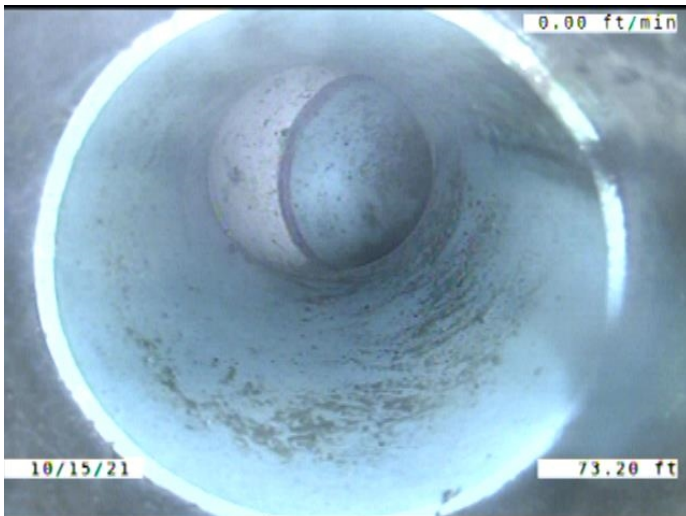
Code: **TF**
 Description: **Tap Factory**

Distance (ft): **73.2**
 Structural Grade: **0**
 O&M Grade: **0**
 Clock Start/From: **1**
 Clock To:
 1st Value: **4.000**
 2nd Value:
 Value Percent:
 Continuous Index:
 Within 8" of Joint: **YES**
 Remarks:

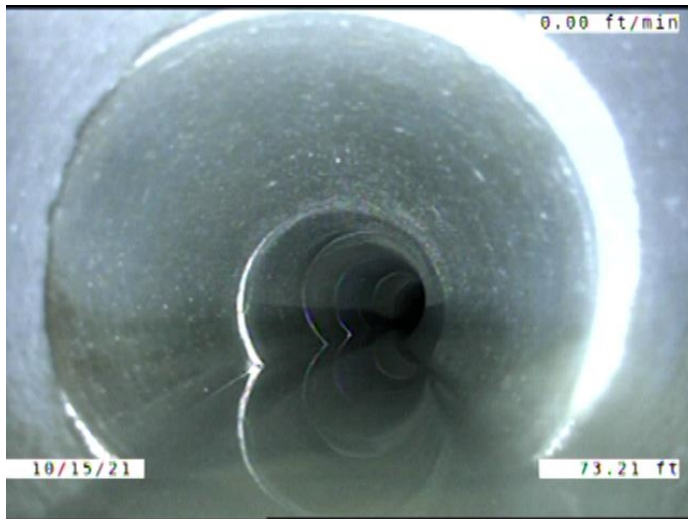
Code:	SZ
Description:	Surface Damage Other
Distance (ft):	73.2
Structural Grade:	0
O&M Grade:	0
Clock Start/From:	8
Clock To:	9
1st Value:	
2nd Value:	
Value Percent:	
Continuous Index:	F02
Within 8" of Joint:	YES
Remarks:	GROOVE IN THE PIPE WALL

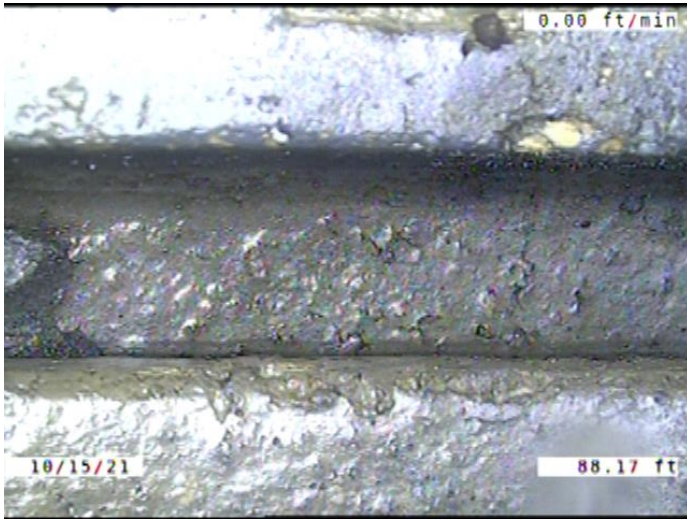
Code: **JAM**
Description: **Joint Angular Medium**

Distance (ft): **88.1**
Structural Grade: **3**
O&M Grade: **0**
Clock Start/From:
Clock To:
1st Value:
2nd Value:
Value Percent:
Continuous Index:
Within 8" of Joint: **NO**
Remarks:

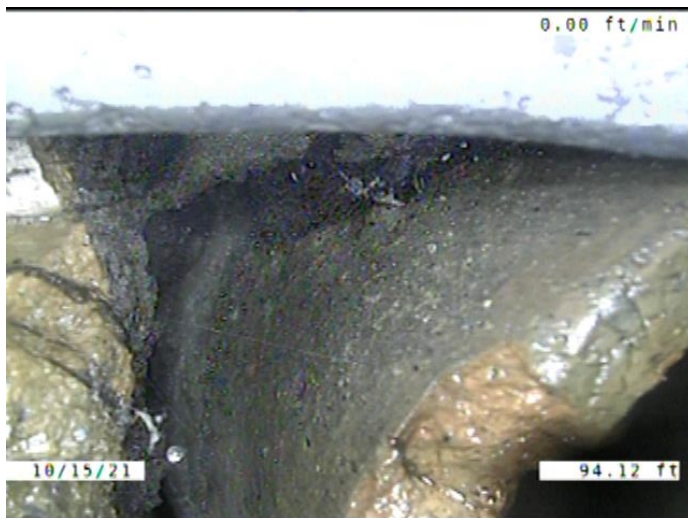
Code: **RFB**
Description: **Roots Fine Barrel**

Distance (ft): **94.1**
Structural Grade: **0**
O&M Grade: **2**
Clock Start/From: **10**
Clock To: **1**
1st Value:
2nd Value:
Value Percent:
Continuous Index:
Within 8" of Joint: **NO**
Remarks:

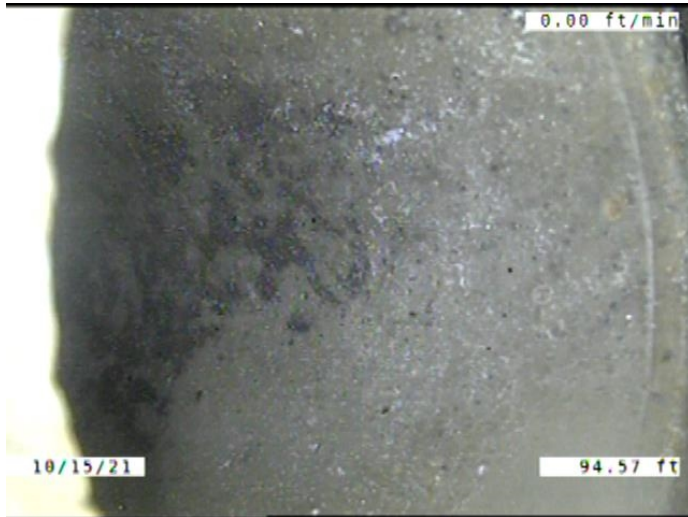
Code: **TBI**
Description: **Tap Break-in Intruding**

Distance (ft): **94.6**
Structural Grade: **0**
O&M Grade: **2**
Clock Start/From: **11**
Clock To:
1st Value: **4.000**
2nd Value: **1.000**
Value Percent:
Continuous Index:
Within 8" of Joint: **YES**
Remarks: **CONSTANTLY RUNNING WATER**

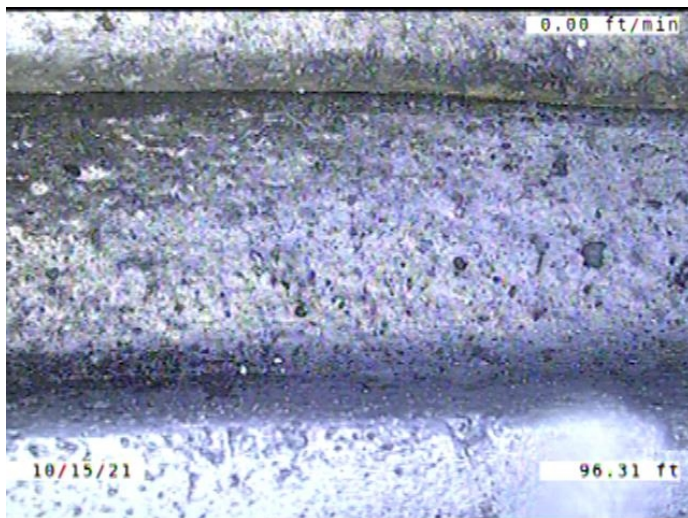
Code: **JAL**
Description: **Joint Angular Large**

Distance (ft): **96.3**
Structural Grade: **4**
O&M Grade: **0**
Clock Start/From:
Clock To:
1st Value:
2nd Value:
Value Percent:
Continuous Index:
Within 8" of Joint: **NO**
Remarks:

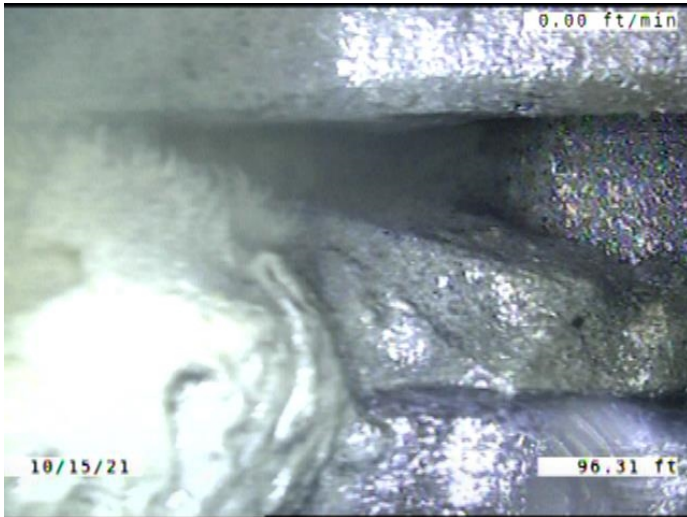
Code: **DAE**
 Description: **Deposits Attached Encrustation**

Distance (ft): **96.3**
 Structural Grade: **0**
 O&M Grade: **2**
 Clock Start/From: **7**
 Clock To: **8**
 1st Value:
 2nd Value:
 Value Percent: **5.000**
 Continuous Index:
 Within 8" of Joint: **YES**
 Remarks:

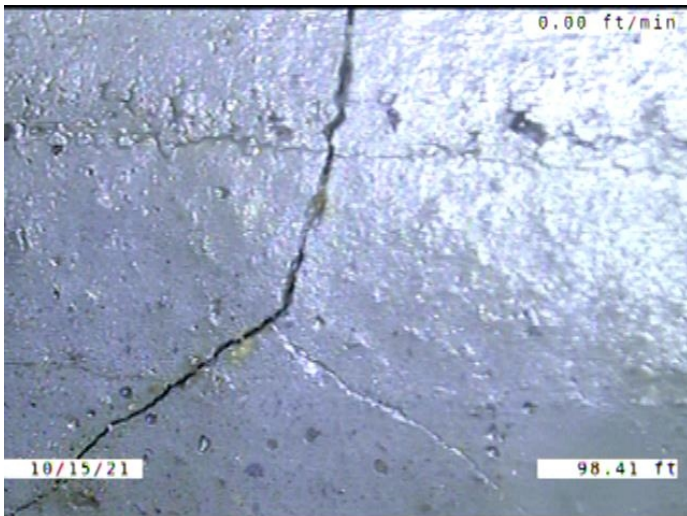
Code: **FM**
 Description: **Fracture Multiple**

Distance (ft): **98.4**
 Structural Grade: **4**
 O&M Grade: **0**
 Clock Start/From: **11**
 Clock To: **4**
 1st Value:
 2nd Value:
 Value Percent:
 Continuous Index:
 Within 8" of Joint: **YES**
 Remarks:

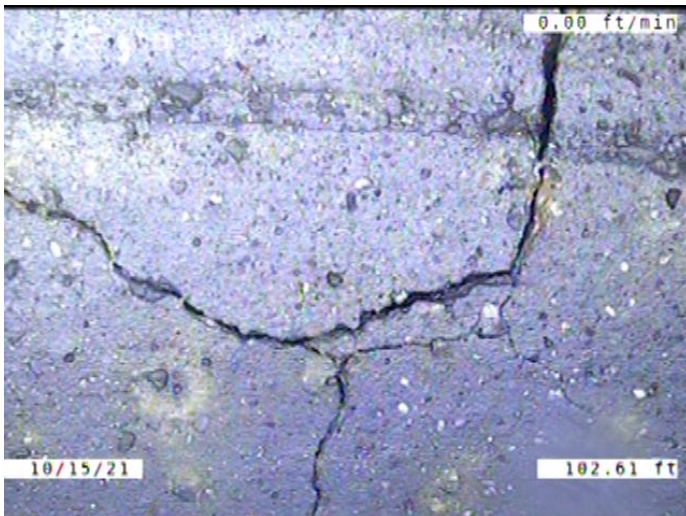
Code: **B**
Description: **Broken**

Distance (ft): **102.6**
Structural Grade: **4**
O&M Grade: **0**
Clock Start/From: **10**
Clock To: **12**
1st Value:
2nd Value:
Value Percent:
Continuous Index:
Within 8" of Joint: **YES**
Remarks:

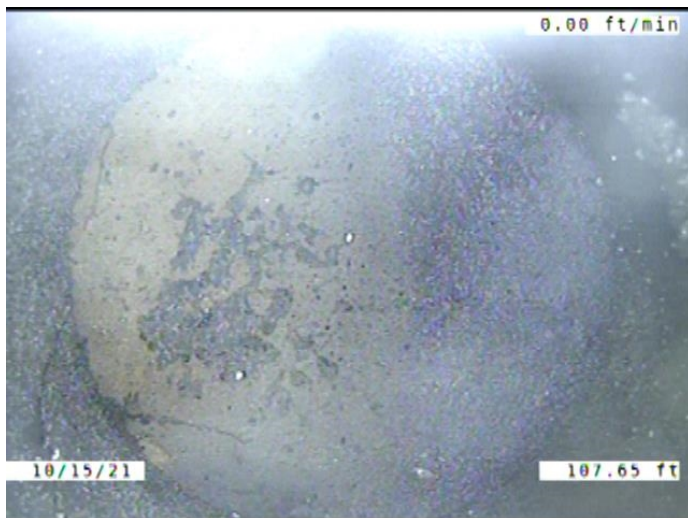
Code: **TFC**
 Description: **Tap Factory Capped**

Distance (ft): **107.7**
 Structural Grade: **0**
 O&M Grade: **0**
 Clock Start/From: **2**
 Clock To:
 1st Value: **4.000**
 2nd Value:
 Value Percent:
 Continuous Index:
 Within 8" of Joint: **YES**
 Remarks:

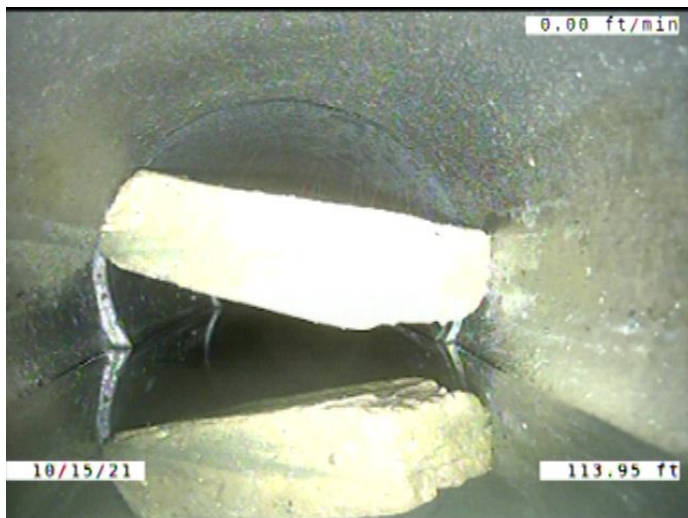
Code: **OBB**
 Description: **Obstruction Brick or Masonry**

Distance (ft): **114.0**
 Structural Grade: **0**
 O&M Grade: **3**
 Clock Start/From: **4**
 Clock To: **10**
 1st Value:
 2nd Value:
 Value Percent: **20.000**
 Continuous Index:
 Within 8" of Joint: **YES**
 Remarks:

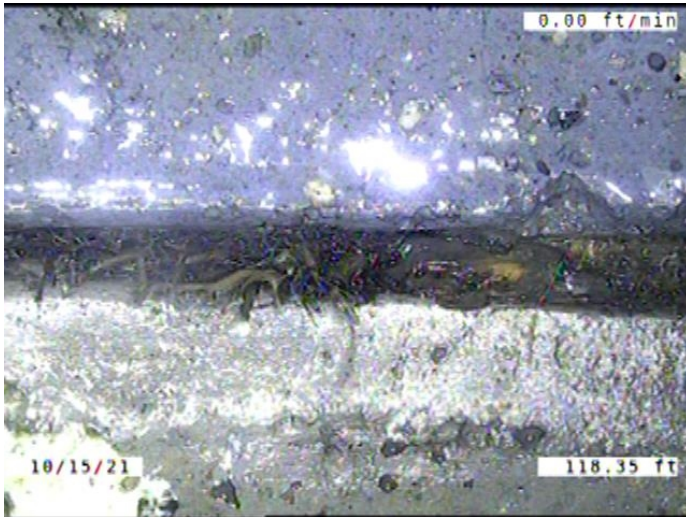
Code: **RFJ**
Description: **Roots Fine Joint**

Distance (ft): **118.4**
Structural Grade: **0**
O&M Grade: **1**
Clock Start/From: **8**
Clock To: **3**
1st Value:
2nd Value:
Value Percent:
Continuous Index: **S03**
Within 8" of Joint: **YES**
Remarks:

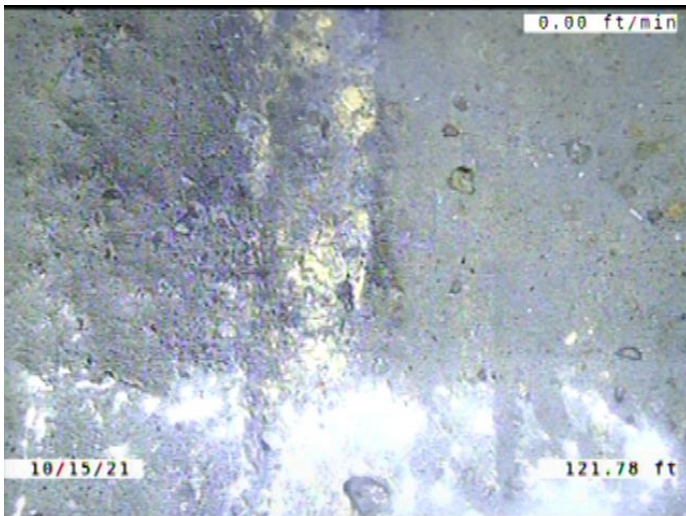
Code: **SZ**
Description: **Surface Damage Other**

Distance (ft): **121.8**
Structural Grade: **0**
O&M Grade: **0**
Clock Start/From: **4**
Clock To:
1st Value:
2nd Value:
Value Percent:
Continuous Index: **S04**
Within 8" of Joint: **YES**
Remarks: **GROOVE IN THE PIPE WALL**

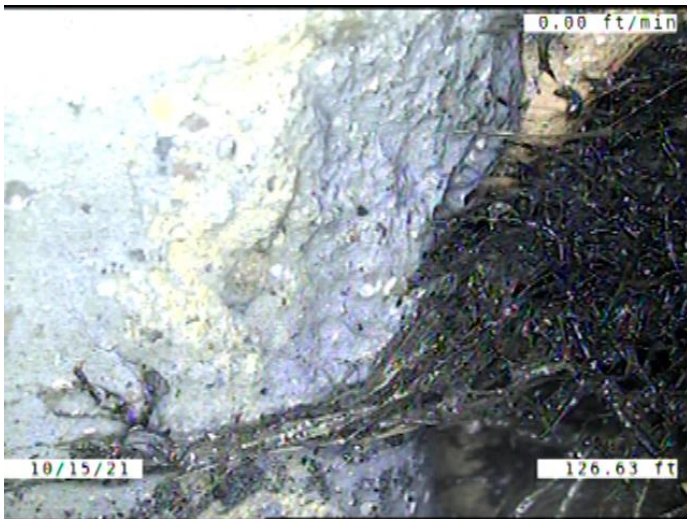
Code: **SSS**
 Description: **Surface Damage Surface Spalling**

Distance (ft): **126.6**
 Structural Grade: **2**
 O&M Grade: **0**
 Clock Start/From: **9**
 Clock To: **1**
 1st Value:
 2nd Value:
 Value Percent:
 Continuous Index:
 Within 8" of Joint: **YES**
 Remarks:

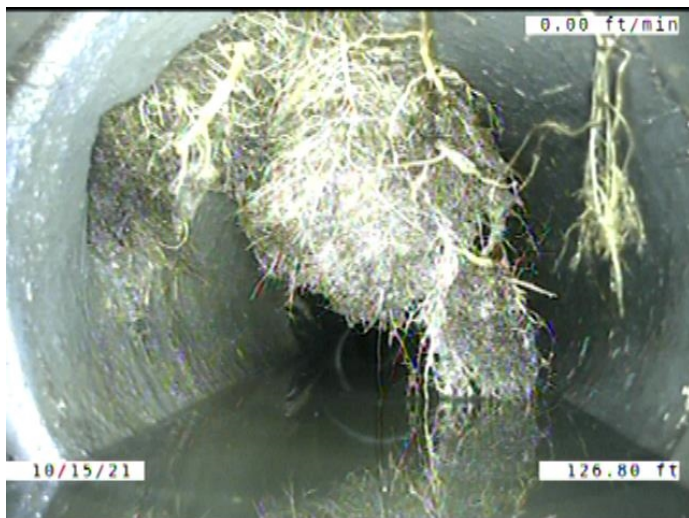
Code:	RML
Description:	Roots Medium Lateral
Distance (ft):	126.8
Structural Grade:	0
O&M Grade:	3
Clock Start/From:	9
Clock To:	4
1st Value:	
2nd Value:	
Value Percent:	45.000
Continuous Index:	
Within 8" of Joint:	NO
Remarks:

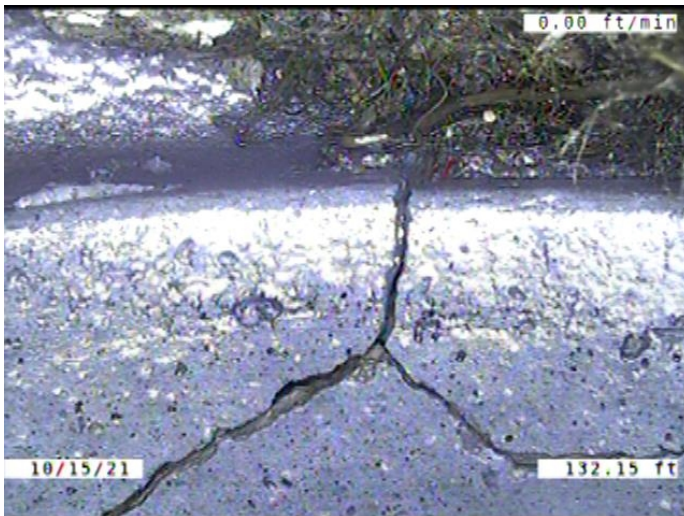
Code: **SZ**
Description: **Surface Damage Other**

Distance (ft): **130.9**
Structural Grade: **0**
O&M Grade: **0**
Clock Start/From: **4**
Clock To:
1st Value:
2nd Value:
Value Percent:
Continuous Index: **F04**
Within 8" of Joint: **YES**
Remarks: **GROOVE IN THE PIPE WALL**

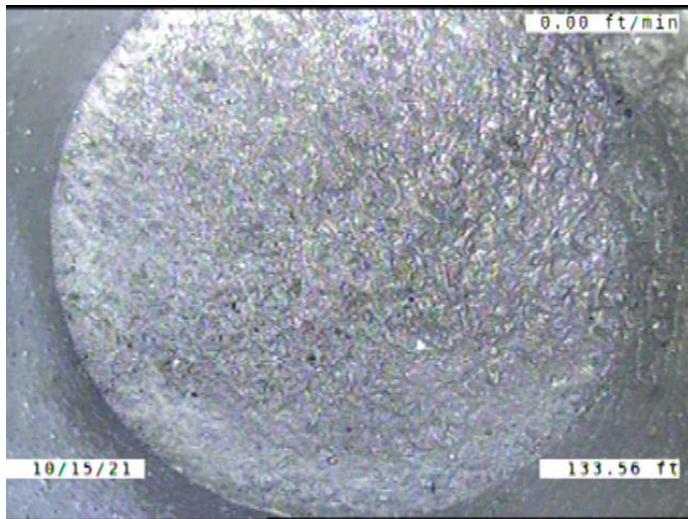
Code: **FM**
Description: **Fracture Multiple**

Distance (ft): **132.1**
Structural Grade: **4**
O&M Grade: **0**
Clock Start/From: **9**
Clock To: **3**
1st Value:
2nd Value:
Value Percent:
Continuous Index:
Within 8" of Joint: **YES**
Remarks:

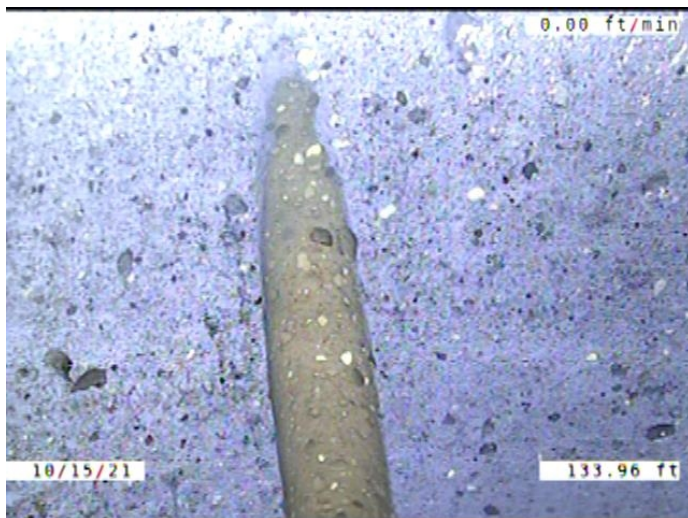
Code: **TFC**
 Description: **Tap Factory Capped**

Distance (ft): **133.6**
 Structural Grade: **0**
 O&M Grade: **0**
 Clock Start/From: **2**
 Clock To:
 1st Value: **4.000**
 2nd Value:
 Value Percent:
 Continuous Index:
 Within 8" of Joint: **YES**
 Remarks:

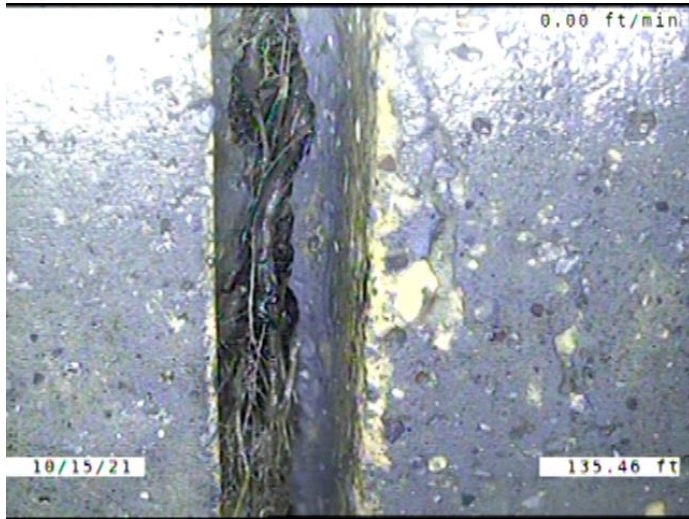
Code: **SZ**
 Description: **Surface Damage Other**

Distance (ft): **134.0**
 Structural Grade: **0**
 O&M Grade: **0**
 Clock Start/From: **9**
 Clock To:
 1st Value:
 2nd Value:
 Value Percent:
 Continuous Index: **S05**
 Within 8" of Joint: **YES**
 Remarks: **GROOVE IN THE PIPE WALL**

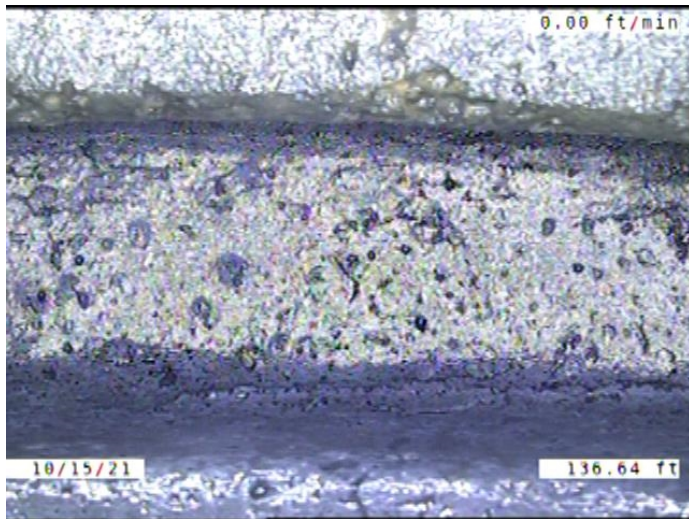
Code: **RFB**
Description: **Roots Fine Barrel**

Distance (ft): **135.5**
Structural Grade: **0**
O&M Grade: **2**
Clock Start/From: **9**
Clock To:
1st Value:
2nd Value:
Value Percent:
Continuous Index:
Within 8" of Joint: **NO**
Remarks: **GROWING THROUGH THE GROOVE**

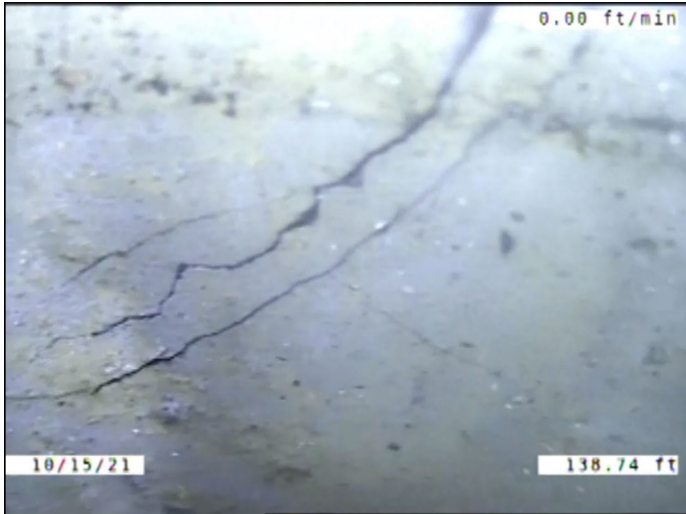
Code: **JAM**
Description: **Joint Angular Medium**

Distance (ft): **136.6**
Structural Grade: **3**
O&M Grade: **0**
Clock Start/From:
Clock To:
1st Value:
2nd Value:
Value Percent:
Continuous Index:
Within 8" of Joint: **NO**
Remarks:

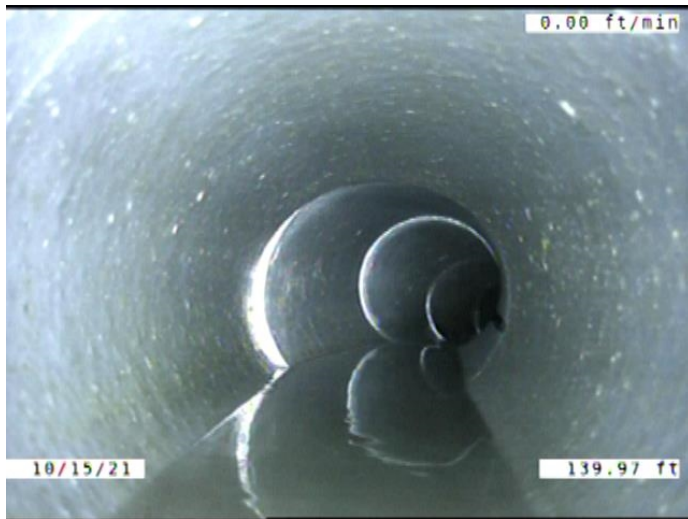
Code: **B**
Description: **Broken**

Distance (ft): **138.7**
Structural Grade: **4**
O&M Grade: **0**
Clock Start/From: **11**
Clock To: **1**
1st Value:
2nd Value:
Value Percent:
Continuous Index:
Within 8" of Joint: **YES**
Remarks:

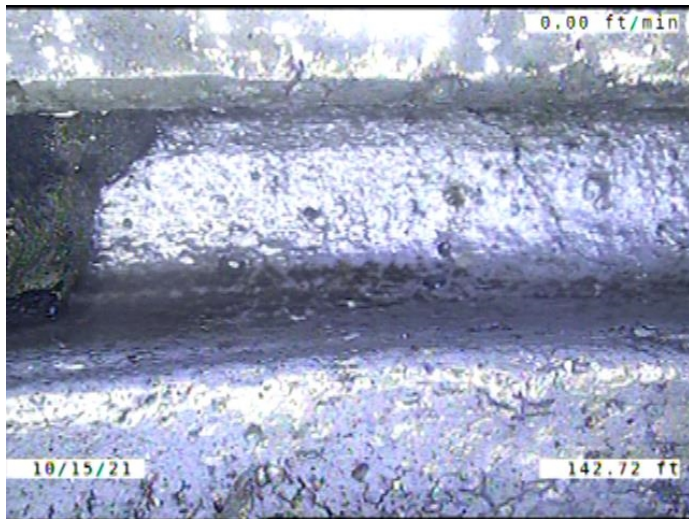
Code: **FM**
Description: **Fracture Multiple**

Distance (ft): **140.4**
Structural Grade: **4**
O&M Grade: **0**
Clock Start/From: **8**
Clock To: **3**
1st Value:
2nd Value:
Value Percent:
Continuous Index:
Within 8" of Joint: **YES**
Remarks:

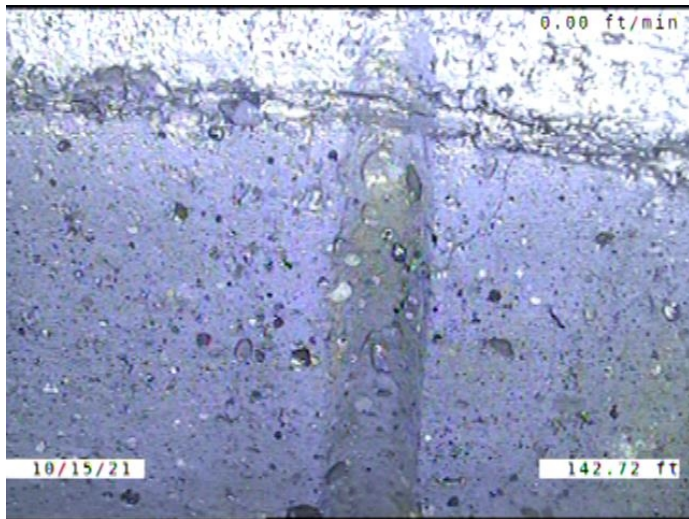
Code: **FM**
 Description: **Fracture Multiple**

Distance (ft): **142.7**
 Structural Grade: **4**
 O&M Grade: **0**
 Clock Start/From: **9**
 Clock To: **11**
 1st Value:
 2nd Value:
 Value Percent:
 Continuous Index:
 Within 8" of Joint: **YES**
 Remarks:

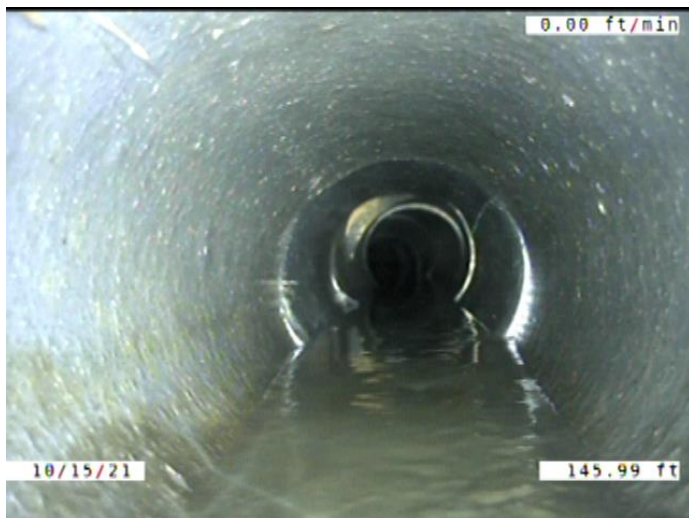
Code: **SZ**
Description: **Surface Damage Other**

Distance (ft): **142.7**
Structural Grade: **0**
O&M Grade: **0**
Clock Start/From: **3**
Clock To:
1st Value:
2nd Value:
Value Percent:
Continuous Index: **S06**
Within 8" of Joint: **YES**
Remarks: **GROOVE IN THE PIPE WALL**

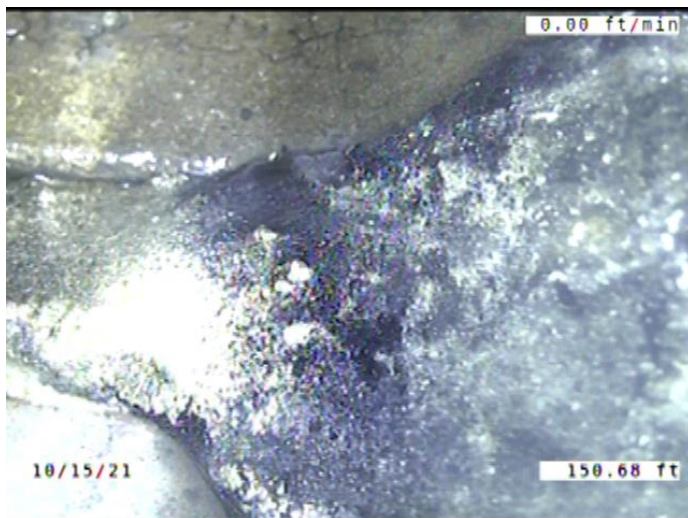
Code: **SMW**
 Description: **Surface Damage Missing Wall**

Distance (ft): **150.7**
 Structural Grade: **5**
 O&M Grade: **0**
 Clock Start/From: **12**
 Clock To: **2**
 1st Value:
 2nd Value:
 Value Percent:
 Continuous Index:
 Within 8" of Joint: **YES**
 Remarks: **INSIDE OF THE JOINT**

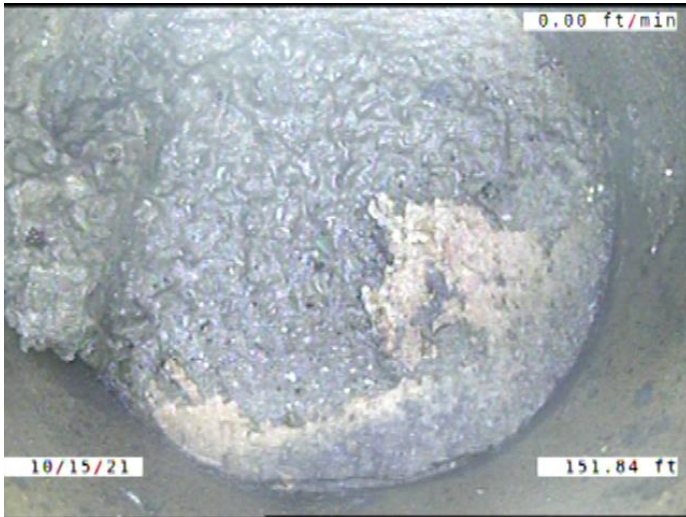
Code: **DAE**
 Description: **Deposits Attached Encrustation**

Distance (ft): **150.7**
 Structural Grade: **0**
 O&M Grade: **2**
 Clock Start/From: **4**
 Clock To: **9**
 1st Value:
 2nd Value:
 Value Percent: **5.000**
 Continuous Index:
 Within 8" of Joint: **YES**
 Remarks:

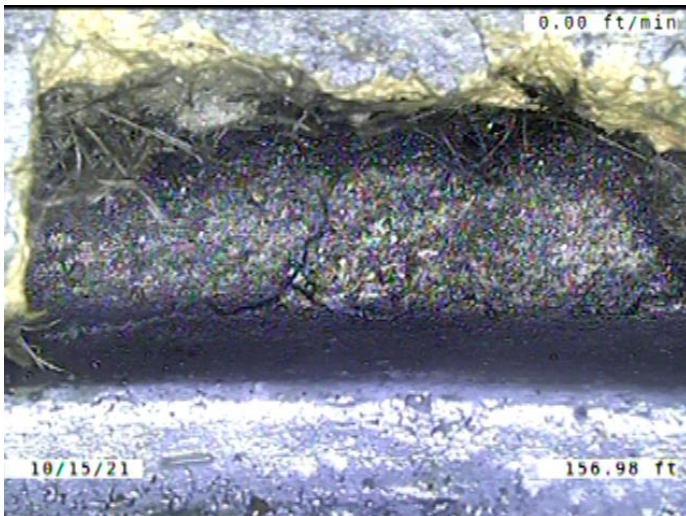
Code: **TFC**
 Description: **Tap Factory Capped**

Distance (ft): **151.8**
 Structural Grade: **0**
 O&M Grade: **0**
 Clock Start/From: **11**
 Clock To:
 1st Value: **4.000**
 2nd Value:
 Value Percent:
 Continuous Index:
 Within 8" of Joint: **YES**
 Remarks:

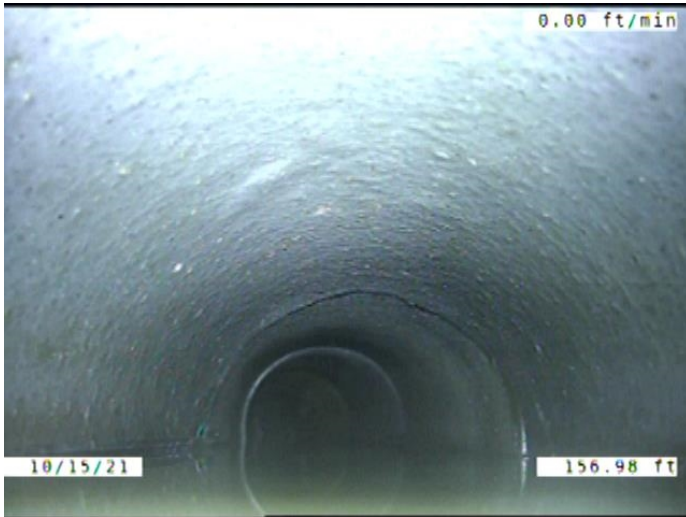
Code: **SMW**
 Description: **Surface Damage Missing Wall**

Distance (ft): **157.0**
 Structural Grade: **5**
 O&M Grade: **0**
 Clock Start/From: **12**
 Clock To: **1**
 1st Value:
 2nd Value:
 Value Percent:
 Continuous Index:
 Within 8" of Joint: **YES**
 Remarks: **INSIDE OF THE JOINT**

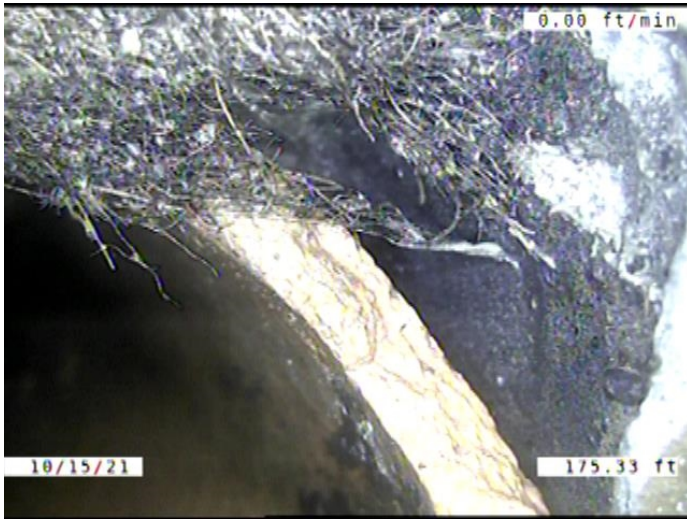
Code: **TBD**
Description: **Tap Break-in/Hammer Defective**

Distance (ft): **174.8**
Structural Grade: **0**
O&M Grade: **3**
Clock Start/From: **11**
Clock To:
1st Value: **4.000**
2nd Value:
Value Percent:
Continuous Index:
Within 8" of Joint: **YES**
Remarks: **Defective**

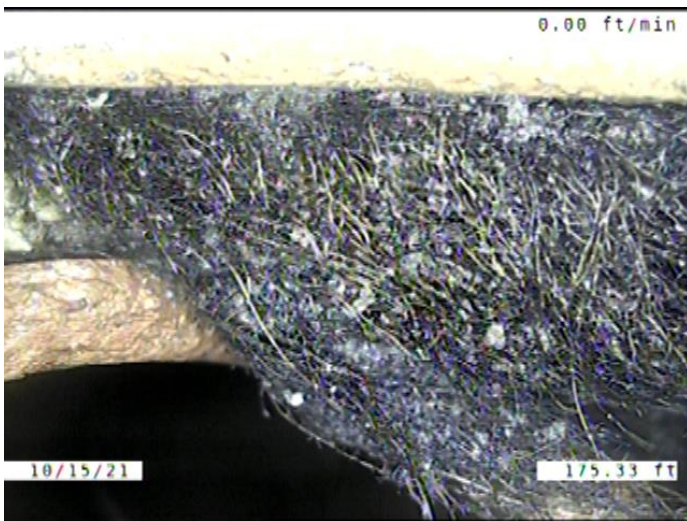
Code: **BSV**
 Description: **Broken Soil Visible**

Distance (ft): **175.3**
 Structural Grade: **5**
 O&M Grade: **0**
 Clock Start/From: **11**
 Clock To: **4**
 1st Value:
 2nd Value:
 Value Percent:
 Continuous Index:
 Within 8" of Joint: **YES**
 Remarks:

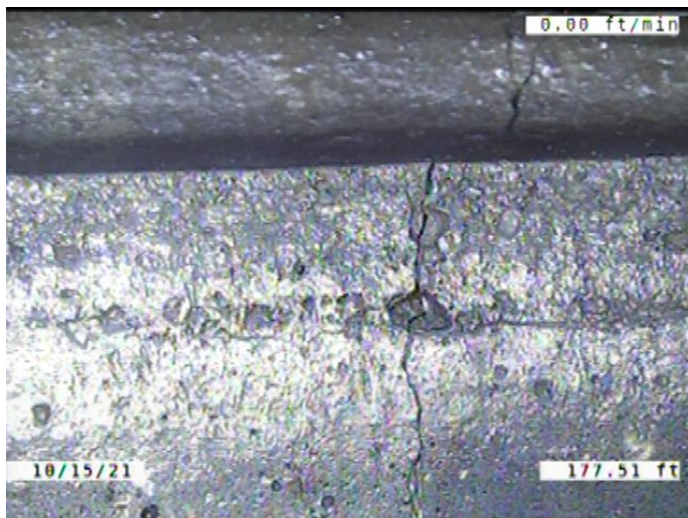
Code: **TBD**
Description: **Tap Break-in/Hammer Defective**

Distance (ft): **175.8**
Structural Grade: **0**
O&M Grade: **3**
Clock Start/From: **2**
Clock To:
1st Value: **4.000**
2nd Value:
Value Percent:
Continuous Index:
Within 8" of Joint: **YES**
Remarks: **Defective**
