Profile/Photo Observation Report

Date:	10/15/2021	Weather:		Coding:	PACP 7.0
Pipe Length (ft):	331.2	Owner:	City of Hobart	Pre Clean:	Heavy Cleaning
P.O.#:	YES502259	Surveyor:	S. Bucklin	PSR:	P-704-016-014
Customer:	City of Hobart	Clean Date:	10/12/2021	Shape:	C

Street:	North Michigan Avenue	Flow Control:	Not Controlled
City:	Hobart, IN	Year Renewed:	
Location:	Local rural streets with light traffic, t	Tape/Media #:	
Purpose:	Routine Assessment	Dia/Height:	8"
Use:	Sanitary Sewage Pipe	Material:	VCP
Drain Area:		Lining:	
Category:	NA		
Comment:			
Location Details:		Direction of Survey:	Downstream
US MH:	M-704-016	DS MH:	M-704-014
		Total Length Surveyed (ft):	331.2

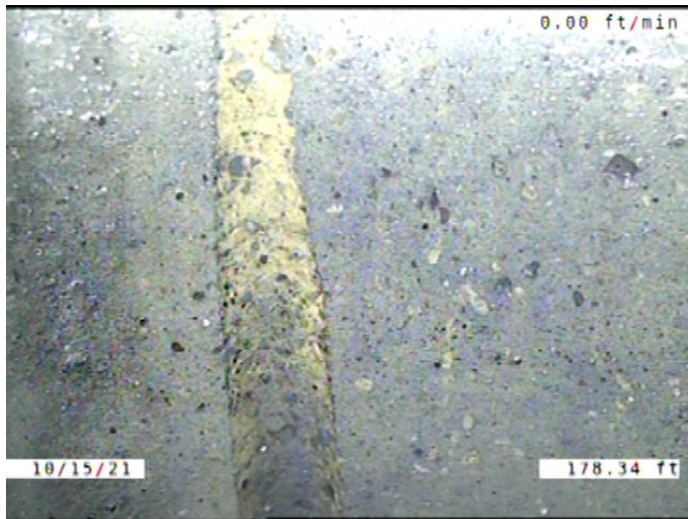
Code: **CM**
Description: **Crack Multiple**

Distance (ft): **177.5**
Structural Grade: **3**
O&M Grade: **0**
Clock Start/From: **8**
Clock To: **11**
1st Value:
2nd Value:
Value Percent:
Continuous Index:
Within 8" of Joint: **YES**
Remarks:

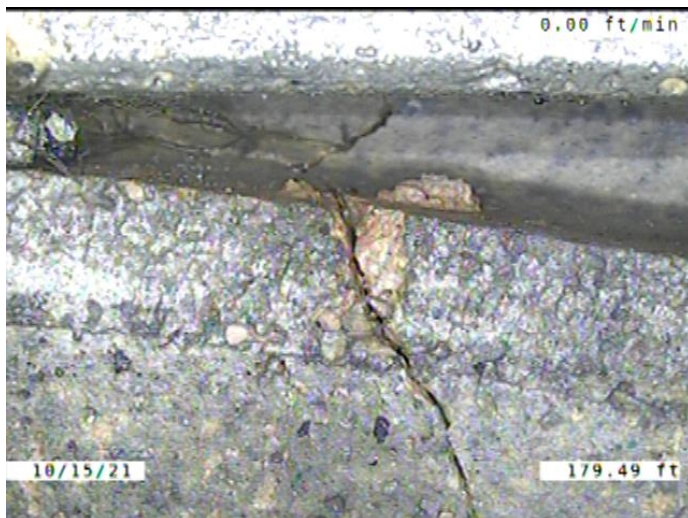
Code: **SZ**
 Description: **Surface Damage Other**

Distance (ft): **178.3**
 Structural Grade: **0**
 O&M Grade: **0**
 Clock Start/From: **8**
 Clock To:
 1st Value:
 2nd Value:
 Value Percent:
 Continuous Index:
 Within 8" of Joint: **YES**
 Remarks: **GROOVE IN THE PIPE WALL**

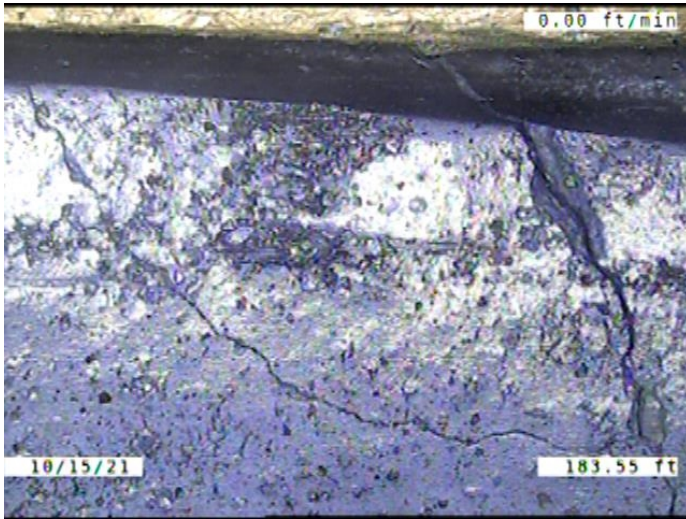
Code: **FM**
 Description: **Fracture Multiple**

Distance (ft): **179.5**
 Structural Grade: **4**
 O&M Grade: **0**
 Clock Start/From: **12**
 Clock To: **3**
 1st Value:
 2nd Value:
 Value Percent:
 Continuous Index:
 Within 8" of Joint: **YES**
 Remarks:

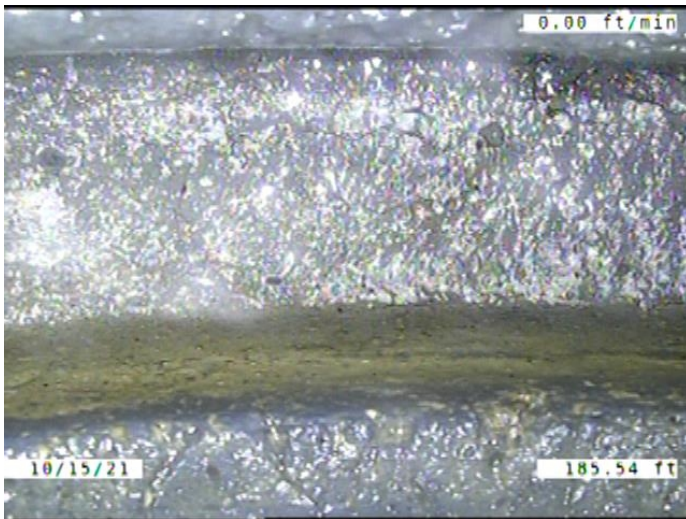
Code: **FM**
 Description: **Fracture Multiple**

Distance (ft): **183.5**
 Structural Grade: **4**
 O&M Grade: **0**
 Clock Start/From: **10**
 Clock To: **3**
 1st Value:
 2nd Value:
 Value Percent:
 Continuous Index:
 Within 8" of Joint: **YES**
 Remarks:

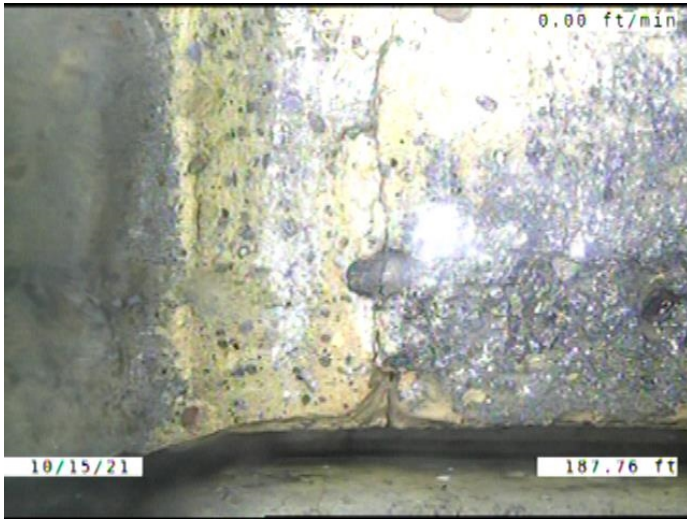
Code: **JAL**
 Description: **Joint Angular Large**

Distance (ft): **185.5**
 Structural Grade: **4**
 O&M Grade: **0**
 Clock Start/From:
 Clock To:
 1st Value:
 2nd Value:
 Value Percent:
 Continuous Index:
 Within 8" of Joint: **NO**
 Remarks:

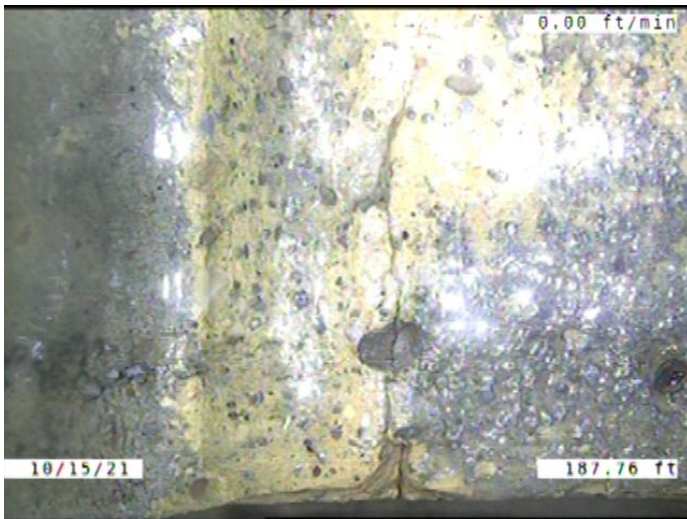
Code: **CL**
Description: **Crack Longitudinal**

Distance (ft): **187.8**
Structural Grade: **2**
O&M Grade: **0**
Clock Start/From: **4**
Clock To:
1st Value:
2nd Value:
Value Percent:
Continuous Index:
Within 8" of Joint: **YES**
Remarks:

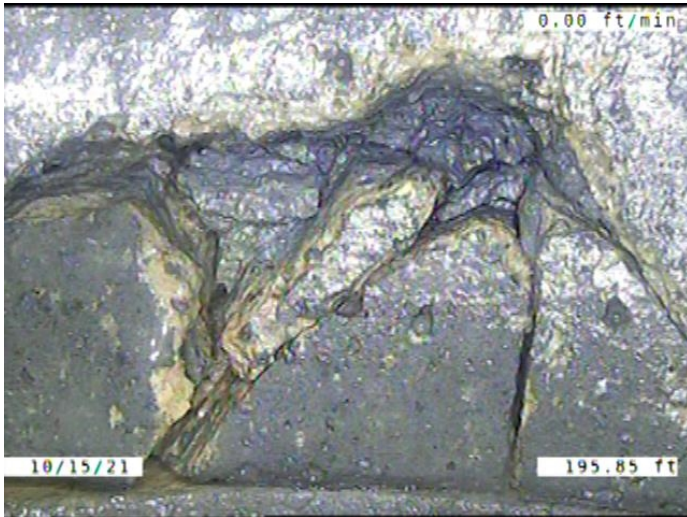
Code: **B**
Description: **Broken**

Distance (ft): **195.8**
Structural Grade: **4**
O&M Grade: **0**
Clock Start/From: **4**
Clock To: **5**
1st Value:
2nd Value:
Value Percent:
Continuous Index:
Within 8" of Joint: **YES**
Remarks:

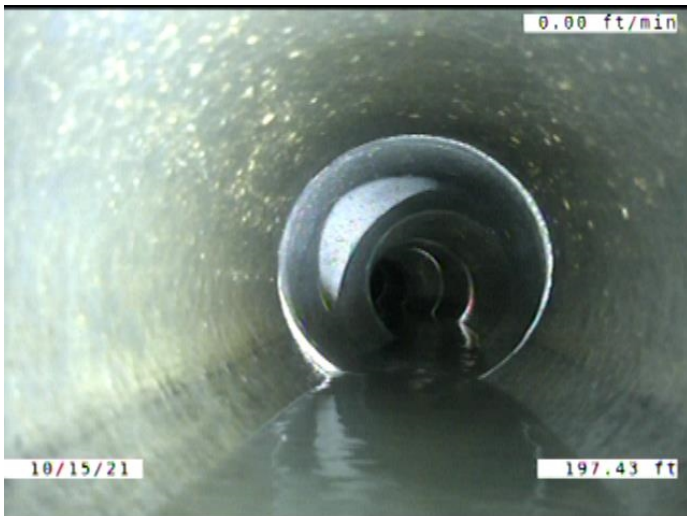
Code: **BSV**
Description: **Broken Soil Visible**

Distance (ft): **195.8**
Structural Grade: **5**
O&M Grade: **0**
Clock Start/From: **11**
Clock To: **1**
1st Value:
2nd Value:
Value Percent:
Continuous Index:
Within 8" of Joint: **YES**
Remarks:

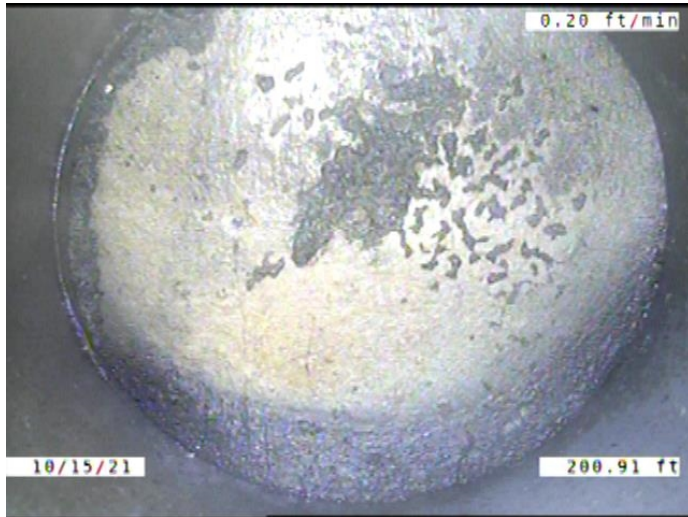
Code: **SZ**
Description: **Surface Damage Other**

Distance (ft): **197.4**
Structural Grade: **0**
O&M Grade: **0**
Clock Start/From: **4**
Clock To:
1st Value:
2nd Value:
Value Percent:
Continuous Index: **F08**
Within 8" of Joint: **YES**
Remarks: **GROOVE IN THE PIPE WALL**

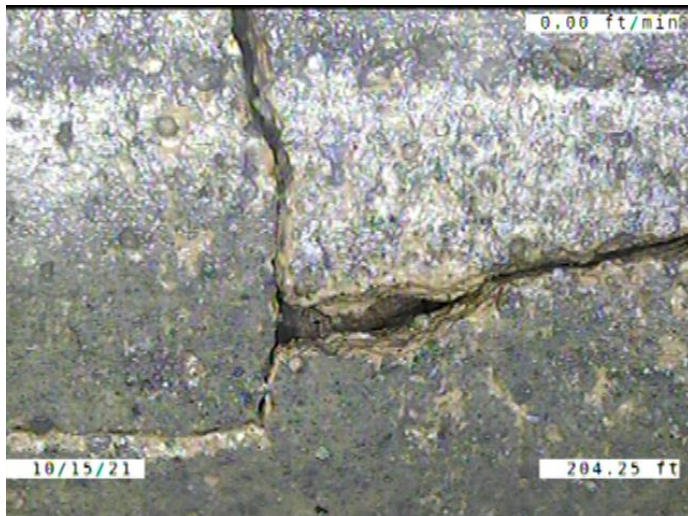
Code: **TFC**
Description: **Tap Factory Capped**

Distance (ft): **200.9**
Structural Grade: **0**
O&M Grade: **0**
Clock Start/From: **11**
Clock To:
1st Value: **4.000**
2nd Value:
Value Percent:
Continuous Index:
Within 8" of Joint: **YES**
Remarks:

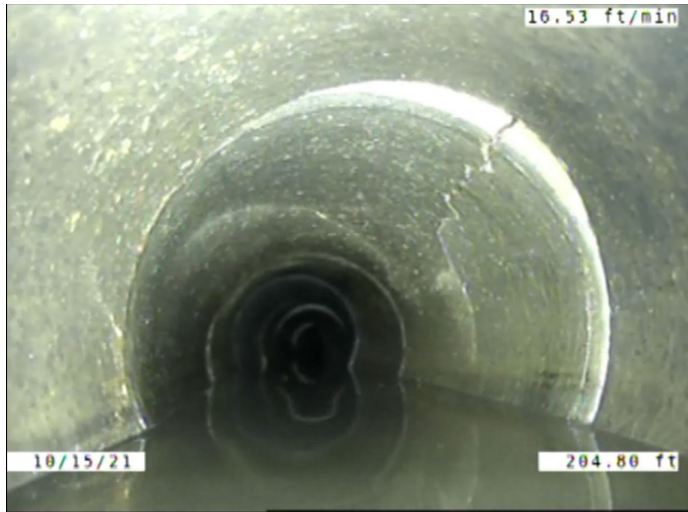
Code: **B**
Description: **Broken**

Distance (ft): **204.3**
Structural Grade: **4**
O&M Grade: **0**
Clock Start/From: **8**
Clock To: **4**
1st Value:
2nd Value:
Value Percent:
Continuous Index:
Within 8" of Joint: **YES**
Remarks:

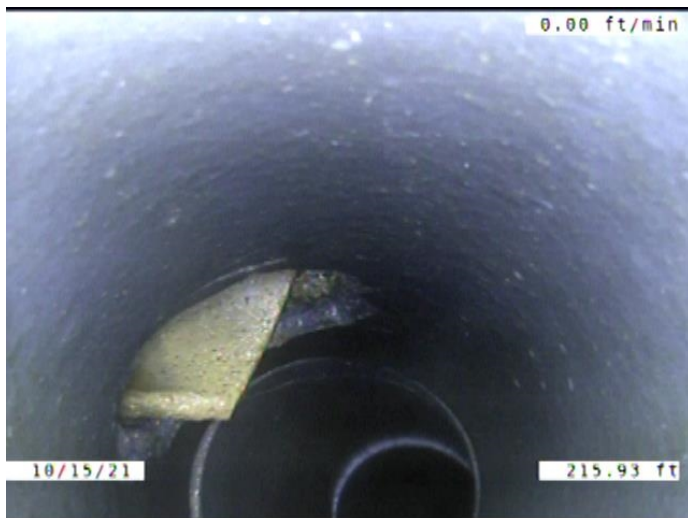
Code: **FM**
Description: **Fracture Multiple**

Distance (ft): **204.8**
Structural Grade: **4**
O&M Grade: **0**
Clock Start/From: **8**
Clock To: **4**
1st Value:
2nd Value:
Value Percent:
Continuous Index: **S09**
Within 8" of Joint: **YES**
Remarks:

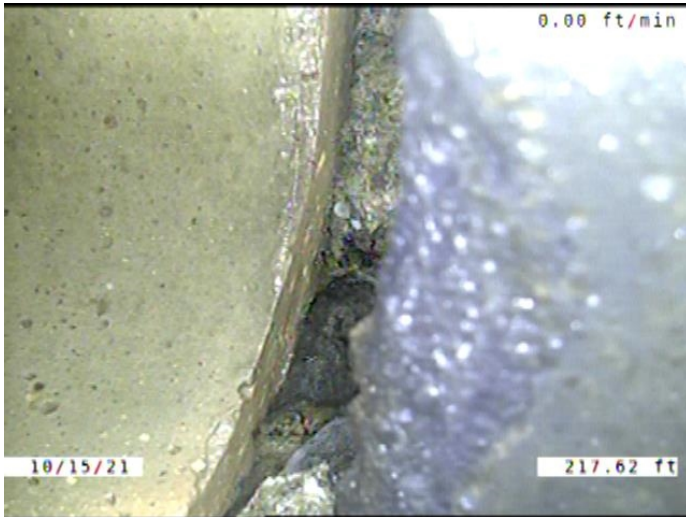
Code: **RFJ**
Description: **Roots Fine Joint**

Distance (ft): **215.9**
Structural Grade: **0**
O&M Grade: **1**
Clock Start/From: **8**
Clock To: **3**
1st Value:
2nd Value:
Value Percent:
Continuous Index: **F03**
Within 8" of Joint: **YES**
Remarks:

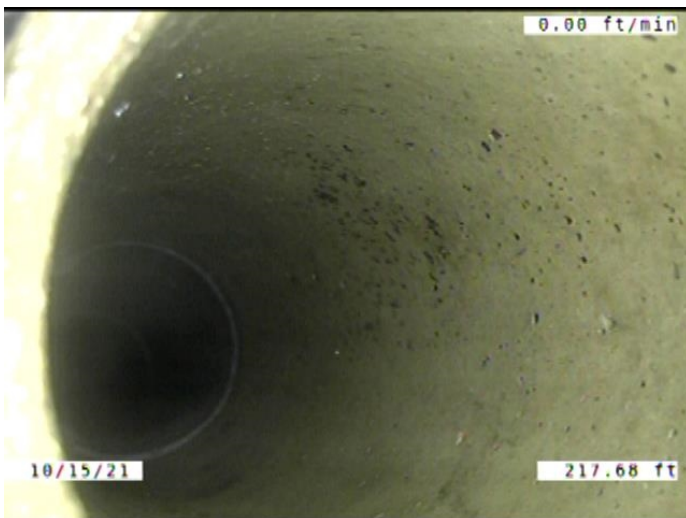
Code: **SSS**
 Description: **Surface Damage Surface Spalling**

Distance (ft): **217.6**
 Structural Grade: **2**
 O&M Grade: **0**
 Clock Start/From: **9**
 Clock To: **12**
 1st Value:
 2nd Value:
 Value Percent:
 Continuous Index:
 Within 8" of Joint: **YES**
 Remarks:

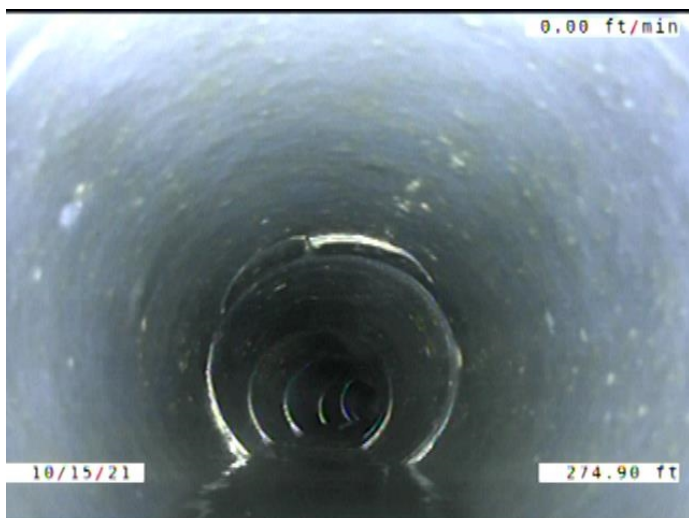
Code: **B**
 Description: **Broken**

Distance (ft): **272.1**
 Structural Grade: **4**
 O&M Grade: **0**
 Clock Start/From: **12**
 Clock To: **4**
 1st Value:
 2nd Value:
 Value Percent:
 Continuous Index:
 Within 8" of Joint: **YES**
 Remarks:

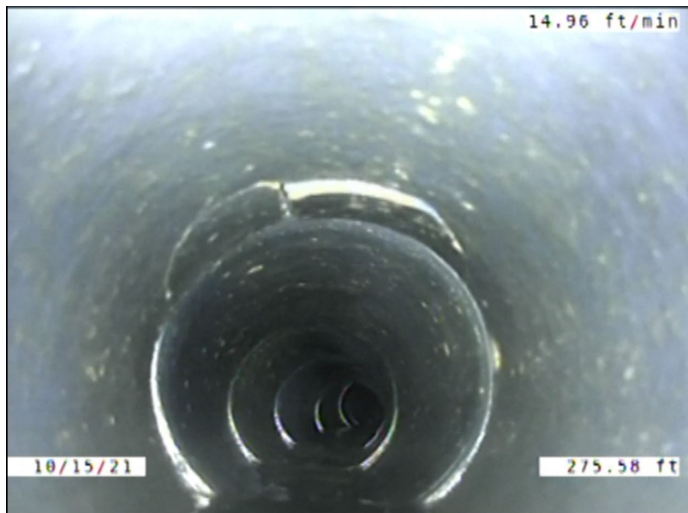
Code: **MWLS**
 Description: **Miscellaneous Water Level Sag**

Distance (ft): **274.9**
 Structural Grade: **3**
 O&M Grade: **0**
 Clock Start/From:
 Clock To:
 1st Value:
 2nd Value:
 Value Percent: **35.000**
 Continuous Index: **F10**
 Within 8" of Joint: **NO**
 Remarks:

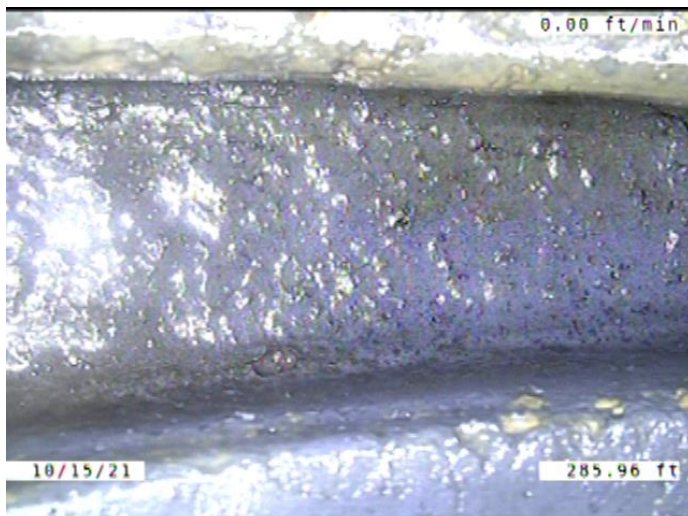
Code: **B**
Description: **Broken**

Distance (ft): **275.6**
Structural Grade: **4**
O&M Grade: **0**
Clock Start/From: **10**
Clock To: **2**
1st Value:
2nd Value:
Value Percent:
Continuous Index:
Within 8" of Joint: **YES**
Remarks:

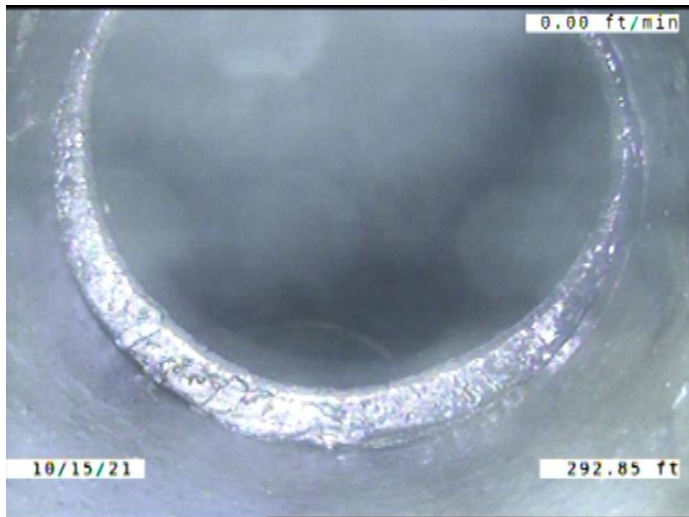
Code: **JAL**
Description: **Joint Angular Large**

Distance (ft): **286.0**
Structural Grade: **4**
O&M Grade: **0**
Clock Start/From:
Clock To:
1st Value:
2nd Value:
Value Percent:
Continuous Index:
Within 8" of Joint: **NO**
Remarks:

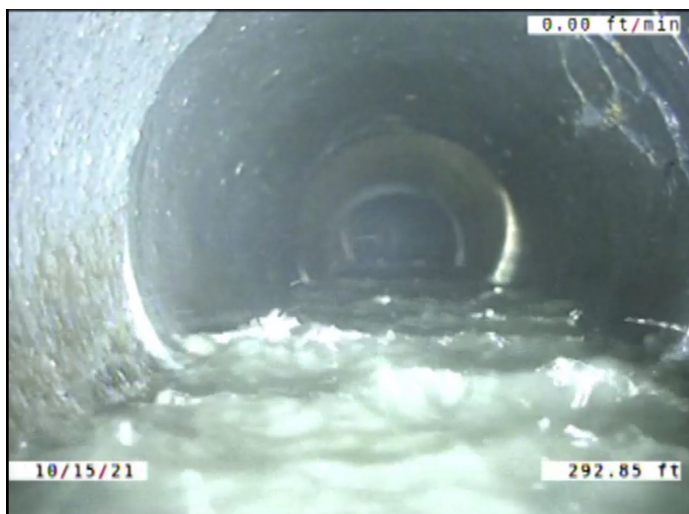
Code: **TF**
 Description: **Tap Factory**

Distance (ft): **292.9**
 Structural Grade: **0**
 O&M Grade: **0**
 Clock Start/From: **2**
 Clock To:
 1st Value: **4.000**
 2nd Value:
 Value Percent:
 Continuous Index:
 Within 8" of Joint: **YES**
 Remarks:

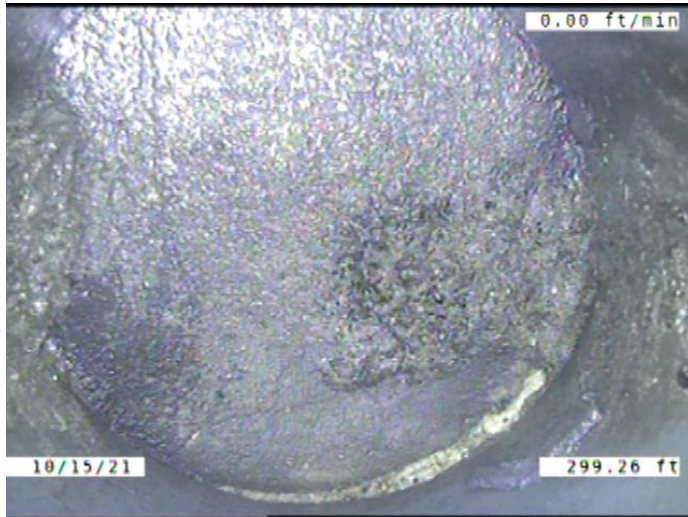
Code: **B**
 Description: **Broken**

Distance (ft): **292.9**
 Structural Grade: **4**
 O&M Grade: **0**
 Clock Start/From: **1**
 Clock To: **3**
 1st Value:
 2nd Value:
 Value Percent:
 Continuous Index:
 Within 8" of Joint: **YES**
 Remarks:
