Profile/Photo Observation Report

Street:	N Michigan Ave.	Flow Control:	Not Controlled
City:	Hobart, IN	Year Renewed:	
Location:	Other	Tape/Media #:	
Purpose:	Not Known	Dia/Height:	8"
Use:	Sanitary	Material:	VCP
Drain Area:	NA	Lining:	
Category:	NA		
Comment:

Location Details:		Direction of Survey:	Downstream
US MH:	M-704-017	DS MH:	M-704-016
		Total Length Surveyed (ft):	16.8

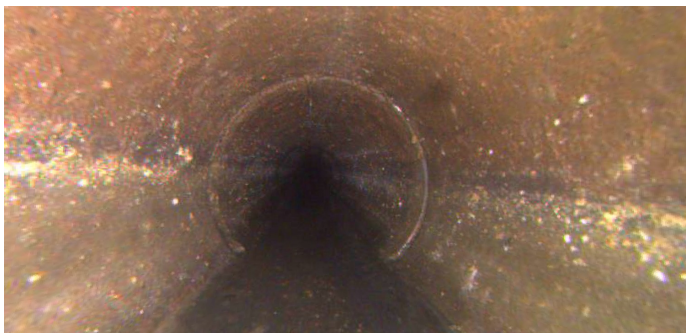
Code: **AMH**
Description: **Manhole**

Distance (ft): **.0**
Structural Grade: **0**
O&M Grade: **0**
Clock Start/From:
Clock To:
1st Value:
2nd Value:
Value Percent:
Continuous Index:
Within 8" of Joint: **NO**
Remarks: **M-704-017**
