# Profile/Photo Observation Report

| Pipe Length (ft): | 330.5 | Owner: | City of Hobart | Pre Clean: | Heavy Cleaning |

| Street: | North Michigan Avenue | Flow Control: | Not Controlled |
| US MH: | M-704-018 | DS MH: | M-704-017 |

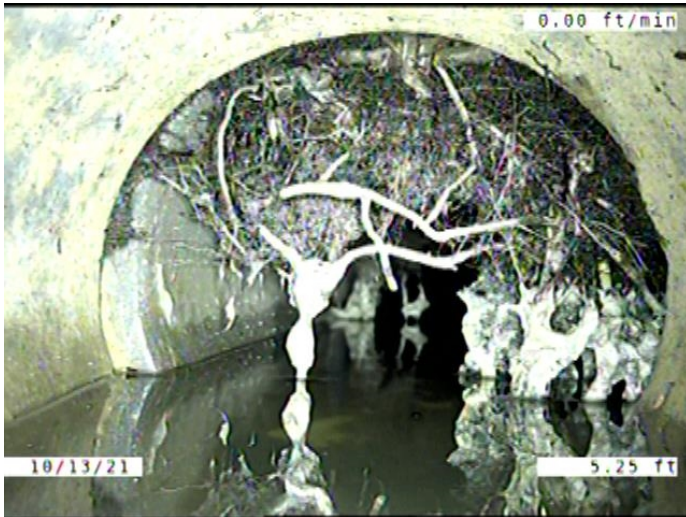
Code: **RMJ**  
 Description: **Roots Medium Joint**

Distance (ft): **5.2**  
 Structural Grade: **0**  
 O&M Grade: **3**  
 Clock Start/From: **9**  
 Clock To: **4**  
 1st Value:  
 2nd Value:  
 Value Percent: **50.000**  
 Continuous Index: **S01**  
 Within 8" of Joint: **YES**  
 Remarks:

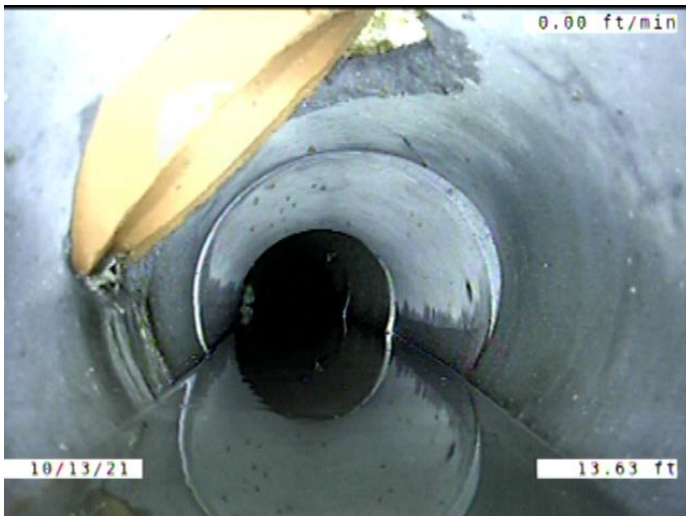
Code: **RMJ**  
 Description: **Roots Medium Joint**

Distance (ft): **13.6**  
 Structural Grade: **0**  
 O&M Grade: **3**  
 Clock Start/From: **9**  
 Clock To: **4**  
 1st Value:  
 2nd Value:  
 Value Percent: **50.000**  
 Continuous Index: **F01**  
 Within 8" of Joint: **YES**  
 Remarks:

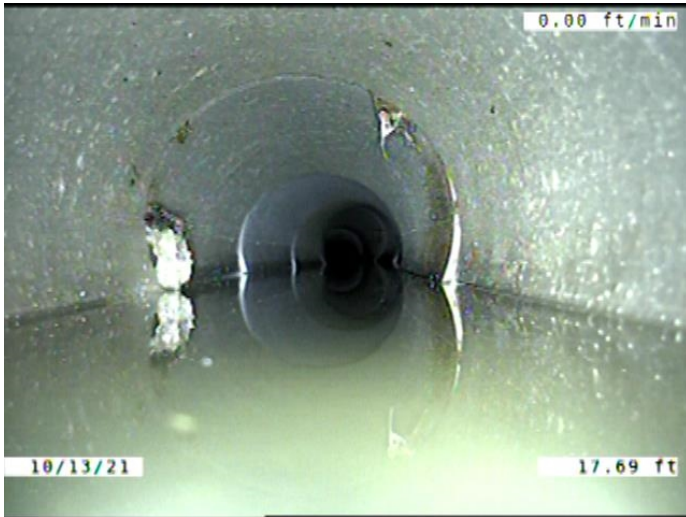
Code: **MWLS**  
 Description: **Miscellaneous Water Level Sag**

Distance (ft): **17.7**  
 Structural Grade: **2**  
 O&M Grade: **0**  
 Clock Start/From:  
 Clock To:  
 1st Value:  
 2nd Value:  
 Value Percent: **15.000**  
 Continuous Index:  
 Within 8" of Joint: **NO**  
 Remarks:

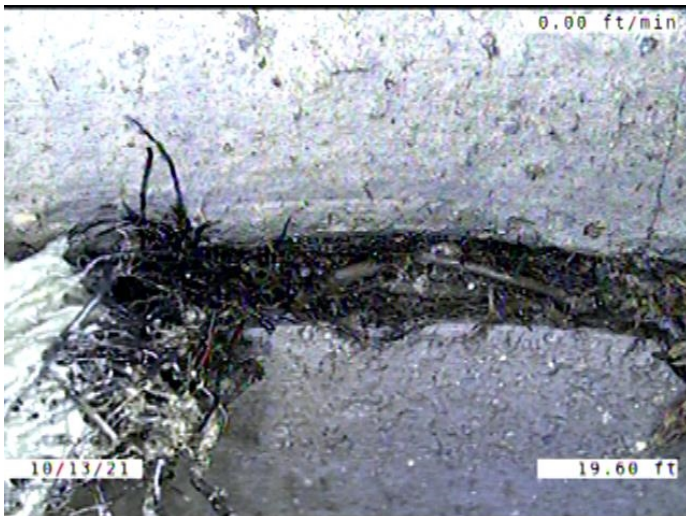
Code: **RMJ**  
 Description: **Roots Medium Joint**

Distance (ft): **19.6**  
 Structural Grade: **0**  
 O&M Grade: **3**  
 Clock Start/From: **9**  
 Clock To: **3**  
 1st Value:  
 2nd Value:  
 Value Percent: **5.000**  
 Continuous Index:  
 Within 8" of Joint: **YES**  
 Remarks:

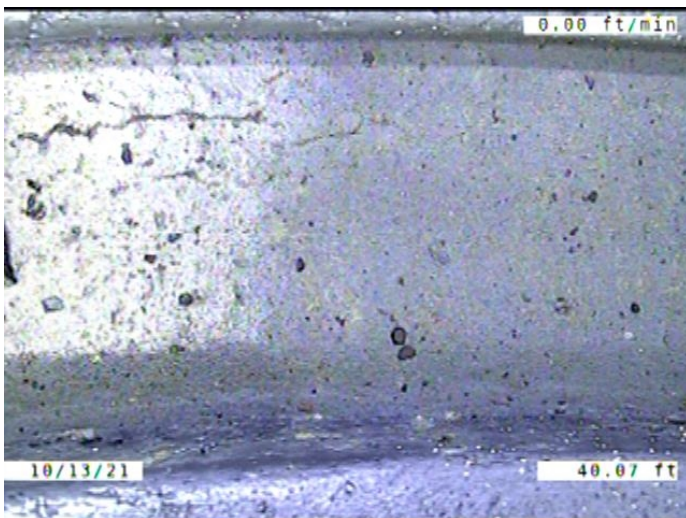
Code: **JAL**  
Description: **Joint Angular Large**

Distance (ft): **40.1**  
Structural Grade: **4**  
O&M Grade: **0**  
Clock Start/From:  
Clock To:  
1st Value:  
2nd Value:  
Value Percent:  
Continuous Index:  
Within 8" of Joint: **NO**  
Remarks:

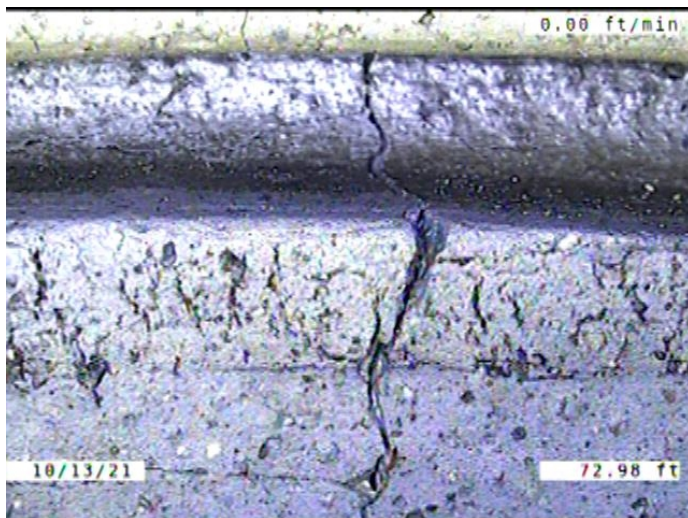
| 73.0 | FM | Fracture Multiple | 1066 | S 4 |

Code: **FM**  
Description: **Fracture Multiple**

Distance (ft): **73.0**  
Structural Grade: **4**  
O&M Grade: **0**  
Clock Start/From: **8**  
Clock To: **4**  
1st Value:  
2nd Value:  
Value Percent:  
Continuous Index:  
Within 8" of Joint: **YES**  
Remarks:

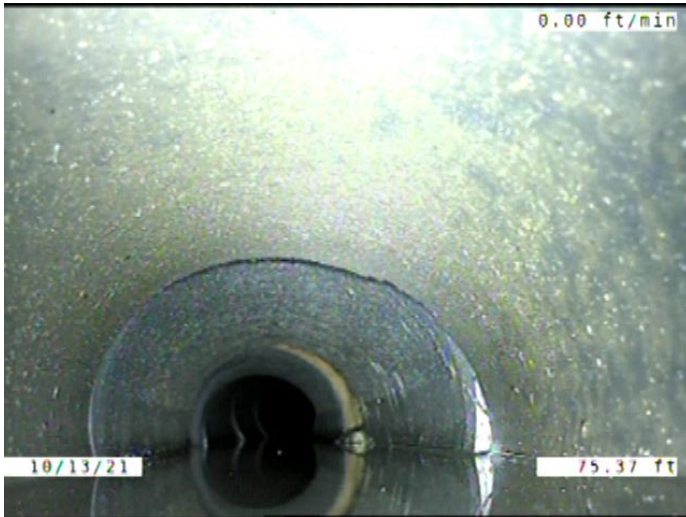
Code: **MWLS**  
 Description: **Miscellaneous Water Level Sag**

Distance (ft): **75.4**  
 Structural Grade: **2**  
 O&M Grade: **0**  
 Clock Start/From:  
 Clock To:  
 1st Value:  
 2nd Value:  
 Value Percent: **15.000**  
 Continuous Index: **S02**  
 Within 8" of Joint: **NO**  
 Remarks:

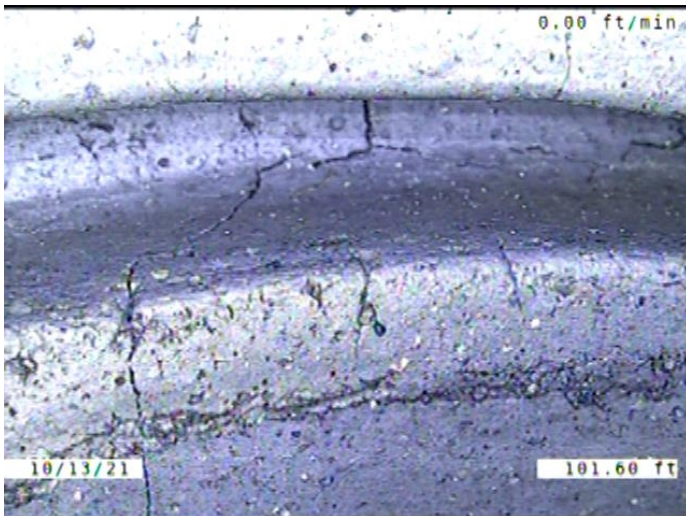
| 101.6 | CM | Crack Multiple | 1446 | S 3 |

Code: **CM**  
Description: **Crack Multiple**

Distance (ft): **101.6**  
Structural Grade: **3**  
O&M Grade: **0**  
Clock Start/From: **10**  
Clock To: **12**  
1st Value:  
2nd Value:  
Value Percent:  
Continuous Index:  
Within 8" of Joint: **YES**  
Remarks:

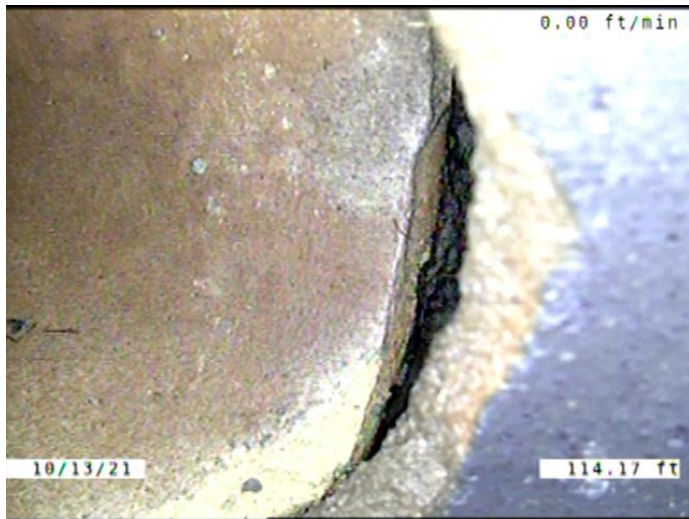
| 114.2 | SSS | Surface Damage Surface Spalling | 1540 | S 2 |

Code: **SSS**  
Description: **Surface Damage Surface Spalling**

Distance (ft): **114.2**  
Structural Grade: **2**  
O&M Grade: **0**  
Clock Start/From: **9**  
Clock To: **12**  
1st Value:  
2nd Value:  
Value Percent:  
Continuous Index:  
Within 8" of Joint: **YES**  
Remarks:

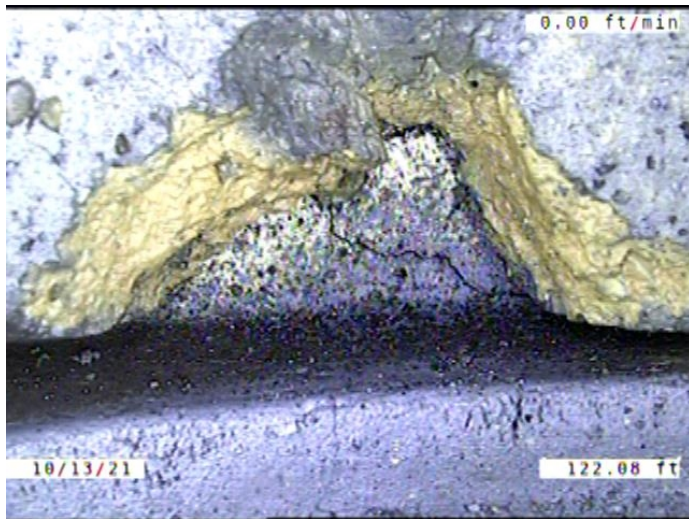
| 122.1 | SMW | Surface Damage Missing Wall | 1638 | S 5 |

Code: **SMW**  
Description: **Surface Damage Missing Wall**

Distance (ft): **122.1**  
Structural Grade: **5**  
O&M Grade: **0**  
Clock Start/From: **10**  
Clock To: **11**  
1st Value:  
2nd Value:  
Value Percent:  
Continuous Index:  
Within 8" of Joint: **YES**  
Remarks: **INSIDE OF THE JOINT**

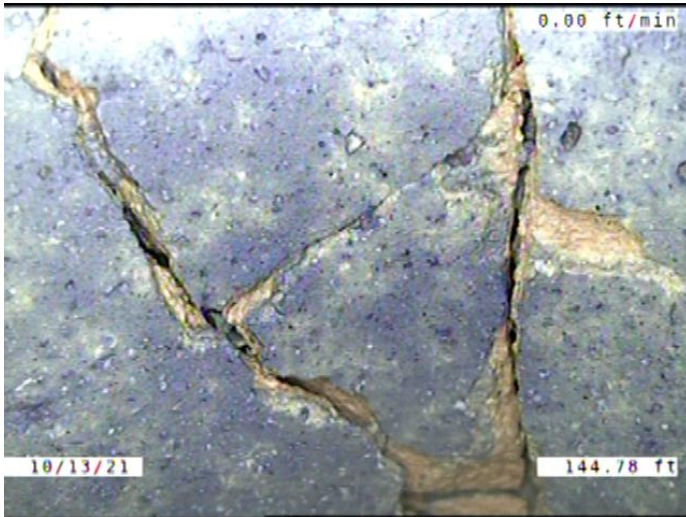
| 144.8 | B | Broken | 2068 | S 4 |

Code: **B**  
Description: **Broken**

Distance (ft): **144.8**  
Structural Grade: **4**  
O&M Grade: **0**  
Clock Start/From: **11**  
Clock To: **1**  
1st Value:  
2nd Value:  
Value Percent:  
Continuous Index:  
Within 8" of Joint: **YES**  
Remarks:

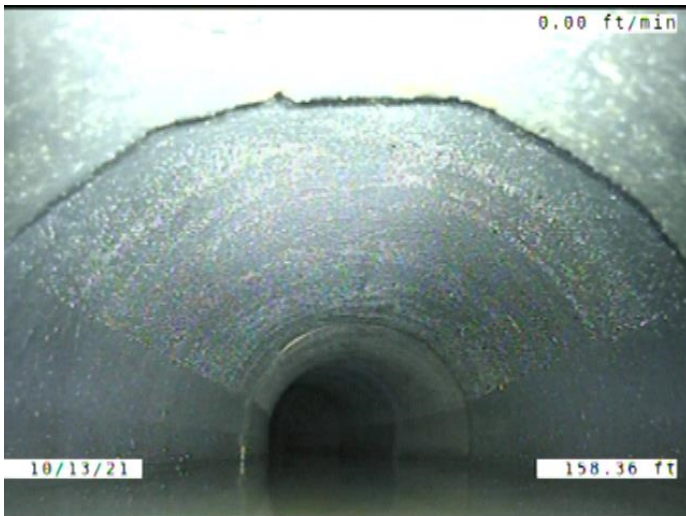
Code: **MWLS**  
Description: **Miscellaneous Water Level Sag**

Distance (ft): **158.4**  
Structural Grade: **2**  
O&M Grade: **0**  
Clock Start/From:  
Clock To:  
1st Value:  
2nd Value:  
Value Percent: **15.000**  
Continuous Index: **S03**  
Within 8" of Joint: **NO**  
Remarks:

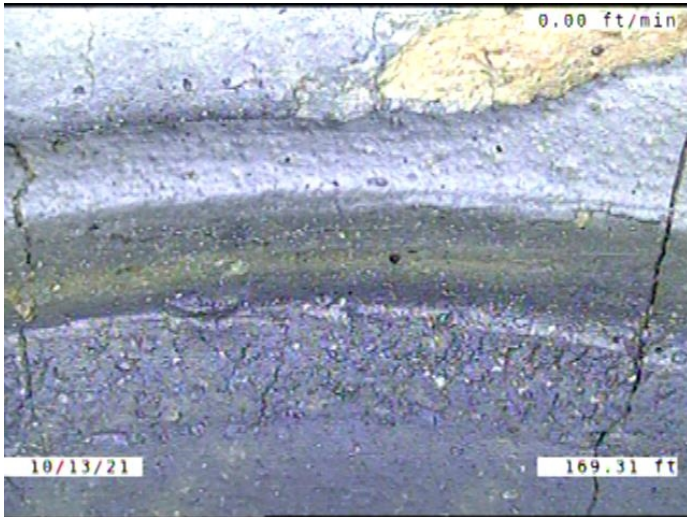
| 169.3 | B | Broken | 2326 | S 4 |

Code: **B**  
Description: **Broken**

Distance (ft): **169.3**  
Structural Grade: **4**  
O&M Grade: **0**  
Clock Start/From: **9**  
Clock To: **3**  
1st Value:  
2nd Value:  
Value Percent:  
Continuous Index:  
Within 8" of Joint: **YES**  
Remarks:

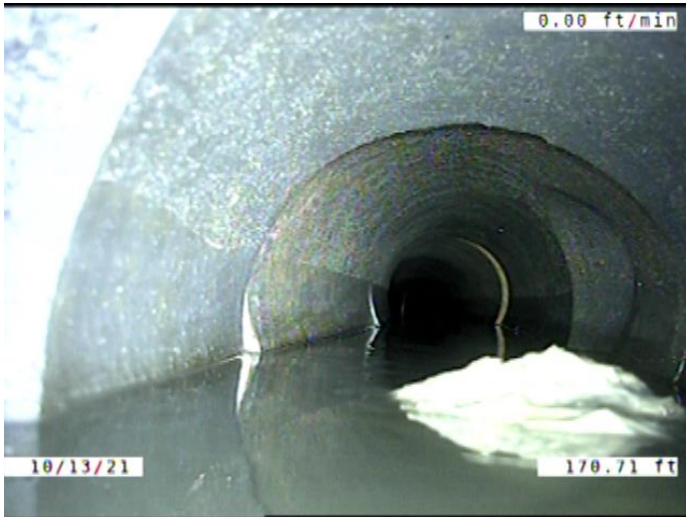
Code: **OBZ**  
 Description: **Obstruction Other**

Distance (ft): **170.7**  
 Structural Grade: **0**  
 O&M Grade: **3**  
 Clock Start/From: **5**  
 Clock To: **7**  
 1st Value:  
 2nd Value:  
 Value Percent: **15.000**  
 Continuous Index:  
 Within 8" of Joint: **NO**  
 Remarks: **RAGS AND TP**

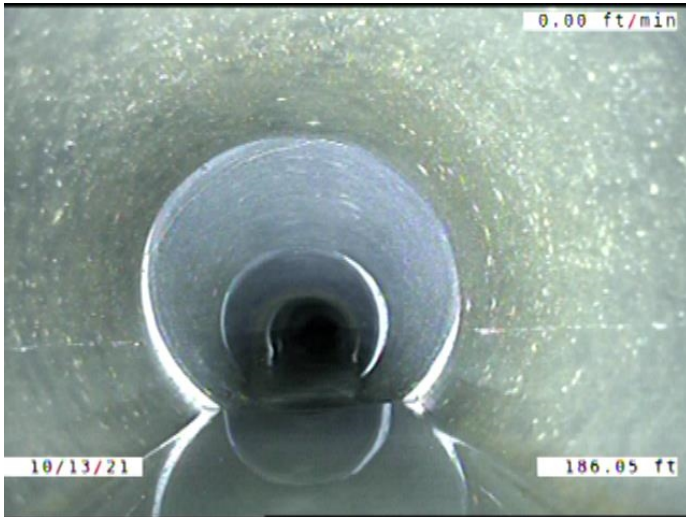
Code: **MWLS**  
 Description: **Miscellaneous Water Level Sag**

Distance (ft): **186.0**  
 Structural Grade: **2**  
 O&M Grade: **0**  
 Clock Start/From:  
 Clock To:  
 1st Value:  
 2nd Value:  
 Value Percent: **15.000**  
 Continuous Index: **F03**  
 Within 8" of Joint: **NO**  
 Remarks:

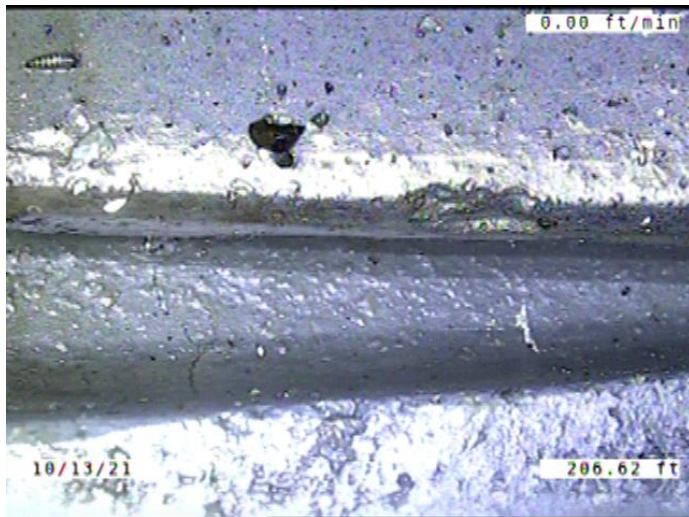
Code: **JAM**  
 Description: **Joint Angular Medium**

Distance (ft): **206.6**  
 Structural Grade: **3**  
 O&M Grade: **0**  
 Clock Start/From:  
 Clock To:  
 1st Value:  
 2nd Value:  
 Value Percent:  
 Continuous Index:  
 Within 8" of Joint: **NO**  
 Remarks:

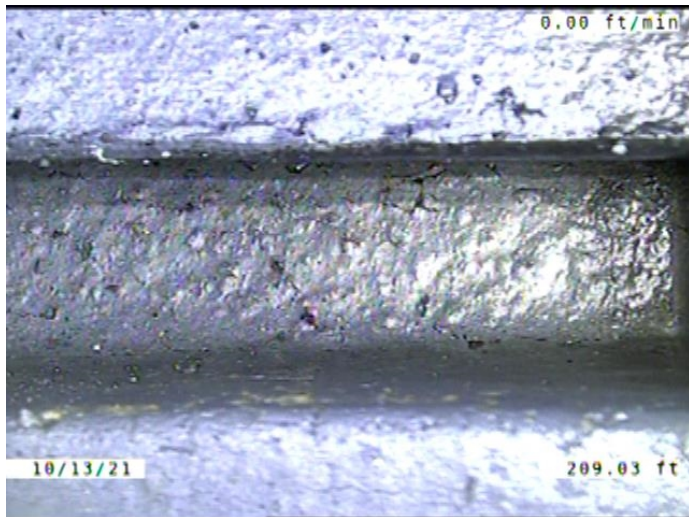
Code: **JAM**  
 Description: **Joint Angular Medium**

Distance (ft): **209.0**  
 Structural Grade: **3**  
 O&M Grade: **0**  
 Clock Start/From:  
 Clock To:  
 1st Value:  
 2nd Value:  
 Value Percent:  
 Continuous Index:  
 Within 8" of Joint: **NO**  
 Remarks:

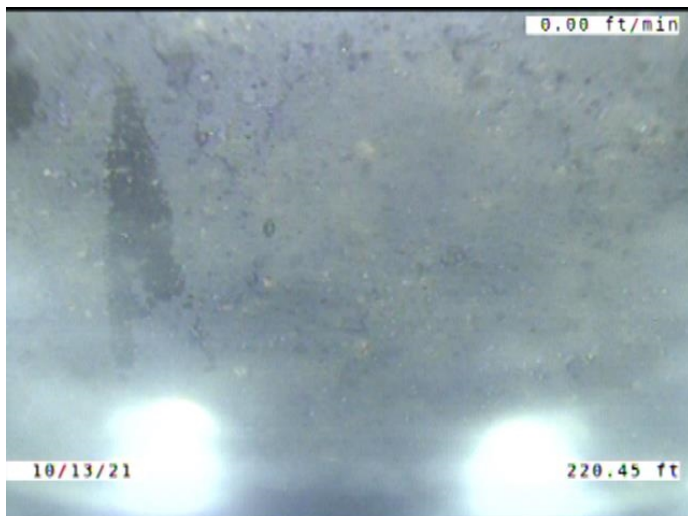
Code: **MCU**  
Description: **Miscellaneous Camera Underwater**

Distance (ft): **220.5**  
Structural Grade: **0**  
O&M Grade: **4**  
Clock Start/From:  
Clock To:  
1st Value:  
2nd Value:  
Value Percent:  
Continuous Index: **S05**  
Within 8" of Joint: **NO**  
Remarks:

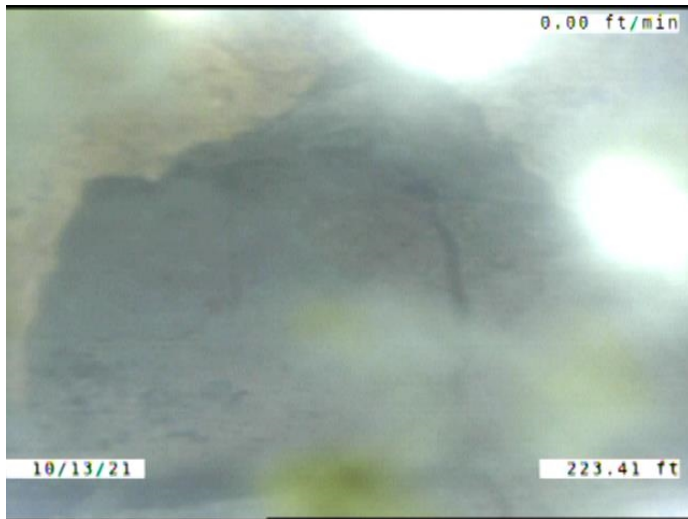
| 223.4 | B | Broken | 3249 | S 4 |

Code: **B**  
Description: **Broken**

Distance (ft): **223.4**  
Structural Grade: **4**  
O&M Grade: **0**  
Clock Start/From: **11**  
Clock To: **1**  
1st Value:  
2nd Value:  
Value Percent:  
Continuous Index:  
Within 8" of Joint: **YES**  
Remarks: **Visible through water**

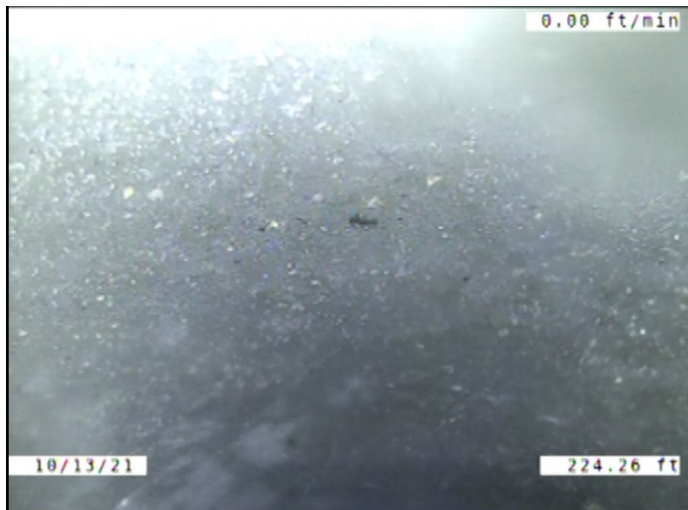
Code: **MCU**  
Description: **Miscellaneous Camera Underwater**

Distance (ft): **224.3**  
Structural Grade: **0**  
O&M Grade: **4**  
Clock Start/From:  
Clock To:  
1st Value:  
2nd Value:  
Value Percent:  
Continuous Index: **F05**  
Within 8" of Joint: **NO**  
Remarks:

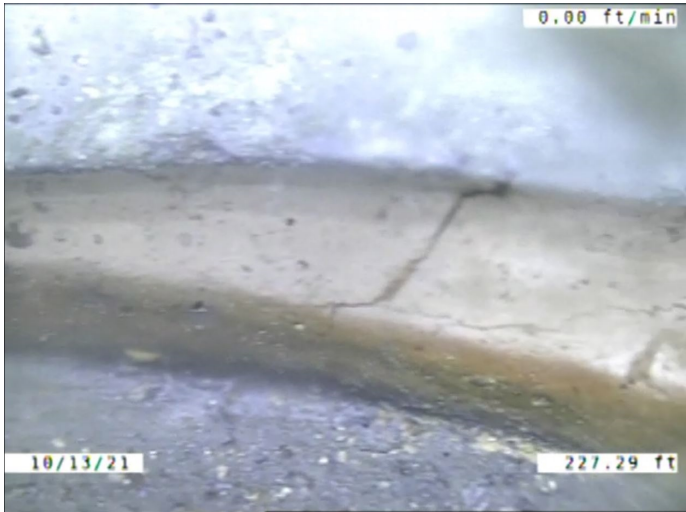
| 227.9 | FM | Fracture Multiple | 3418 | S 4 |

Code: **FM**  
Description: **Fracture Multiple**

Distance (ft): **227.9**  
Structural Grade: **4**  
O&M Grade: **0**  
Clock Start/From: **8**  
Clock To: **4**  
1st Value:  
2nd Value:  
Value Percent:  
Continuous Index:  
Within 8" of Joint: **YES**  
Remarks:

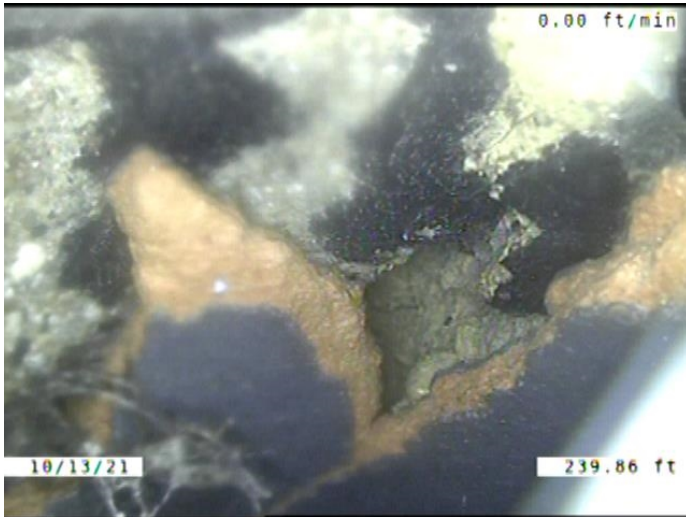
| 239.9 | BSV | Broken Soil Visible | 3731 | S 5 |

Code: **BSV**  
Description: **Broken Soil Visible**

Distance (ft): **239.9**  
Structural Grade: **5**  
O&M Grade: **0**  
Clock Start/From: **9**  
Clock To: **3**  
1st Value:  
2nd Value:  
Value Percent:  
Continuous Index:  
Within 8" of Joint: **YES**  
Remarks:

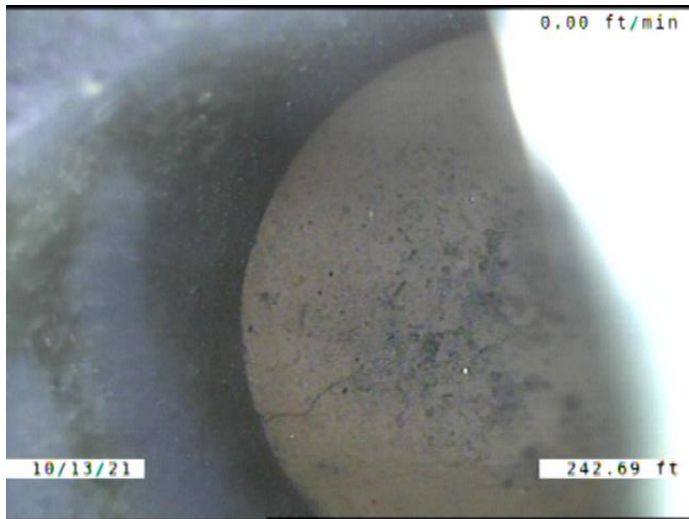
Code: **TFC**  
Description: **Tap Factory Capped**

Distance (ft): **242.7**  
Structural Grade: **0**  
O&M Grade: **0**  
Clock Start/From: **3**  
Clock To:  
1st Value: **4.000**  
2nd Value:  
Value Percent:  
Continuous Index:  
Within 8" of Joint: **YES**  
Remarks:

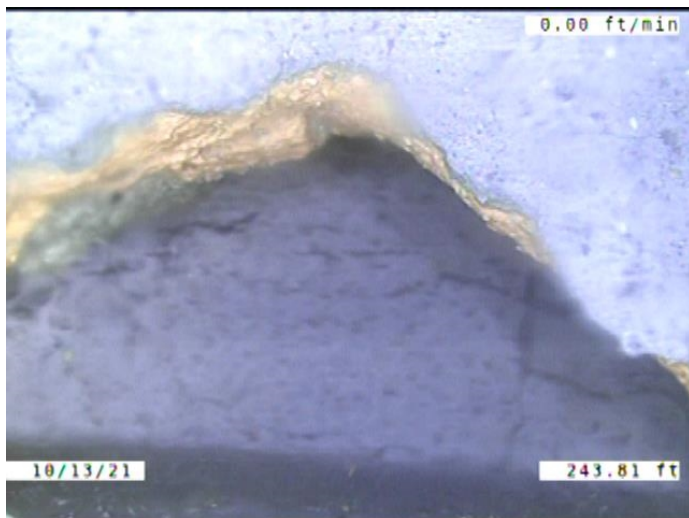
| 243.8 | SMW | Surface Damage Missing Wall | 3861 | S 5 |

Code: **SMW**  
Description: **Surface Damage Missing Wall**

Distance (ft): **243.8**  
Structural Grade: **5**  
O&M Grade: **0**  
Clock Start/From: **10**  
Clock To: **11**  
1st Value:  
2nd Value:  
Value Percent:  
Continuous Index:  
Within 8" of Joint: **YES**  
Remarks: **INSIDE OF THE JOINT**

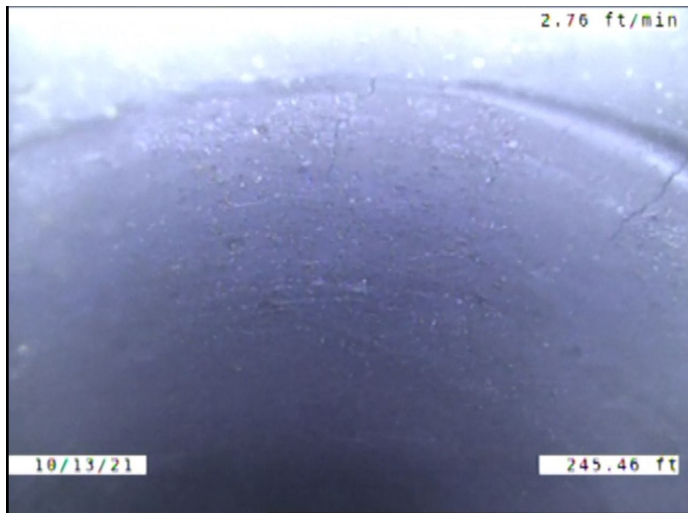
| 245.5 | FM(S04) | Fracture Multiple | 3896 | S 4 |

Code: **FM**  
Description: **Fracture Multiple**

Distance (ft): **245.5**  
Structural Grade: **4**  
O&M Grade: **0**  
Clock Start/From: **8**  
Clock To: **4**  
1st Value:  
2nd Value:  
Value Percent:  
Continuous Index: **S04**  
Within 8" of Joint: **YES**  
Remarks: **Wandering**

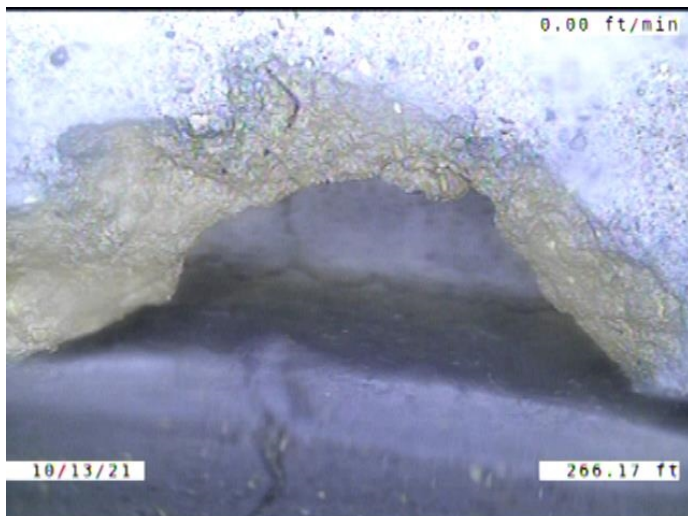
| 266.2 | SZ | Surface Damage Other | 4094 | NA |

Code: **SZ**  
Description: **Surface Damage Other**

Distance (ft): **266.2**  
Structural Grade: **0**  
O&M Grade: **0**  
Clock Start/From: **12**  
Clock To:  
1st Value:  
2nd Value:  
Value Percent:  
Continuous Index:  
Within 8" of Joint: **YES**  
Remarks: **A PIECE CHIPPED AWAY FROM THE JOINT**

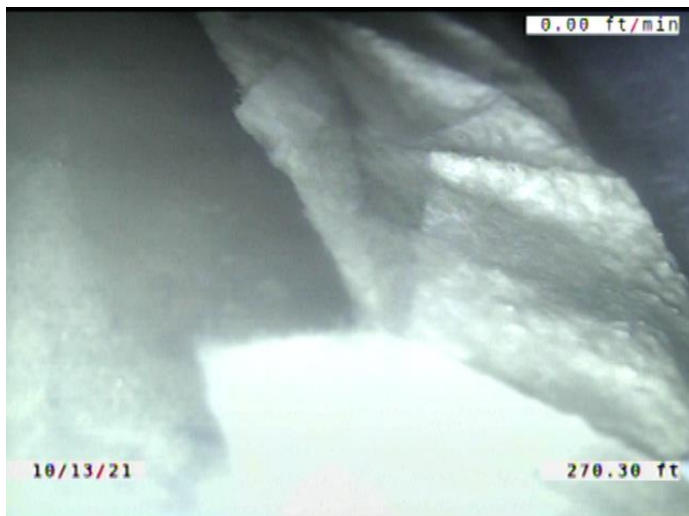
Code: **DAR**  
 Description: **Deposits Attached Ragging**

Distance (ft): **270.3**  
 Structural Grade: **0**  
 O&M Grade: **2**  
 Clock Start/From: **5**  
 Clock To:  
 1st Value:  
 2nd Value:  
 Value Percent: **5.000**  
 Continuous Index:  
 Within 8" of Joint: **YES**  
 Remarks:

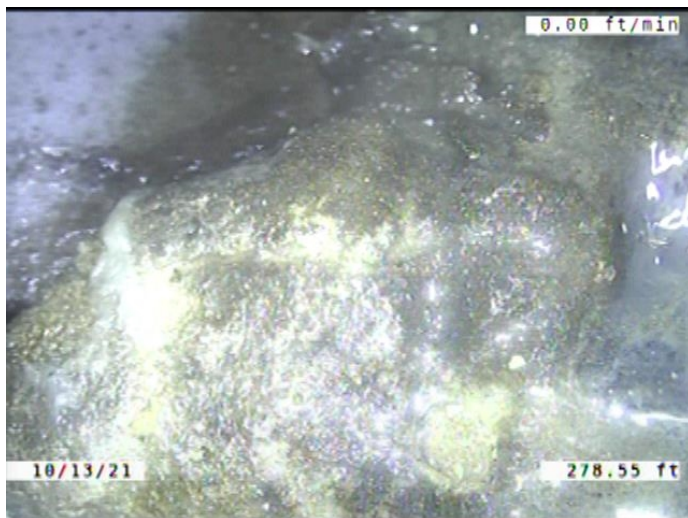
| Code: | <b>DAE</b> |
| Description: | <b>Deposits Attached Encrustation</b> |
| Distance (ft): | <b>278.5</b> |
| O&M Grade: | <b>2</b> |

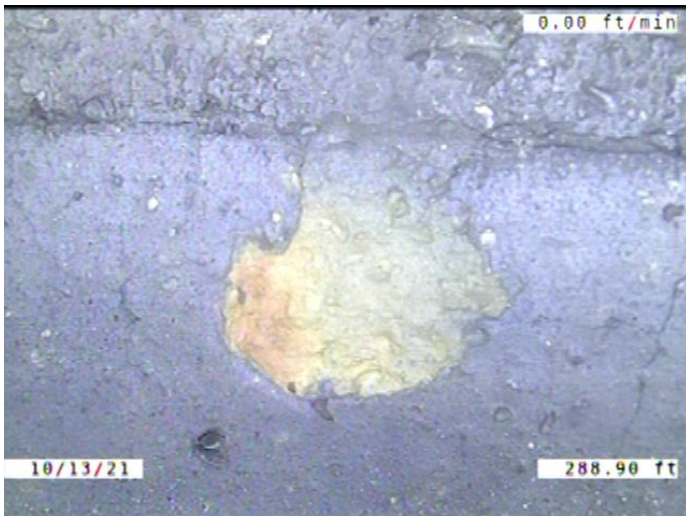
| 288.9 | SSS | Surface Damage Surface Spalling | 4350 | S 2 |

Code: **SSS**  
 Description: **Surface Damage Surface Spalling**

Distance (ft): **288.9**  
 Structural Grade: **2**  
 O&M Grade: **0**  
 Clock Start/From: **1**  
 Clock To: **2**  
 1st Value:  
 2nd Value:  
 Value Percent:  
 Continuous Index:  
 Within 8" of Joint: **YES**  
 Remarks:

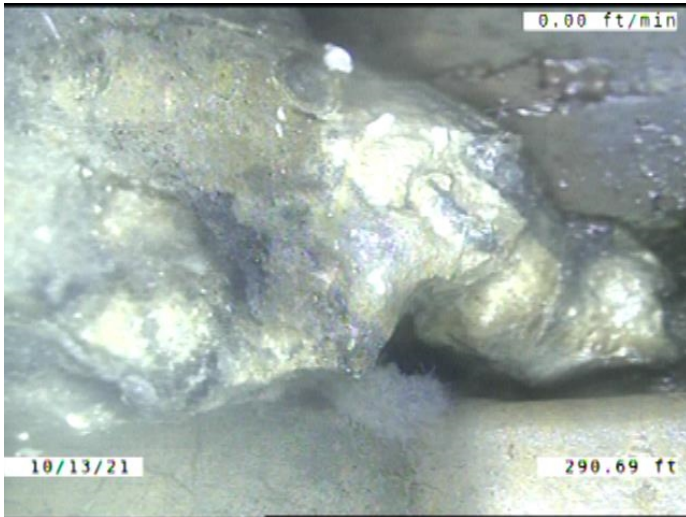
Code: **DAE**  
Description: **Deposits Attached Encrustation**

Distance (ft): **290.7**  
Structural Grade: **0**  
O&M Grade: **2**  
Clock Start/From: **4**  
Clock To: **8**  
1st Value:  
2nd Value:  
Value Percent: **5.000**  
Continuous Index:  
Within 8" of Joint: **YES**  
Remarks:

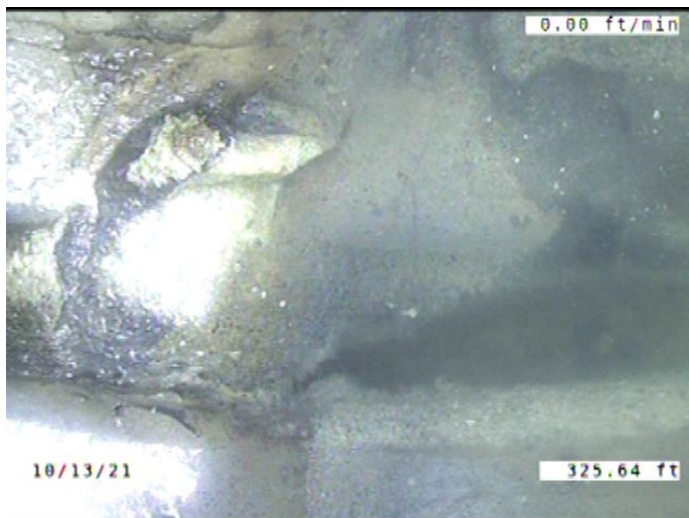
Code: **DAE**  
Description: **Deposits Attached Encrustation**

Distance (ft): **325.6**  
Structural Grade: **0**  
O&M Grade: **2**  
Clock Start/From: **4**  
Clock To: **1**  
1st Value:  
2nd Value:  
Value Percent: **5.000**  
Continuous Index:  
Within 8" of Joint: **YES**  
Remarks:

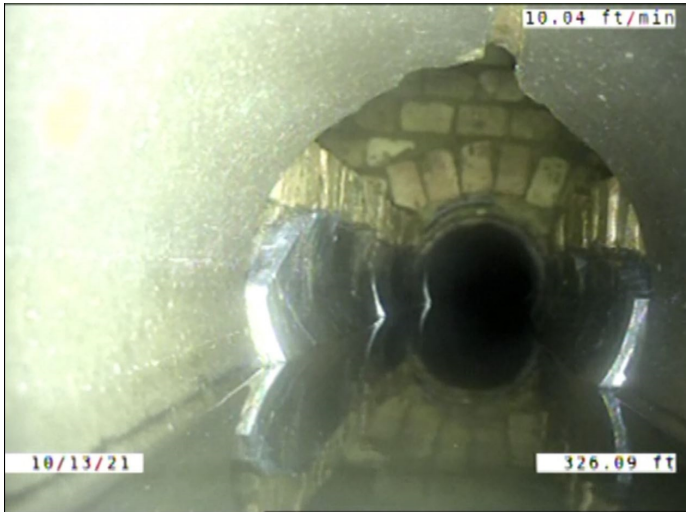
| 326.1 | FM(F04) | Fracture Multiple | 4685 | S 4 |

Code: **FM**  
Description: **Fracture Multiple**

Distance (ft): **326.1**  
Structural Grade: **4**  
O&M Grade: **0**  
Clock Start/From: **8**  
Clock To: **4**  
1st Value:  
2nd Value:  
Value Percent:  
Continuous Index: **F04**  
Within 8" of Joint: **YES**  
Remarks: **Wandering**

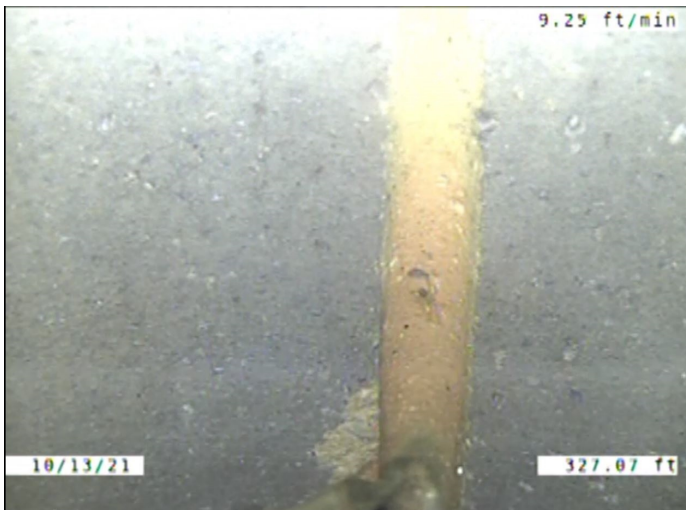
| 327.1 | SZ | Surface Damage Other | 4695 | NA |

Code: **SZ**  
Description: **Surface Damage Other**

Distance (ft): **327.1**  
Structural Grade: **0**  
O&M Grade: **0**  
Clock Start/From: **12**  
Clock To:  
1st Value:  
2nd Value:  
Value Percent:  
Continuous Index:  
Within 8" of Joint: **NO**  
Remarks: **Groove in pipe**

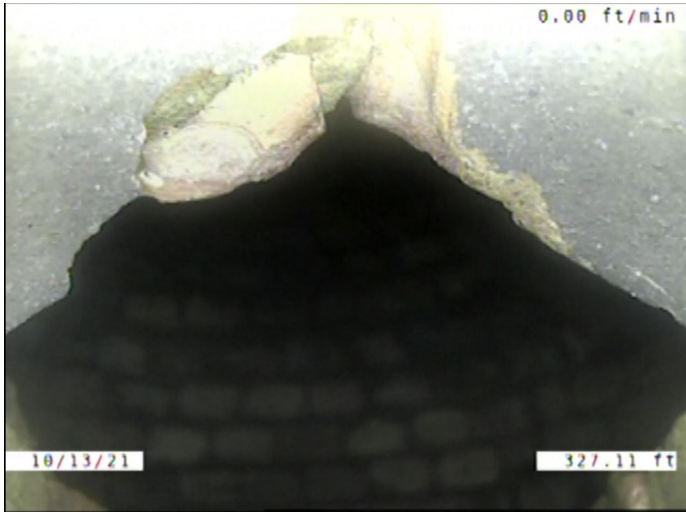
| 327.1 | B | Broken | 4704 | S 4 |

Code: **B**  
Description: **Broken**

Distance (ft): **327.1**  
Structural Grade: **4**  
O&M Grade: **0**  
Clock Start/From: **12**  
Clock To:  
1st Value:  
2nd Value:  
Value Percent:  
Continuous Index:  
Within 8" of Joint: **NO**  
Remarks:
