Profile/Photo Observation Report

Date:	10/15/2021	Weather:		Coding:	PACP 7.0
Pipe Length (ft):	333.0	Owner:	City of Hobart	Pre Clean:	Heavy Cleaning
P.O.#:	YES502259	Surveyor:	S. Bucklin	PSR:	P-704-019-018
Customer:	City of Hobart	Clean Date:	10/09/2021	Shape:	C

Street:	North Michigan Avenue	Flow Control:	Not Controlled
City:	Hobart, IN	Year Renewed:	
Location:	Local rural streets with light traffic, t	Tape/Media #:	
Purpose:	Routine Assessment	Dia/Height:	8"
Use:	Sanitary Sewage Pipe	Material:	VCP
Drain Area:		Lining:	
Category:	NA		
Comment:			
Location Details:		Direction of Survey:	Downstream
US MH:	M-704-019	DS MH:	M-704-018
		Total Length Surveyed (ft):	247.6

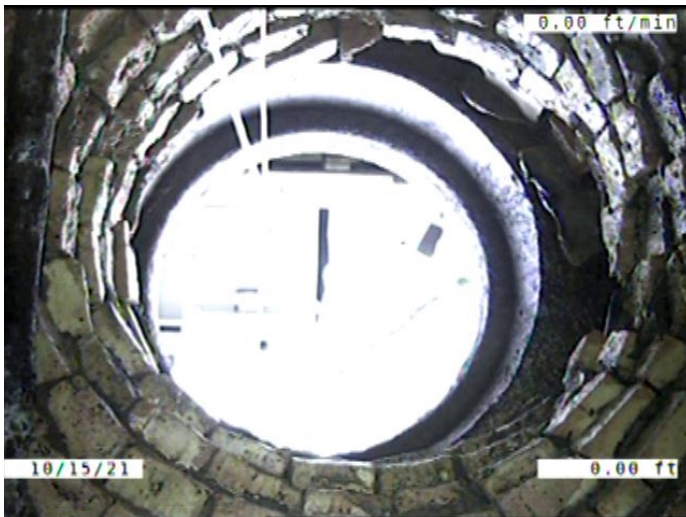
Code: **AMH**
Description: **Manhole**

Distance (ft): **.0**
Structural Grade: **0**
O&M Grade: **0**
Clock Start/From:
Clock To:
1st Value:
2nd Value:
Value Percent:
Continuous Index:
Within 8" of Joint: **NO**
Remarks: **M-704-019**

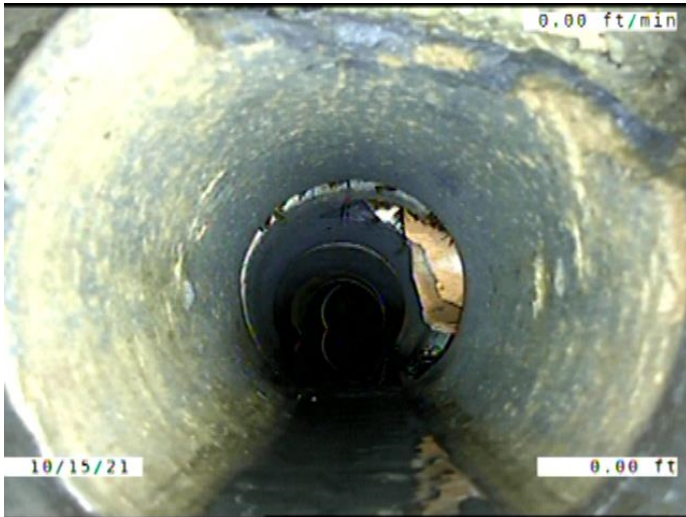
Code: **MWL**
 Description: **Miscellaneous Water Level**

Distance (ft): **.0**
 Structural Grade: **0**
 O&M Grade: **0**
 Clock Start/From:
 Clock To:
 1st Value:
 2nd Value:
 Value Percent: **5.000**
 Continuous Index:
 Within 8" of Joint: **NO**
 Remarks:

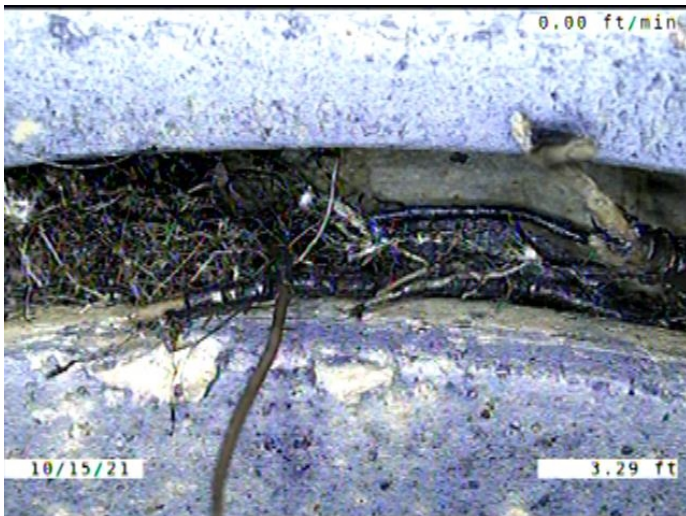
Code: **RFJ**
 Description: **Roots Fine Joint**

Distance (ft): **3.3**
 Structural Grade: **0**
 O&M Grade: **1**
 Clock Start/From: **8**
 Clock To: **4**
 1st Value:
 2nd Value:
 Value Percent:
 Continuous Index: **S01**
 Within 8" of Joint: **YES**
 Remarks:

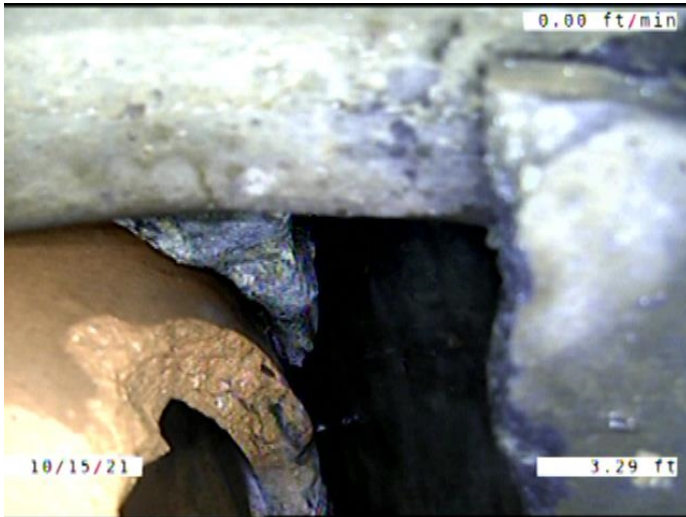
Code: **HVV**
 Description: **Hole Void Visible**

Distance (ft): **3.3**
 Structural Grade: **5**
 O&M Grade: **0**
 Clock Start/From: **3**
 Clock To: **4**
 1st Value:
 2nd Value:
 Value Percent:
 Continuous Index:
 Within 8" of Joint: **YES**
 Remarks: **SOIL AND VOID VISIBLE**

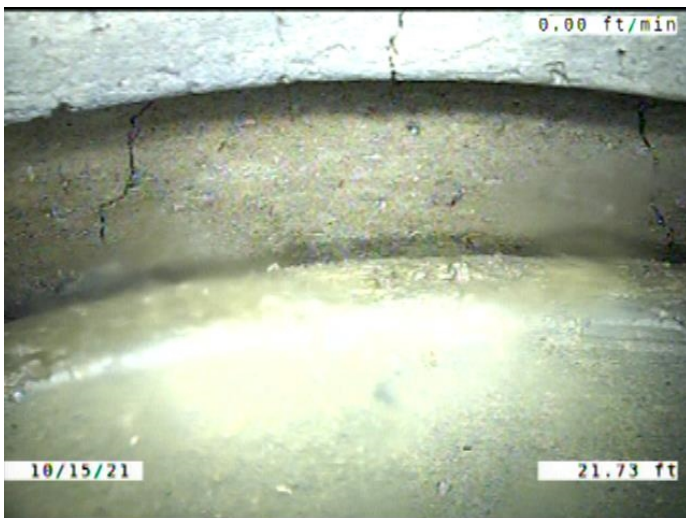
Code: **JAM**
Description: **Joint Angular Medium**

Distance (ft): **21.7**
Structural Grade: **3**
O&M Grade: **0**
Clock Start/From:
Clock To:
1st Value:
2nd Value:
Value Percent:
Continuous Index:
Within 8" of Joint: **NO**
Remarks:

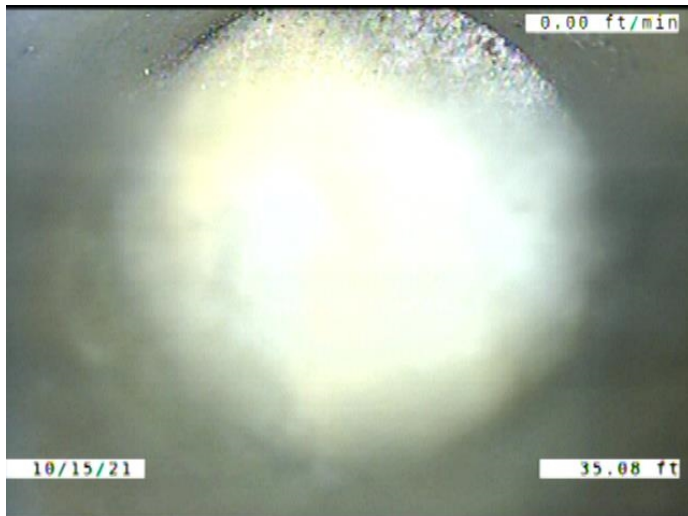
Code: **TFC**
 Description: **Tap Factory Capped**

Distance (ft): **35.1**
 Structural Grade: **0**
 O&M Grade: **0**
 Clock Start/From: **2**
 Clock To:
 1st Value: **4.000**
 2nd Value:
 Value Percent:
 Continuous Index:
 Within 8" of Joint: **YES**
 Remarks:

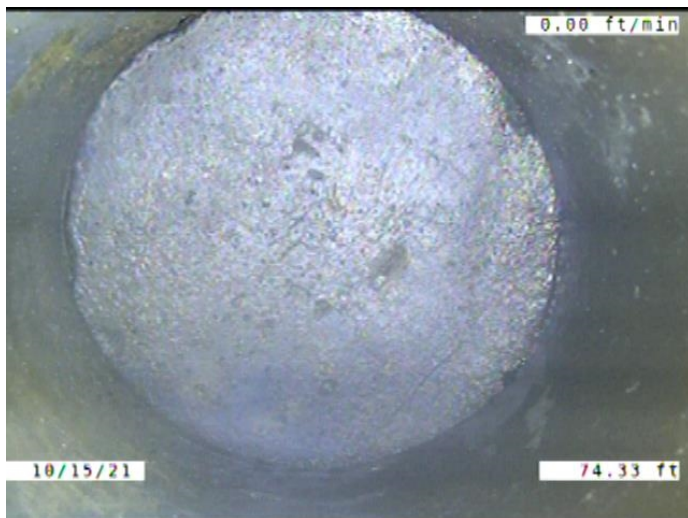
Code: **TFC**
 Description: **Tap Factory Capped**

Distance (ft): **74.3**
 Structural Grade: **0**
 O&M Grade: **0**
 Clock Start/From: **2**
 Clock To:
 1st Value: **4.000**
 2nd Value:
 Value Percent:
 Continuous Index:
 Within 8" of Joint: **YES**
 Remarks:

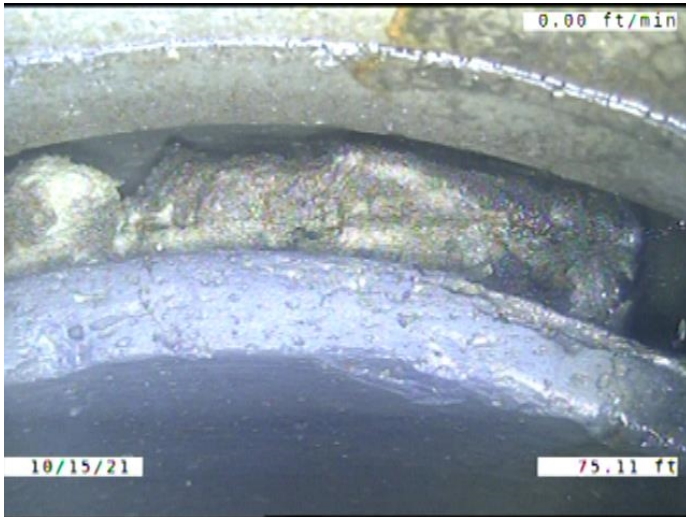
Code: **JOMD**
Description: **Joint Offset Medium Defective**

Distance (ft): **75.1**
Structural Grade: **3**
O&M Grade: **0**
Clock Start/From:
Clock To:
1st Value:
2nd Value:
Value Percent:
Continuous Index:
Within 8" of Joint: **NO**
Remarks:

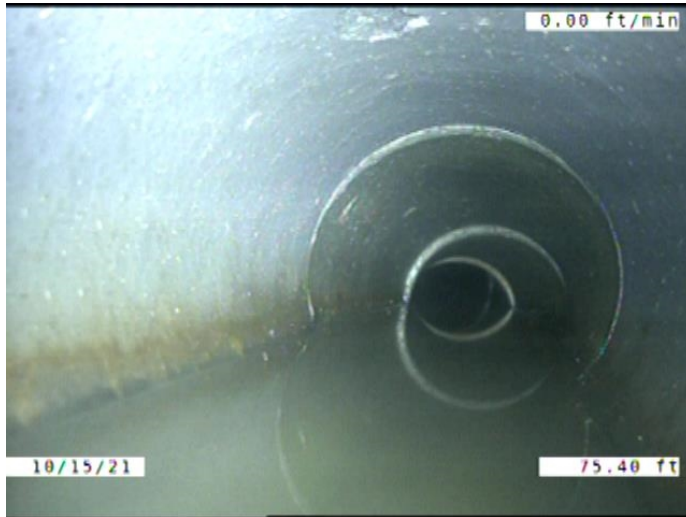
Code: **MWLS**
 Description: **Miscellaneous Water Level Sag**

Distance (ft): **75.4**
 Structural Grade: **3**
 O&M Grade: **0**
 Clock Start/From:
 Clock To:
 1st Value:
 2nd Value:
 Value Percent: **40.000**
 Continuous Index: **S06**
 Within 8" of Joint: **NO**
 Remarks:

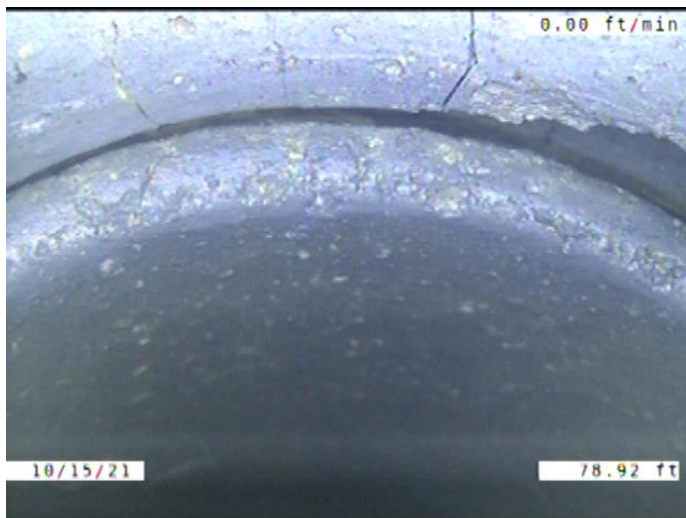
Code: **JOM**
 Description: **Joint Offset Medium**

Distance (ft): **78.9**
 Structural Grade: **3**
 O&M Grade: **0**
 Clock Start/From:
 Clock To:
 1st Value:
 2nd Value:
 Value Percent:
 Continuous Index:
 Within 8" of Joint: **NO**
 Remarks:

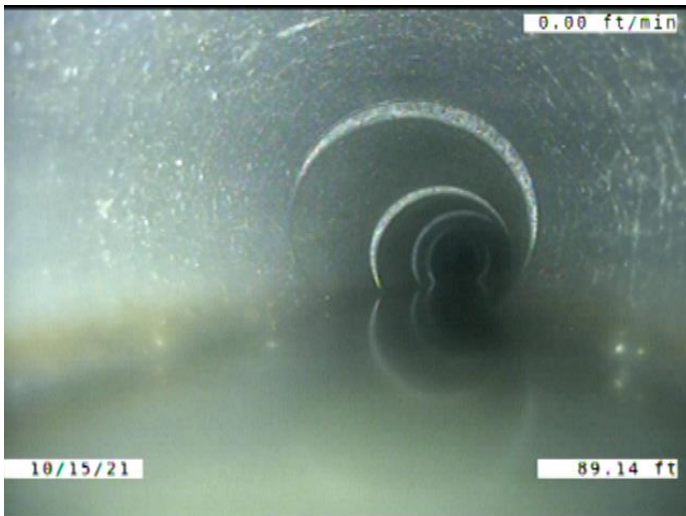
Code: **RFJ**
 Description: **Roots Fine Joint**

Distance (ft): **89.1**
 Structural Grade: **0**
 O&M Grade: **1**
 Clock Start/From: **8**
 Clock To: **4**
 1st Value:
 2nd Value:
 Value Percent:
 Continuous Index: **F01**
 Within 8" of Joint: **YES**
 Remarks:

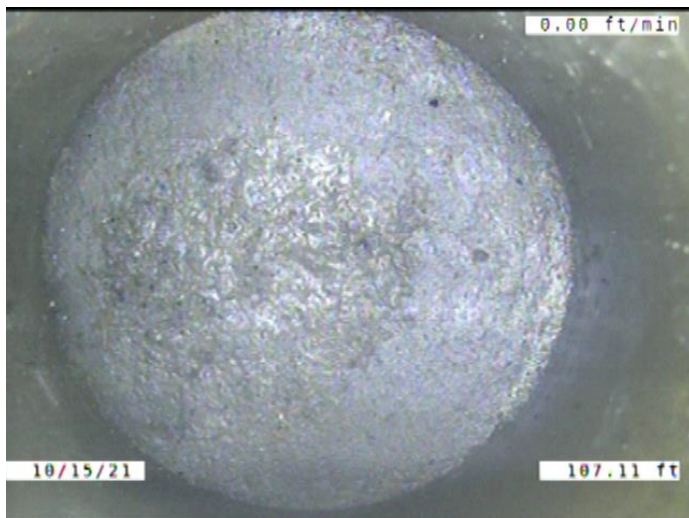
Code: **TFC**
Description: **Tap Factory Capped**

Distance (ft): **107.1**
Structural Grade: **0**
O&M Grade: **0**
Clock Start/From: **2**
Clock To:
1st Value: **4.000**
2nd Value:
Value Percent:
Continuous Index:
Within 8" of Joint: **YES**
Remarks:

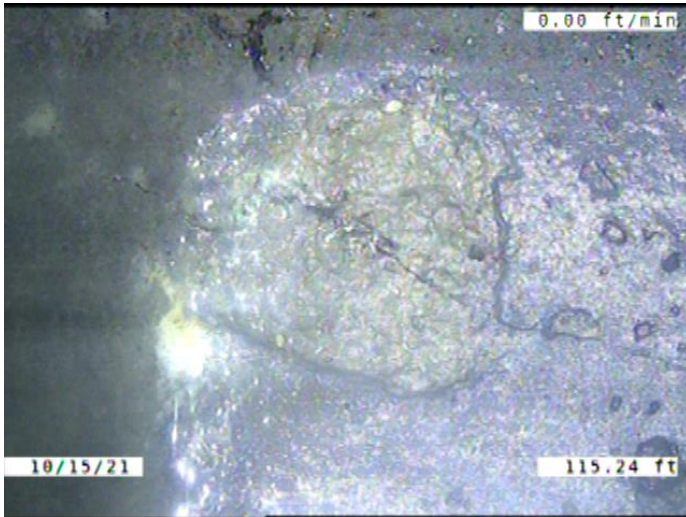
Code: **SSS**
Description: **Surface Damage Surface Spalling**

Distance (ft): **115.2**
Structural Grade: **2**
O&M Grade: **0**
Clock Start/From: **4**
Clock To:
1st Value:
2nd Value:
Value Percent:
Continuous Index:
Within 8" of Joint: **NO**
Remarks:

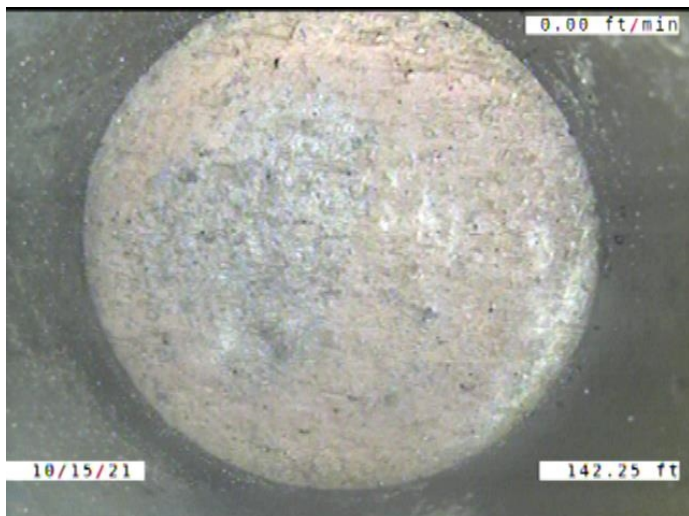
Code: **TFC**
 Description: **Tap Factory Capped**

Distance (ft): **142.2**
 Structural Grade: **0**
 O&M Grade: **0**
 Clock Start/From: **2**
 Clock To:
 1st Value: **4.000**
 2nd Value:
 Value Percent:
 Continuous Index:
 Within 8" of Joint: **YES**
 Remarks:

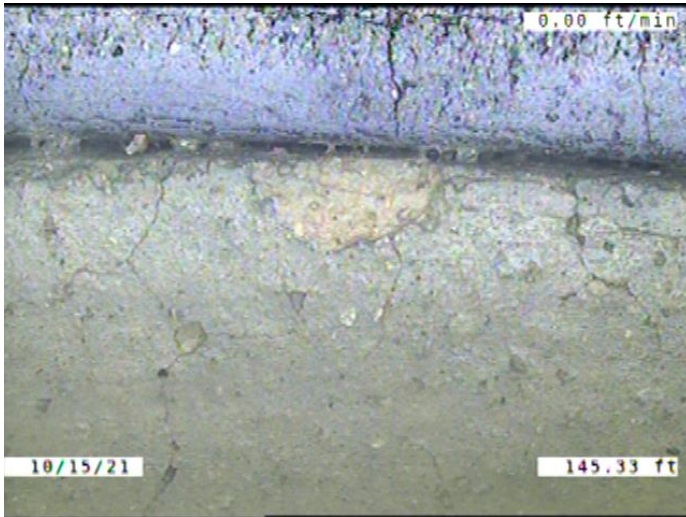
Code: **SSS**
 Description: **Surface Damage Surface Spalling**

Distance (ft): **145.3**
 Structural Grade: **2**
 O&M Grade: **0**
 Clock Start/From: **1**
 Clock To:
 1st Value:
 2nd Value:
 Value Percent:
 Continuous Index:
 Within 8" of Joint: **YES**
 Remarks:

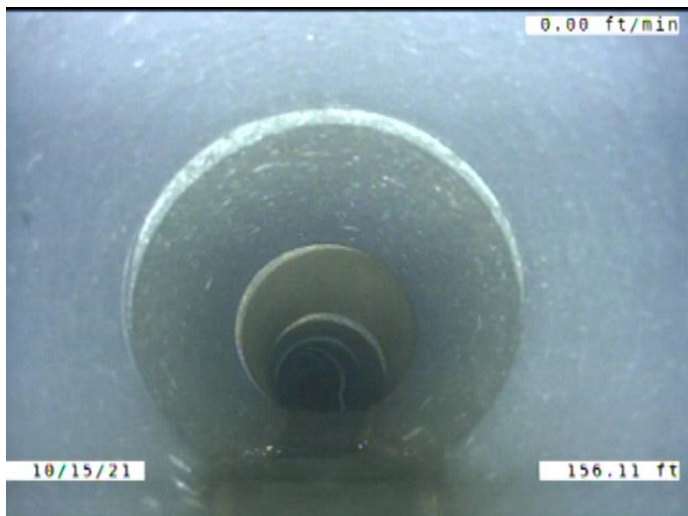
Code: **MWLS**
 Description: **Miscellaneous Water Level Sag**

Distance (ft): **156.1**
 Structural Grade: **2**
 O&M Grade: **0**
 Clock Start/From:
 Clock To:
 1st Value:
 2nd Value:
 Value Percent: **10.000**
 Continuous Index: **F07**
 Within 8" of Joint: **NO**
 Remarks:

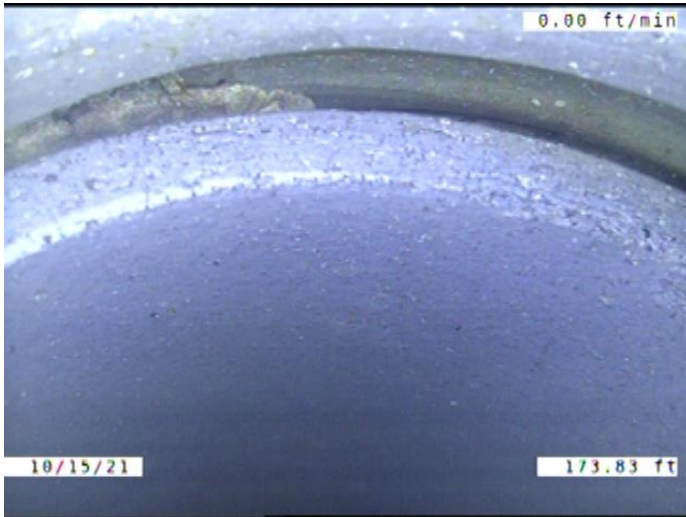
Code: **JOMD**
 Description: **Joint Offset Medium Defective**

Distance (ft): **173.8**
 Structural Grade: **3**
 O&M Grade: **0**
 Clock Start/From:
 Clock To:
 1st Value:
 2nd Value:
 Value Percent:
 Continuous Index:
 Within 8" of Joint: **NO**
 Remarks:

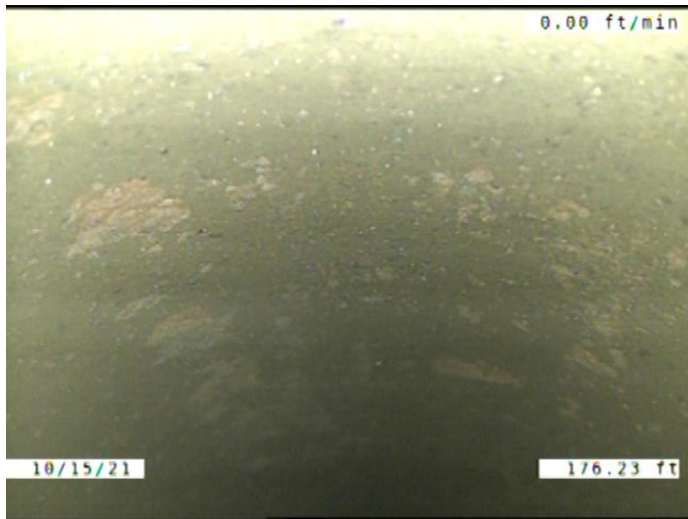
Code: **SSS**
 Description: **Surface Damage Surface Spalling**

Distance (ft): **176.2**
 Structural Grade: **2**
 O&M Grade: **0**
 Clock Start/From: **8**
 Clock To: **4**
 1st Value:
 2nd Value:
 Value Percent:
 Continuous Index:
 Within 8" of Joint: **YES**
 Remarks:

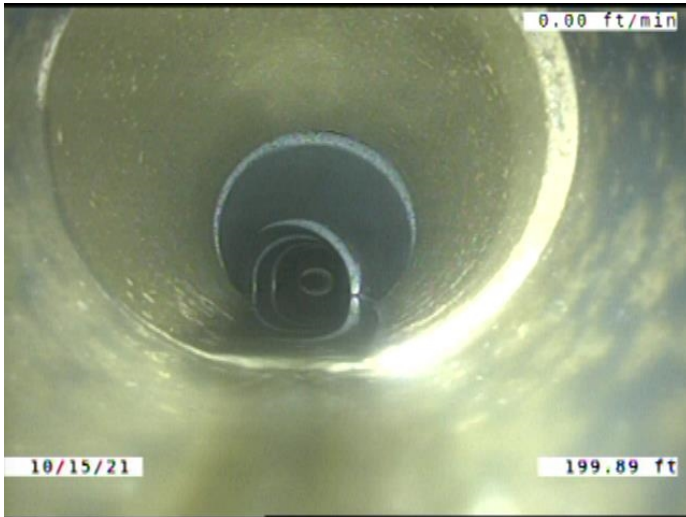
Code: **MWLS**
Description: **Miscellaneous Water Level Sag**

Distance (ft): **199.9**
Structural Grade: **2**
O&M Grade: **0**
Clock Start/From:
Clock To:
1st Value:
2nd Value:
Value Percent: **15.000**
Continuous Index: **F08**
Within 8" of Joint: **NO**
Remarks:

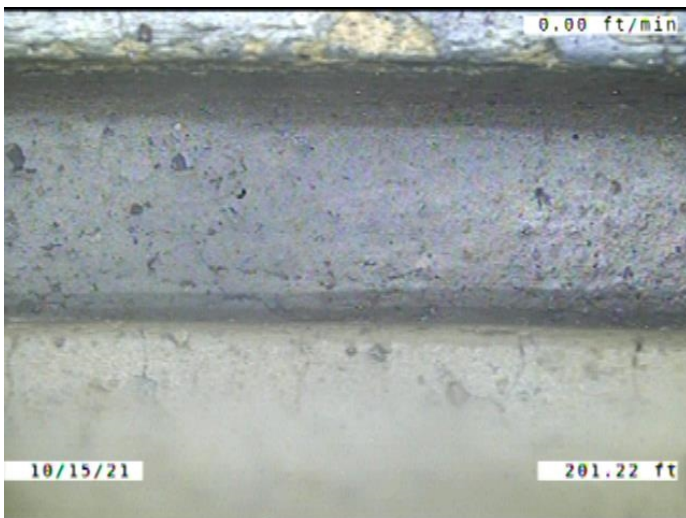
Code: **JAM**
Description: **Joint Angular Medium**

Distance (ft): **201.2**
Structural Grade: **3**
O&M Grade: **0**
Clock Start/From:
Clock To:
1st Value:
2nd Value:
Value Percent:
Continuous Index:
Within 8" of Joint: **NO**
Remarks:

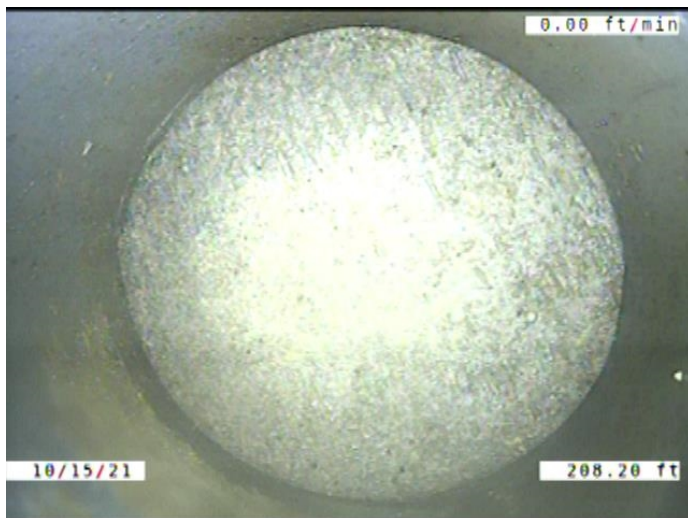
Code: **TFC**
Description: **Tap Factory Capped**

Distance (ft): **208.2**
Structural Grade: **0**
O&M Grade: **0**
Clock Start/From: **2**
Clock To:
1st Value: **4.000**
2nd Value:
Value Percent:
Continuous Index:
Within 8" of Joint: **YES**
Remarks:

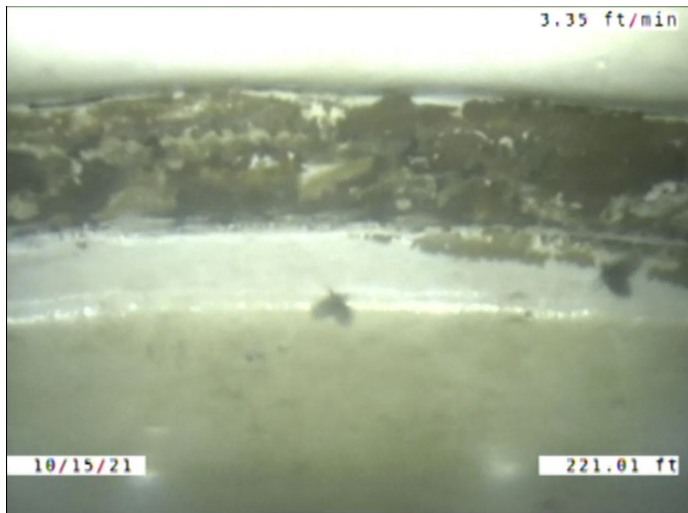
Code: **CM**
 Description: **Crack Multiple**

Distance (ft): **221.0**
 Structural Grade: **3**
 O&M Grade: **0**
 Clock Start/From: **8**
 Clock To: **4**
 1st Value:
 2nd Value:
 Value Percent:
 Continuous Index: **F12**
 Within 8" of Joint: **YES**
 Remarks:

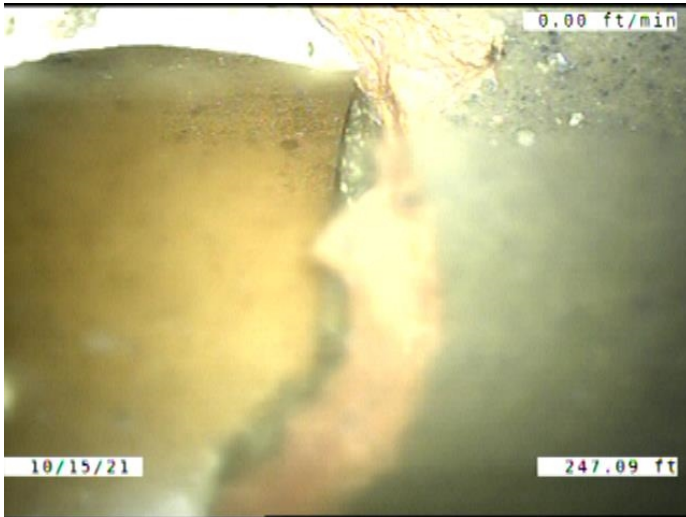
Code: **SSS**
 Description: **Surface Damage Surface Spalling**

Distance (ft): **247.1**
 Structural Grade: **2**
 O&M Grade: **0**
 Clock Start/From: **9**
 Clock To: **12**
 1st Value:
 2nd Value:
 Value Percent:
 Continuous Index:
 Within 8" of Joint: **YES**
 Remarks:
