Profile/Photo Observation Report

Street:	Off Victor Drive	Flow Control:	
City:	Hobart, IN	Year Renewed:	
Location:	Yard	Tape/Media #:	891
Purpose:	Routine Assessment	Dia/Height:	8"
Use:	Sanitary	Material:	VCP
Drain Area:		Lining:	
Category:	NA		
Comment:

Location Details:		Direction of Survey:	Downstream
US MH:	M-704-52	DS MH:	M-704-53
		Total Length Surveyed (ft):	44.8

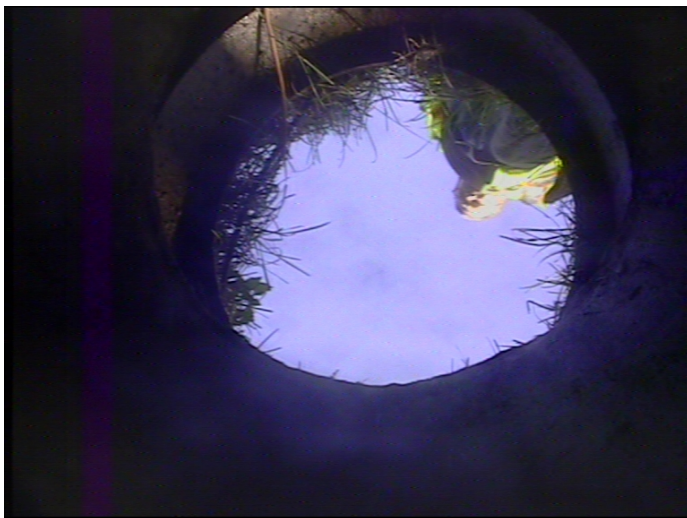
The diagram illustrates a vertical manhole inspection. A vertical shaft is shown with a red arrow pointing downwards, labeled "Camera Direction". The shaft is labeled with "M-704-52" at the top and "M-704-53" at the bottom. A table of observations is provided, detailing the position, code, observation, video time, and grade for each point.

Position	Code	Observation	Video (sec)	Grade
.0	AMH	Manhole	0	NA
.0	MWL	Water Level	14	NA
12.2	TF	Tap Factory	52	NA
42.7	DAE	Deposits Attached Encrustation	97	M 4
44.8	RMJ	Roots Medium Joint	122	M 3
44.8	MSA	Abandoned Survey	171	NA
