Profile/Photo Observation Report

Date:	10/21/2021	Weather:		Coding:	PACP 6.0
Pipe Length (ft):		Owner:	Hobart, IN	Pre Clean:	Not Known
P.O.#:	927_1	Surveyor:	M. Pielacha	PSR:	P-705-018-017
Customer:	Hobart, IN	Clean Date:		Shape:	C

Street:	East 6th Street	Flow Control:	
City:	Hobart, IN	Year Renewed:	
Location:	Light Highway	Tape/Media #:	927
Purpose:	Routine Assessment	Dia/Height:	10"
Use:	Sanitary	Material:	VCP
Drain Area:		Lining:	
Category:	NA		
Comment:

Location Details:		Direction of Survey:	Downstream
US MH:	M-705-17	DS MH:	M-705-18
		Total Length Surveyed (ft):	37.5

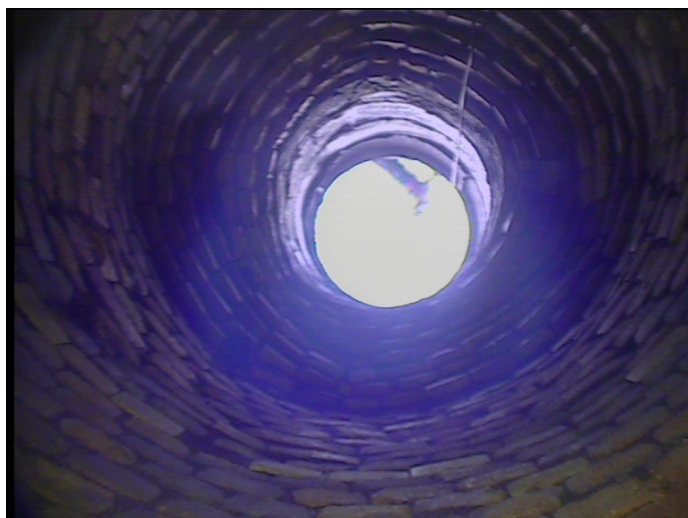
Code: **AMH**
 Description: **Manhole**

Distance (ft): **.0**
 Structural Grade: **0**
 O&M Grade: **0**
 Clock Start/From:
 Clock To:
 1st Value:
 2nd Value:
 Value Percent:
 Continuous Index:
 Within 8" of Joint: **NO**
 Remarks: **M-705-17**

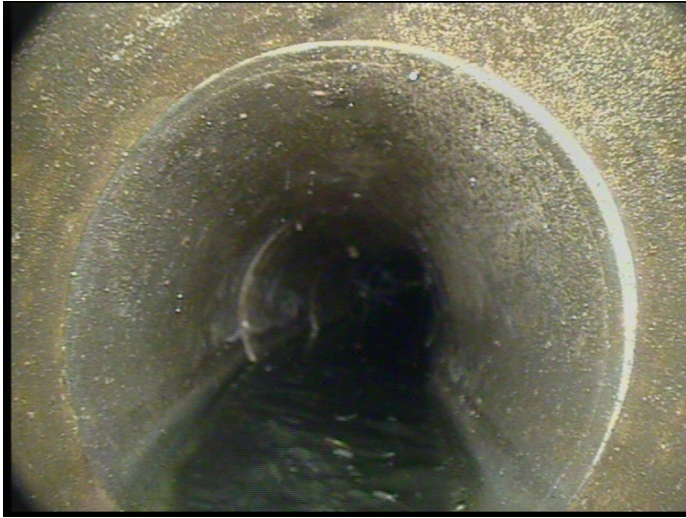
Code: **MWL**
Description: **Water Level**

Distance (ft): **.0**
Structural Grade: **0**
O&M Grade: **0**
Clock Start/From:
Clock To:
1st Value:
2nd Value:
Value Percent: **5.000**
Continuous Index:
Within 8" of Joint: **NO**
Remarks:
