# Profile/Photo Observation Report

Date:	03/09/2022	Weather:		Coding:	PACP 7.0
Pipe Length (ft):	268.0	Owner:	City of Hobart	Pre Clean:	Heavy Cleaning
P.O.#:	YES502259	Surveyor:	S. Bucklin	PSR:	P-705-022-019
Customer:	City of Hobart, IN (Red	Clean Date:	03/06/2022	Shape:	C

Street:	South Lake Street	Flow Control:	Not Controlled
City:	Hobart, IN	Year Renewed:	
Location:	Local rural streets with light traffic, t	Tape/Media #:	
Purpose:	Routine Assessment	Dia/Height:	8"
Use:	Sanitary Sewage Pipe	Material:	VCP
Drain Area:		Lining:	None
Category:	NA		
Comment:			
Location Details:		Direction of Survey:	Downstream
US MH:	M-705-019	DS MH:	M-705-022
		Total Length Surveyed (ft):	261.1

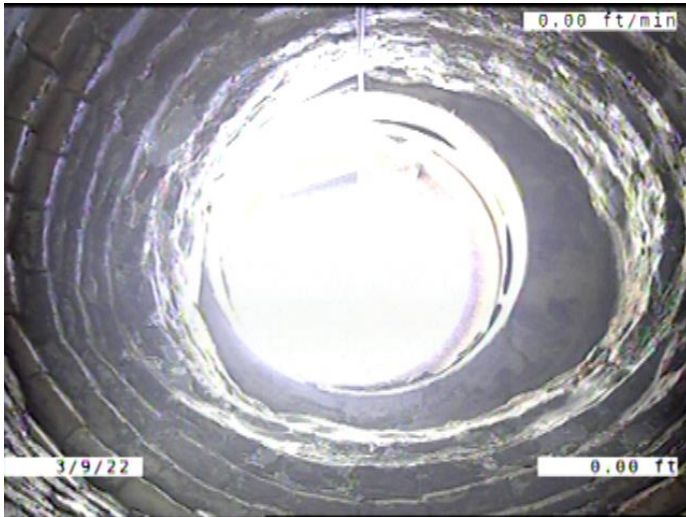
Code: **AMH**  
 Description: **Manhole**

Distance (ft): **.0**  
 Structural Grade: **0**  
 O&M Grade: **0**  
 Clock Start/From:  
 Clock To:  
 1st Value:  
 2nd Value:  
 Value Percent:  
 Continuous Index:  
 Within 8" of Joint: **NO**  
 Remarks: **M-705-019**

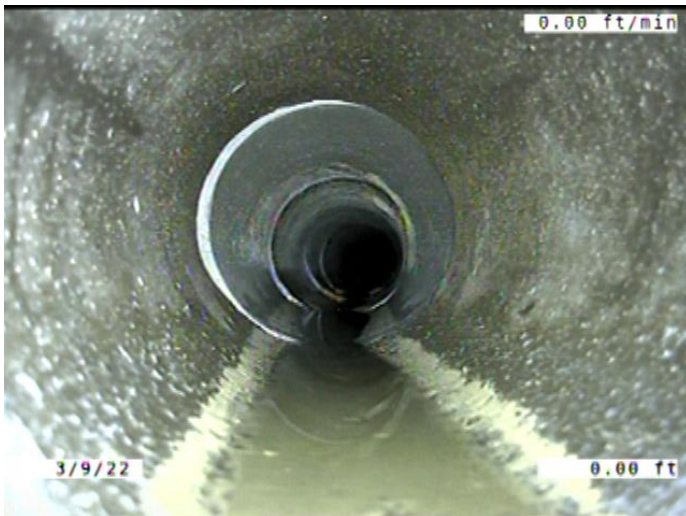
Code: **MWL**  
 Description: **Miscellaneous Water Level**

Distance (ft): **.0**  
 Structural Grade: **0**  
 O&M Grade: **0**  
 Clock Start/From:  
 Clock To:  
 1st Value:  
 2nd Value:  
 Value Percent: **5.000**  
 Continuous Index:  
 Within 8" of Joint: **NO**  
 Remarks:

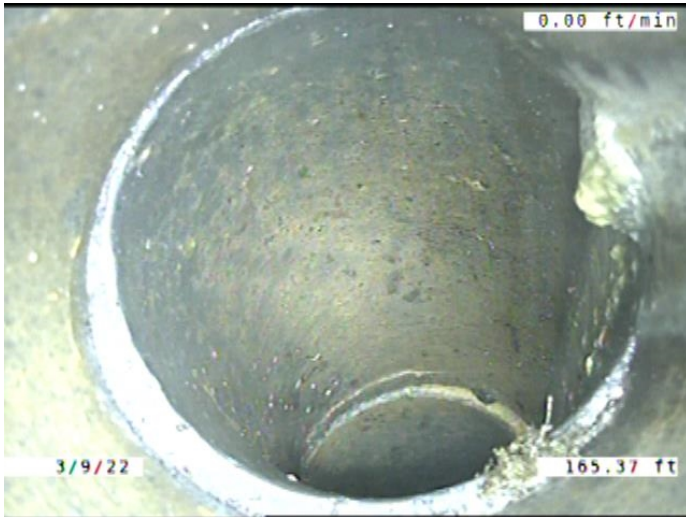
Code: **TF**  
 Description: **Tap Factory**

Distance (ft): **165.4**  
 Structural Grade: **0**  
 O&M Grade: **0**  
 Clock Start/From: **2**  
 Clock To:  
 1st Value: **6.000**  
 2nd Value:  
 Value Percent:  
 Continuous Index:  
 Within 8" of Joint: **YES**  
 Remarks:

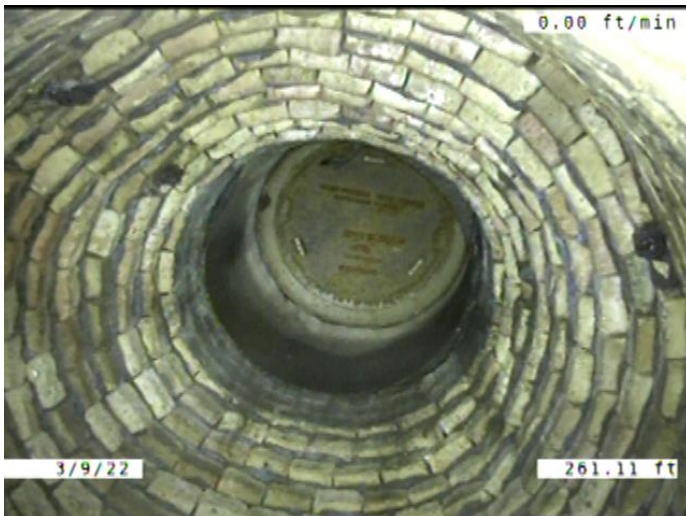
Code: **AMH**  
 Description: **Manhole**

Distance (ft): **261.1**  
 Structural Grade: **0**  
 O&M Grade: **0**  
 Clock Start/From:  
 Clock To:  
 1st Value:  
 2nd Value:  
 Value Percent:  
 Continuous Index:  
 Within 8" of Joint: **NO**  
 Remarks: **M-705-022**
