Profile/Photo Observation Report

Date:	08/11/2022	Weather:		Coding:	PACP 7.0
Pipe Length (ft):	334.0	Owner:	City of Hobart	Pre Clean:	Heavy Cleaning
P.O.#:	YES502259	Surveyor:	S. Bucklin	PSR:	P-705-047-035
Customer:	City of Hobart	Clean Date:	08/03/2022	Shape:	C

Street:	2nd Street	Flow Control:	Not Controlled
City:	Hobart, IN	Year Renewed:	
Location:	Local rural streets with light traffic, t	Tape/Media #:	
Purpose:	Routine Assessment	Dia/Height:	18"
Use:	Sanitary Sewage Pipe	Material:	VCP
Drain Area:		Lining:	None
Category:	NA		
Comment:			
Location Details:		Direction of Survey:	Downstream
US MH:	M-705-035	DS MH:	M-705-047
		Total Length Surveyed (ft):	331.2

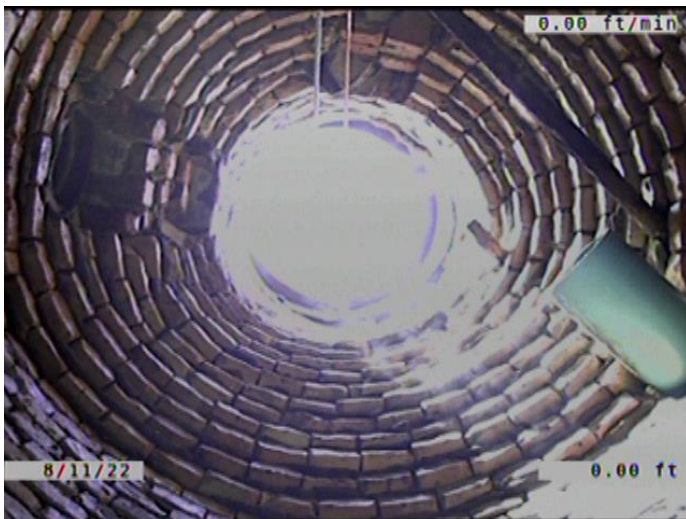
Code: **AMH**
Description: **Manhole**

Distance (ft): **.0**
Structural Grade: **0**
O&M Grade: **0**
Clock Start/From:
Clock To:
1st Value:
2nd Value:
Value Percent:
Continuous Index:
Within 8" of Joint: **NO**
Remarks: **M-705-035**

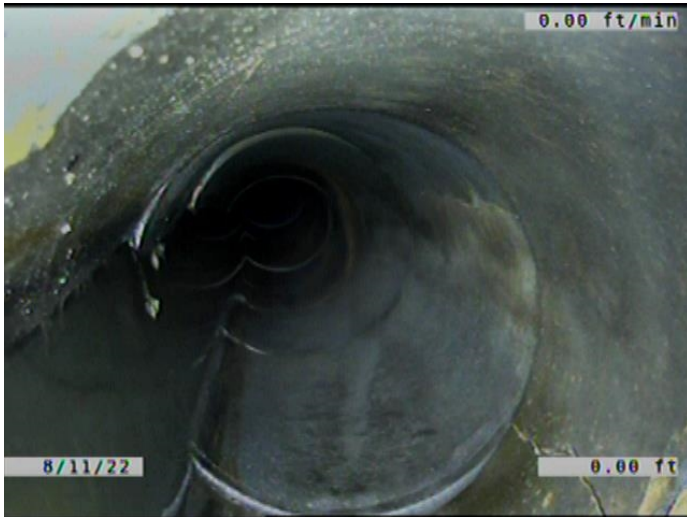
Code: **MWL**
 Description: **Miscellaneous Water Level**

Distance (ft): **.0**
 Structural Grade: **0**
 O&M Grade: **0**
 Clock Start/From:
 Clock To:
 1st Value:
 2nd Value:
 Value Percent: **5.000**
 Continuous Index:
 Within 8" of Joint: **NO**
 Remarks:

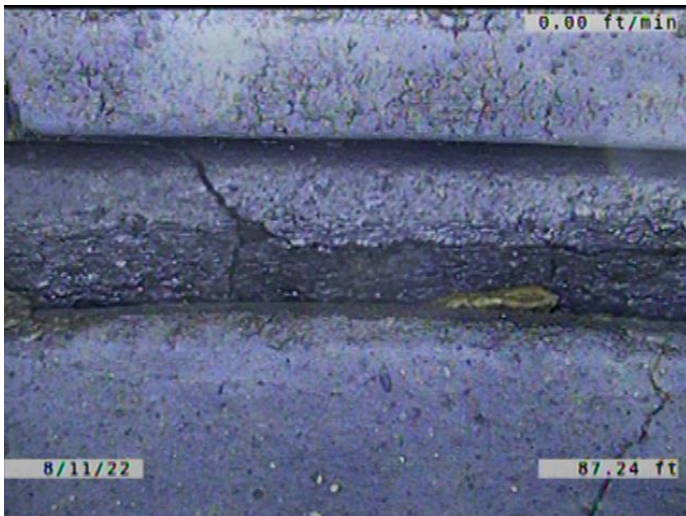
Code: **JAM**
Description: **Joint Angular Medium**

Distance (ft): **87.2**
Structural Grade: **3**
O&M Grade: **0**
Clock Start/From:
Clock To:
1st Value:
2nd Value:
Value Percent:
Continuous Index:
Within 8" of Joint: **NO**
Remarks:

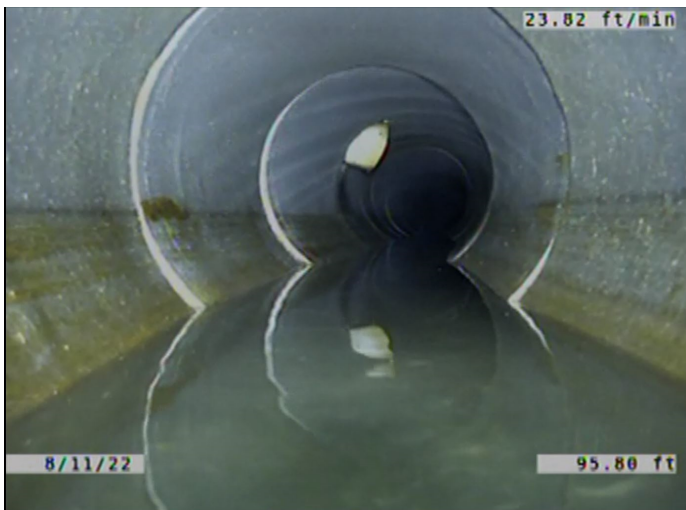
Code: **LR**
Description: **Line Right**

Distance (ft): **95.8**
Structural Grade: **0**
O&M Grade: **1**
Clock Start/From:
Clock To:
1st Value:
2nd Value:
Value Percent: **5.000**
Continuous Index:
Within 8" of Joint: **NO**
Remarks:

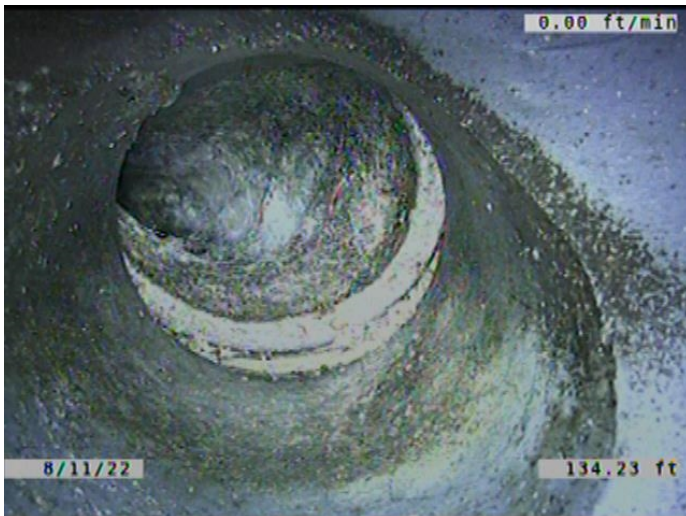
Code: **TF**
Description: **Tap Factory**

Distance (ft): **134.2**
Structural Grade: **0**
O&M Grade: **0**
Clock Start/From: **11**
Clock To:
1st Value: **6.000**
2nd Value:
Value Percent:
Continuous Index:
Within 8" of Joint: **YES**
Remarks: **SERVICE OFFSET. SOIL VISIBLE.**

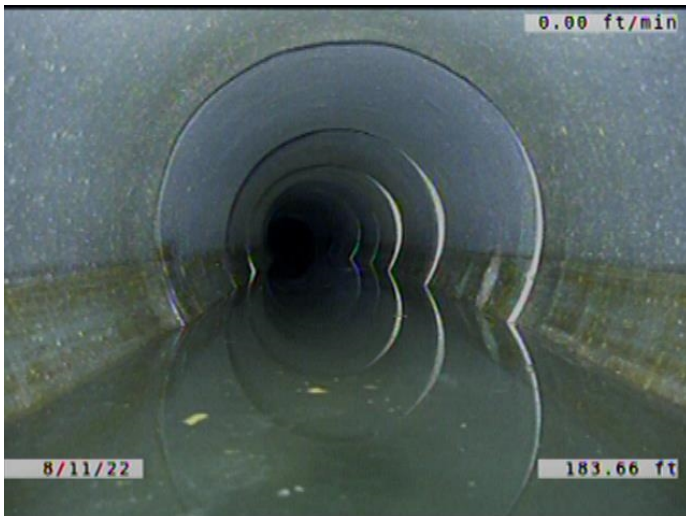
Code: **MWL**
Description: **Miscellaneous Water Level**

Distance (ft): **183.7**
Structural Grade: **0**
O&M Grade: **0**
Clock Start/From:
Clock To:
1st Value:
2nd Value:
Value Percent: **20.000**
Continuous Index:
Within 8" of Joint: **NO**
Remarks:

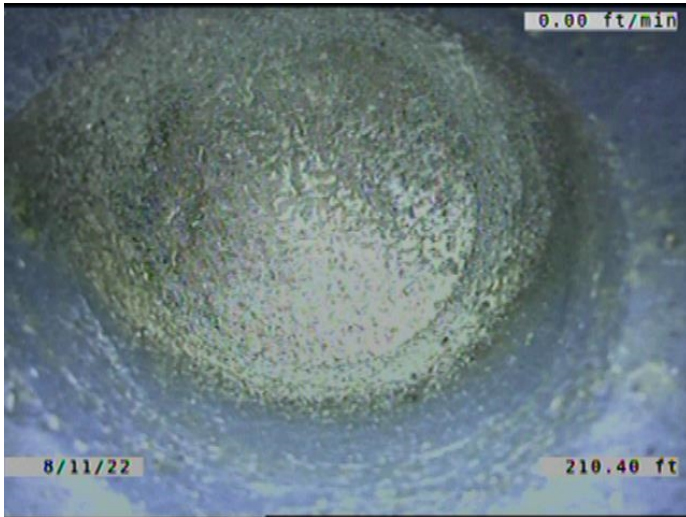
Code: **TFC**
 Description: **Tap Factory Capped**

Distance (ft): **210.4**
 Structural Grade: **0**
 O&M Grade: **0**
 Clock Start/From: **11**
 Clock To:
 1st Value: **6.000**
 2nd Value:
 Value Percent:
 Continuous Index:
 Within 8" of Joint: **YES**
 Remarks:

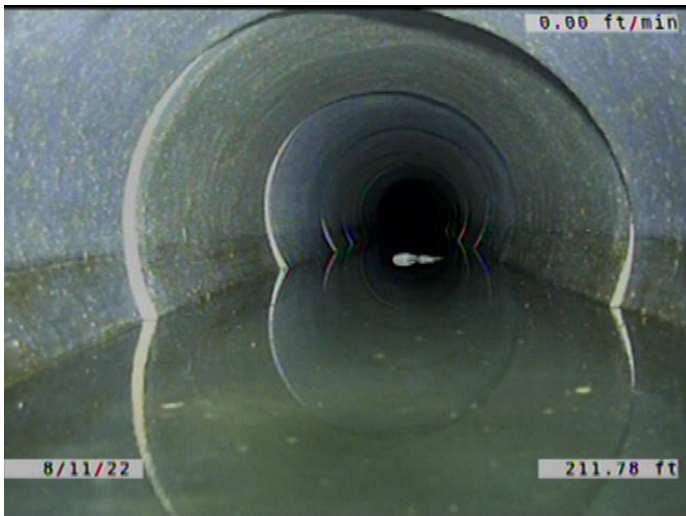
Code: **MWLS**
 Description: **Miscellaneous Water Level Sag**

Distance (ft): **211.8**
 Structural Grade: **2**
 O&M Grade: **0**
 Clock Start/From:
 Clock To:
 1st Value:
 2nd Value:
 Value Percent: **30.000**
 Continuous Index:
 Within 8" of Joint: **NO**
 Remarks:

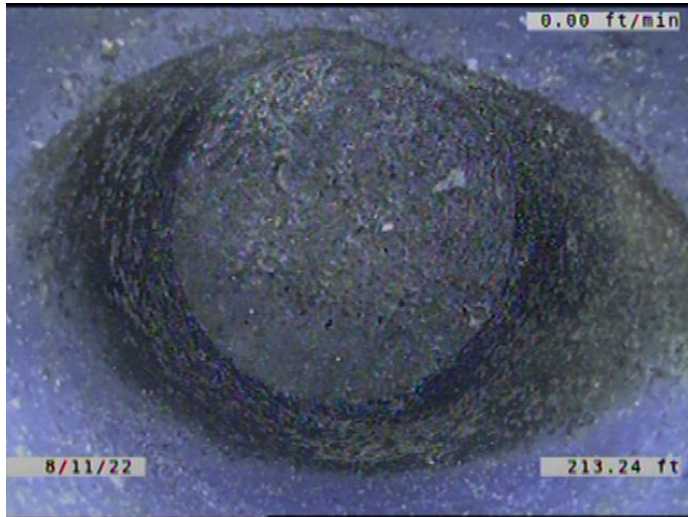
Code: **TFC**
 Description: **Tap Factory Capped**

Distance (ft): **213.2**
 Structural Grade: **0**
 O&M Grade: **0**
 Clock Start/From: **1**
 Clock To:
 1st Value: **6.000**
 2nd Value:
 Value Percent:
 Continuous Index:
 Within 8" of Joint: **YES**
 Remarks:

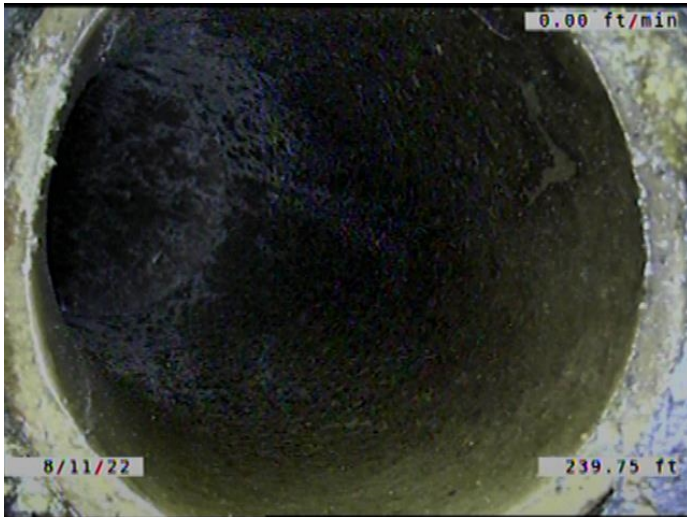
Code: **TB**
 Description: **Tap Break-in/Hammer**

Distance (ft): **239.8**
 Structural Grade: **0**
 O&M Grade: **0**
 Clock Start/From: **12**
 Clock To:
 1st Value: **6.000**
 2nd Value:
 Value Percent:
 Continuous Index:
 Within 8" of Joint: **YES**
 Remarks:

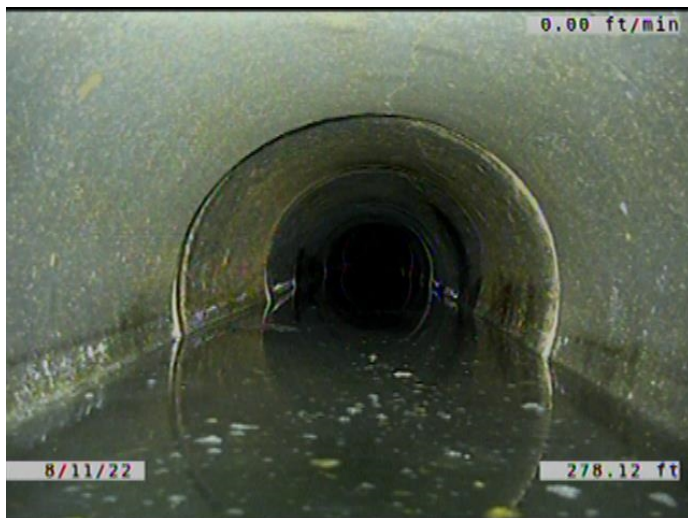
Code: **MWL**
Description: **Miscellaneous Water Level**

Distance (ft): **278.1**
Structural Grade: **0**
O&M Grade: **0**
Clock Start/From:
Clock To:
1st Value:
2nd Value:
Value Percent: **40.000**
Continuous Index:
Within 8" of Joint: **NO**
Remarks:

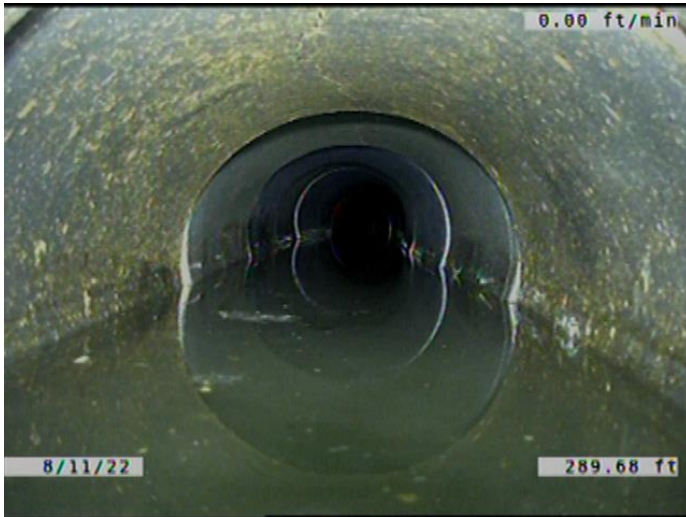
Code: **MWL**
Description: **Miscellaneous Water Level**

Distance (ft): **289.7**
Structural Grade: **0**
O&M Grade: **0**
Clock Start/From:
Clock To:
1st Value:
2nd Value:
Value Percent: **50.000**
Continuous Index:
Within 8" of Joint: **NO**
Remarks:

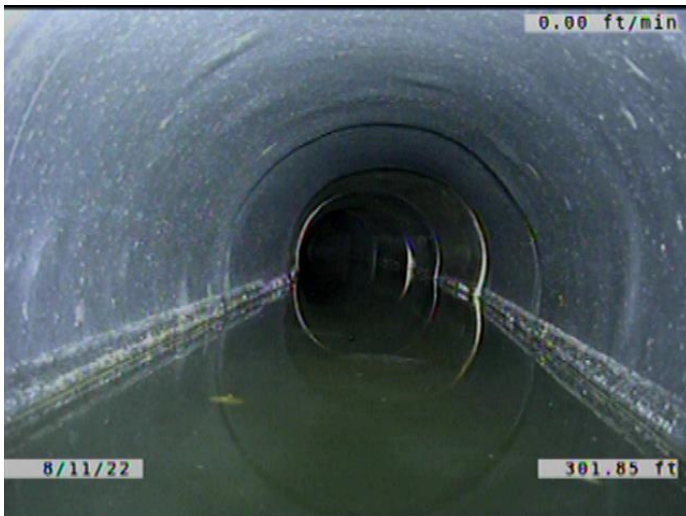
Code: **MWL**
Description: **Miscellaneous Water Level**

Distance (ft): **301.8**
Structural Grade: **0**
O&M Grade: **0**
Clock Start/From:
Clock To:
1st Value:
2nd Value:
Value Percent: **30.000**
Continuous Index:
Within 8" of Joint: **NO**
Remarks:

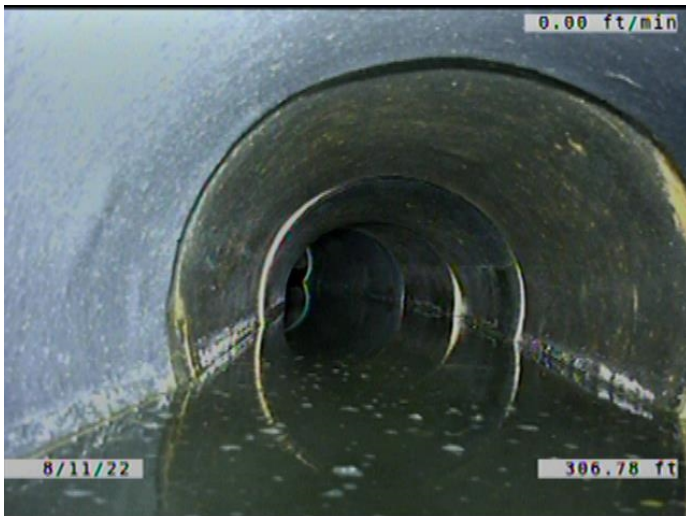
Code: **LL**
Description: **Line Left**

Distance (ft): **306.8**
Structural Grade: **0**
O&M Grade: **4**
Clock Start/From:
Clock To:
1st Value:
2nd Value:
Value Percent: **25.000**
Continuous Index:
Within 8" of Joint: **NO**
Remarks:

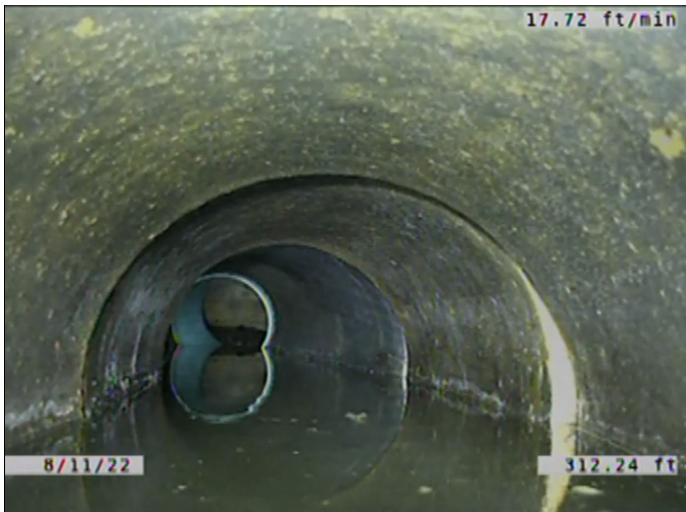
Code: **LL**
Description: **Line Left**

Distance (ft): **312.2**
Structural Grade: **0**
O&M Grade: **1**
Clock Start/From:
Clock To:
1st Value:
2nd Value:
Value Percent: **5.000**
Continuous Index:
Within 8" of Joint: **NO**
Remarks:

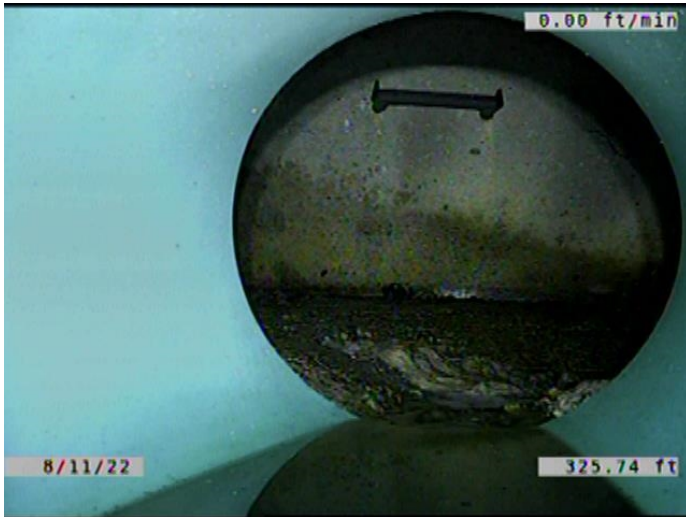
Code: **MWL**
Description: **Miscellaneous Water Level**

Distance (ft): **325.7**
Structural Grade: **0**
O&M Grade: **0**
Clock Start/From:
Clock To:
1st Value:
2nd Value:
Value Percent: **5.000**
Continuous Index:
Within 8" of Joint: **NO**
Remarks:

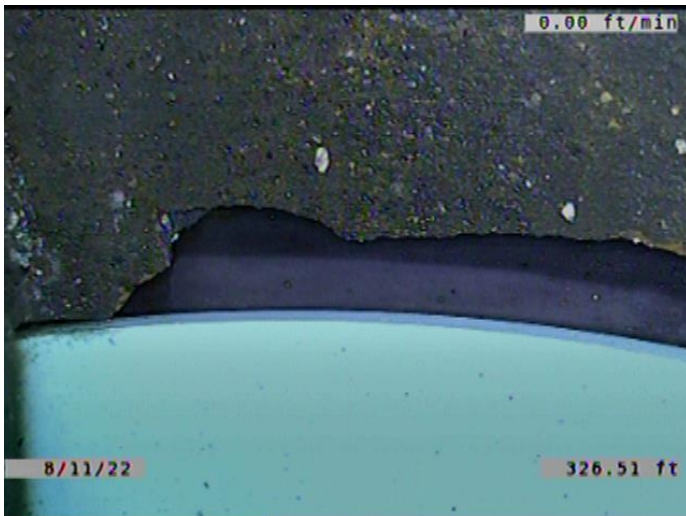
Code: **JAM**
Description: **Joint Angular Medium**

Distance (ft): **326.5**
Structural Grade: **3**
O&M Grade: **0**
Clock Start/From:
Clock To:
1st Value:
2nd Value:
Value Percent:
Continuous Index:
Within 8" of Joint: **NO**
Remarks:

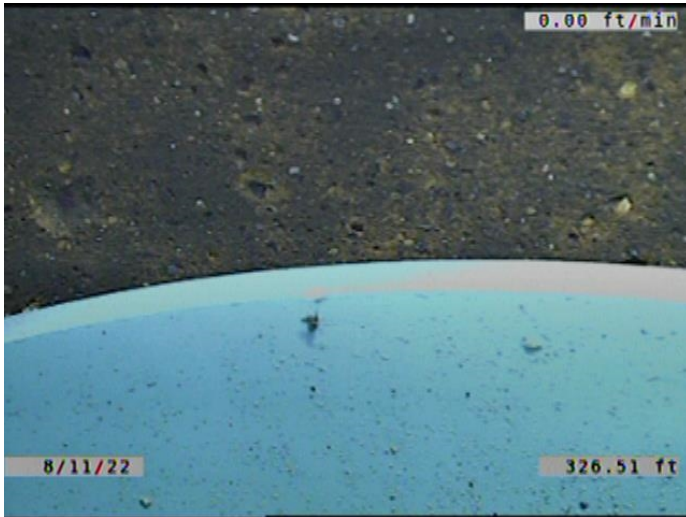
Code: **MMC**
 Description: **Miscellaneous Material Change**

Distance (ft): **326.5**
 Structural Grade: **0**
 O&M Grade: **0**
 Clock Start/From:
 Clock To:
 1st Value:
 2nd Value:
 Value Percent:
 Continuous Index:
 Within 8" of Joint: **NO**
 Remarks: **VCP TO PVC**

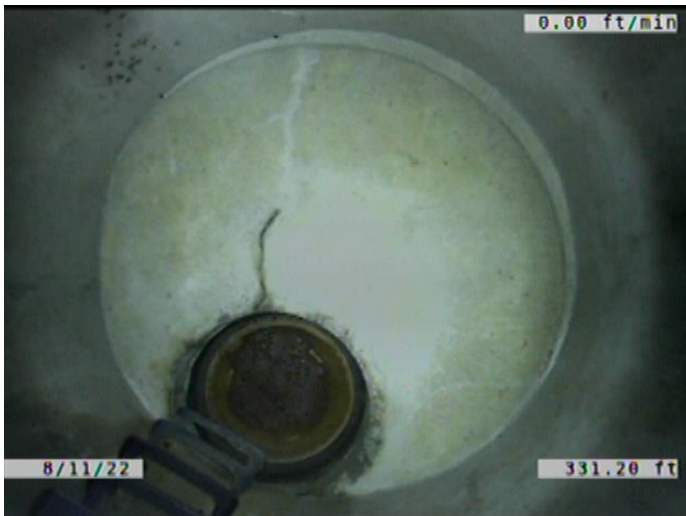
Code: **AMH**
 Description: **Manhole**

Distance (ft): **331.2**
 Structural Grade: **0**
 O&M Grade: **0**
 Clock Start/From:
 Clock To:
 1st Value:
 2nd Value:
 Value Percent:
 Continuous Index:
 Within 8" of Joint: **NO**
 Remarks: **M-705-047**
