## Profile/Photo Observation Report

Date:	<b>09/17/2022</b>	Weather:		Coding:	<b>PACP 7.0</b>
Pipe Length (ft):	<b>214.4</b>	Owner:	<b>City of Hobart</b>	Pre Clean:	<b>No Pre-Cleaning</b>
P.O.#:	<b>YES502259</b>	Surveyor:	<b>S. Bucklin</b>	PSR:	<b>M-705-050-M-705-085</b>
Customer:	<b>City of Hobart</b>	Clean Date:		Shape:	<b>C</b>

US MH: **M-705-050**

DS MH: **M-705-085**

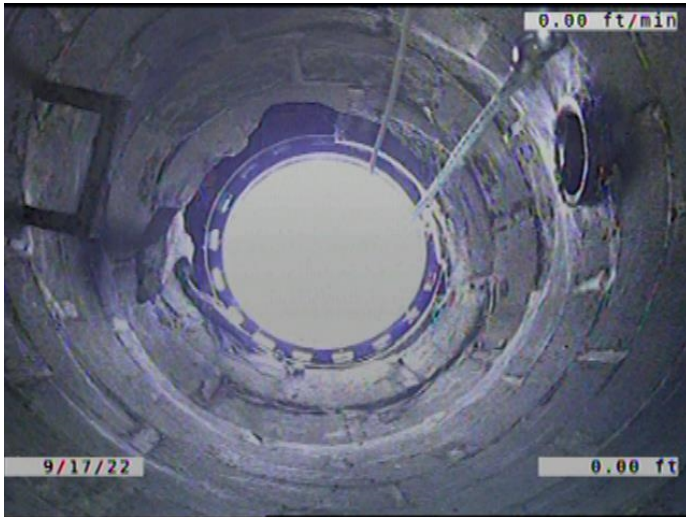
Code: **AMH**  
 Description: **Manhole**

Distance (ft): **.0**  
 Structural Grade: **0**  
 O&M Grade: **0**  
 Clock Start/From:  
 Clock To:  
 1st Value:  
 2nd Value:  
 Value Percent:  
 Continuous Index:  
 Within 8" of Joint: **NO**  
 Remarks: **M-705-050**

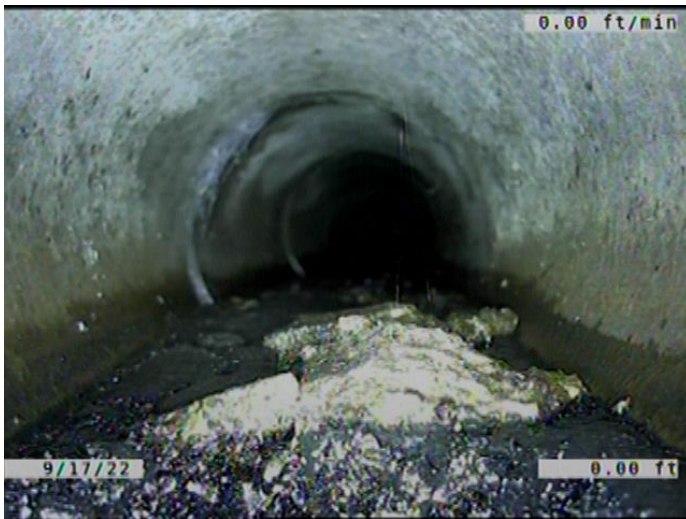
Code: **MWL**  
 Description: **Miscellaneous Water Level**

Distance (ft): **.0**  
 Structural Grade: **0**  
 O&M Grade: **0**  
 Clock Start/From:  
 Clock To:  
 1st Value:  
 2nd Value:  
 Value Percent: **5.000**  
 Continuous Index:  
 Within 8" of Joint: **NO**  
 Remarks:

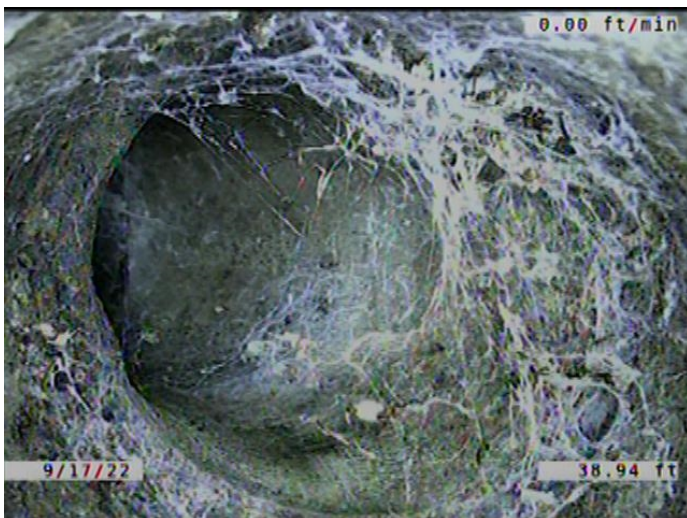
Code: **TF**  
Description: **Tap Factory**

Distance (ft): **38.9**  
Structural Grade: **0**  
O&M Grade: **0**  
Clock Start/From: **11**  
Clock To:  
1st Value: **6.000**  
2nd Value:  
Value Percent:  
Continuous Index:  
Within 8" of Joint: **YES**  
Remarks:

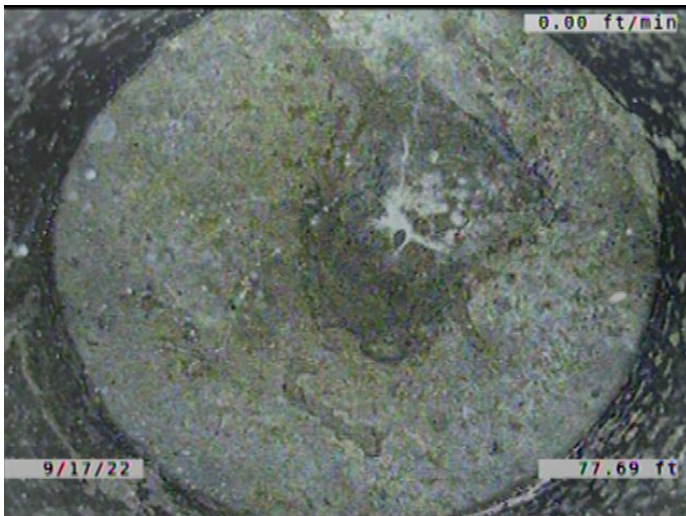
Code: **TFC**  
Description: **Tap Factory Capped**

Distance (ft): **77.7**  
Structural Grade: **0**  
O&M Grade: **0**  
Clock Start/From: **2**  
Clock To:  
1st Value: **6.000**  
2nd Value:  
Value Percent:  
Continuous Index:  
Within 8" of Joint: **YES**  
Remarks:

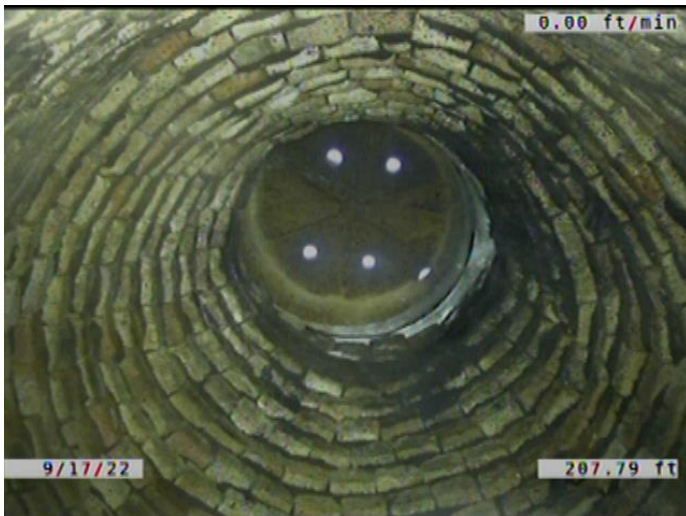
Code: **AMH**  
 Description: **Manhole**

Distance (ft): **207.8**  
 Structural Grade: **0**  
 O&M Grade: **0**  
 Clock Start/From:  
 Clock To:  
 1st Value:  
 2nd Value:  
 Value Percent:  
 Continuous Index:  
 Within 8" of Joint: **NO**  
 Remarks: **M-705-085**
