Profile/Photo Observation Report

Date:	04/21/2018	Weather:		Coding:	PACP 6.0
Pipe Length (ft):	182.4	Owner:	NA	Pre Clean:	Not Known
P.O.#:		Surveyor:	Jen Costello	PSR:	P-705-045-079
Customer:		Clean Date:	01/01/1900	Shape:	C

Street:	E 4TH ST & EAST ST	Flow Control:	Not Controlled
City:	Hobart, IN	Year Renewed:	
Location:	Light Highway	Tape/Media #:	
Purpose:	Maintenance Related	Dia/Height:	8"
Use:	Sanitary	Material:	VCP
Drain Area:	NA	Lining:	Cured in Place
Category:	NA		
Comment:	gravel at 23'.

Location Details:		Direction of Survey:	Upstream
US MH:	M-705-079	DS MH:	M-705-045
		Total Length Surveyed (ft):	25.0

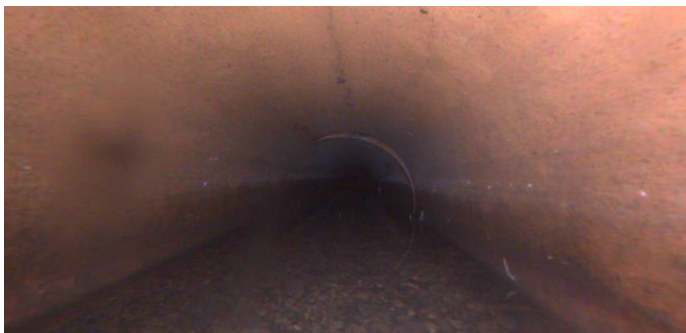
Code: **AMH**
Description: **Manhole**

Distance (ft): **.0**
Structural Grade: **0**
O&M Grade: **0**
Clock Start/From:
Clock To:
1st Value:
2nd Value:
Value Percent:
Continuous Index:
Within 8" of Joint: **NO**
Remarks: **M-705-045**
