Profile/Photo Observation Report

Date:	02/26/2022	Weather:		Coding:	PACP 7.0
Pipe Length (ft):	304.3	Owner:	City of Hobart	Pre Clean:	Heavy Cleaning
P.O.#:	YES502259	Surveyor:	S. Bucklin	PSR:	P-706-007.1-007
Customer:	City of Hobart, IN (Red	Clean Date:	02/22/2022	Shape:	C

Street:	South Linda Street	Flow Control:	Not Controlled
City:	Hobart, IN	Year Renewed:	
Location:	Local rural streets with light traffic, t	Tape/Media #:	
Purpose:	Routine Assessment	Dia/Height:	12"
Use:	Sanitary Sewage Pipe	Material:	VCP
Drain Area:		Lining:	None
Category:	NA		
Comment:			
Location Details:		Direction of Survey:	Downstream
US MH:	M-706-007	DS MH:	M-706-007.1
		Total Length Surveyed (ft):	299.8

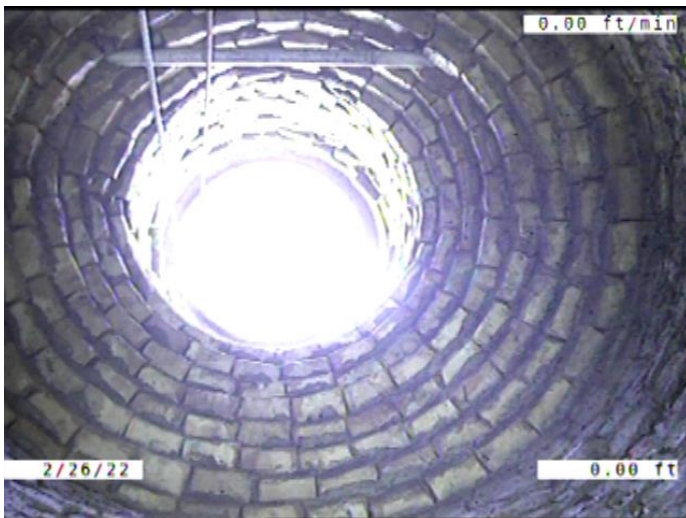
Code: **AMH**
Description: **Manhole**

Distance (ft): **.0**
Structural Grade: **0**
O&M Grade: **0**
Clock Start/From:
Clock To:
1st Value:
2nd Value:
Value Percent:
Continuous Index:
Within 8" of Joint: **NO**
Remarks: **M-706-007**

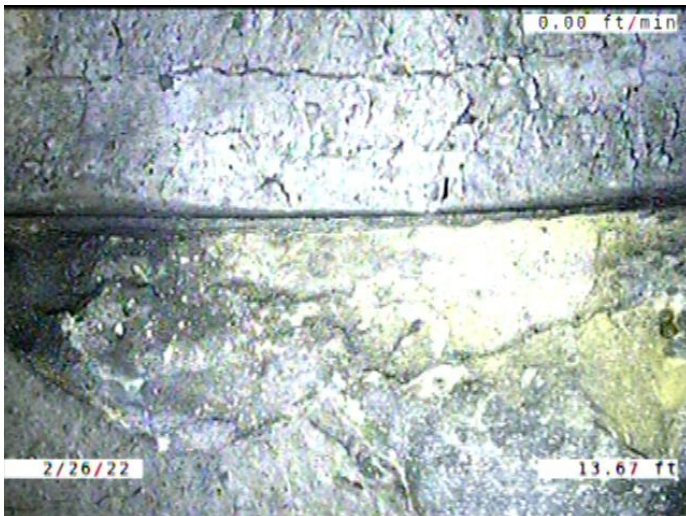
Code: **ISGT**
 Description: **Intruding Sealing Material Grout**

Distance (ft): **13.7**
 Structural Grade: **0**
 O&M Grade: **2**
 Clock Start/From: **4**
 Clock To: **9**
 1st Value:
 2nd Value:
 Value Percent: **5.000**
 Continuous Index:
 Within 8" of Joint: **NO**
 Remarks:

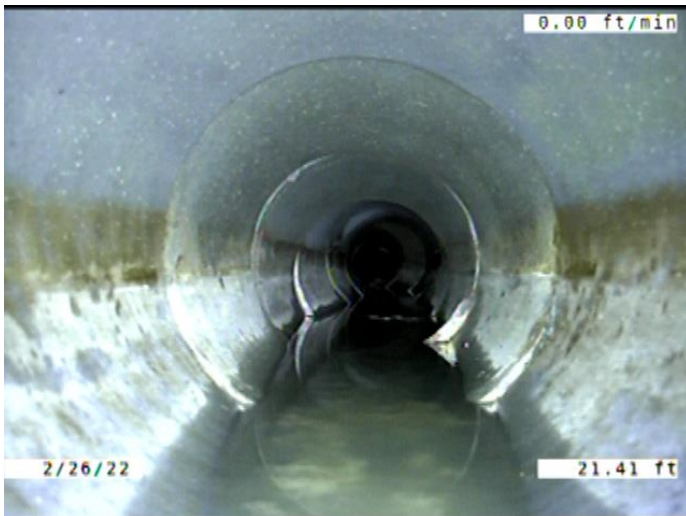
Code: **MWLS**
Description: **Miscellaneous Water Level Sag**

Distance (ft): **21.4**
Structural Grade: **2**
O&M Grade: **0**
Clock Start/From:
Clock To:
1st Value:
2nd Value:
Value Percent: **10.000**
Continuous Index: **S04**
Within 8" of Joint: **NO**
Remarks:

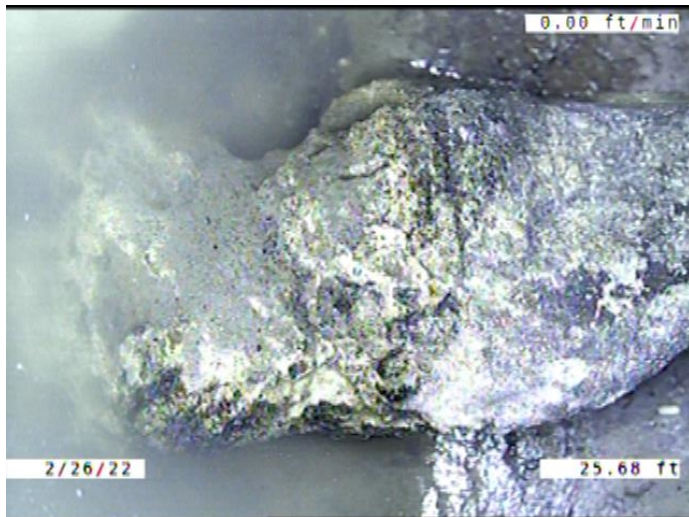
Code: **ISGT**
 Description: **Intruding Sealing Material Grout**

Distance (ft): **25.7**
 Structural Grade: **0**
 O&M Grade: **2**
 Clock Start/From: **4**
 Clock To: **5**
 1st Value:
 2nd Value:
 Value Percent: **5.000**
 Continuous Index:
 Within 8" of Joint: **NO**
 Remarks:

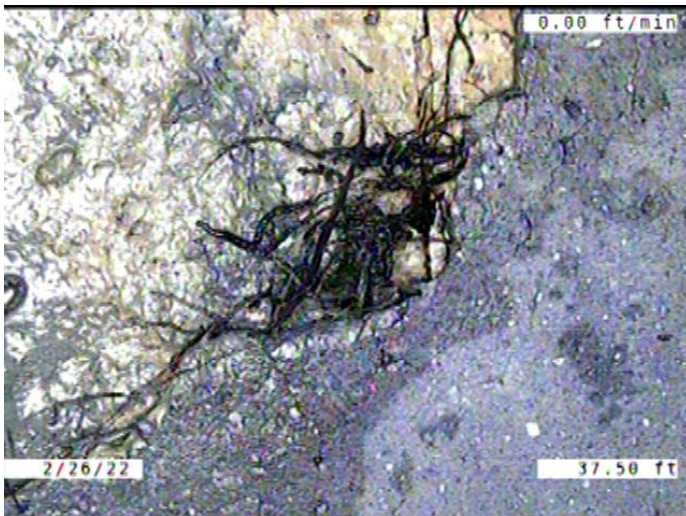
Code: **RFB**
 Description: **Roots Fine Barrel**

Distance (ft): **37.5**
 Structural Grade: **0**
 O&M Grade: **2**
 Clock Start/From: **4**
 Clock To: **5**
 1st Value:
 2nd Value:
 Value Percent:
 Continuous Index:
 Within 8" of Joint: **NO**
 Remarks:

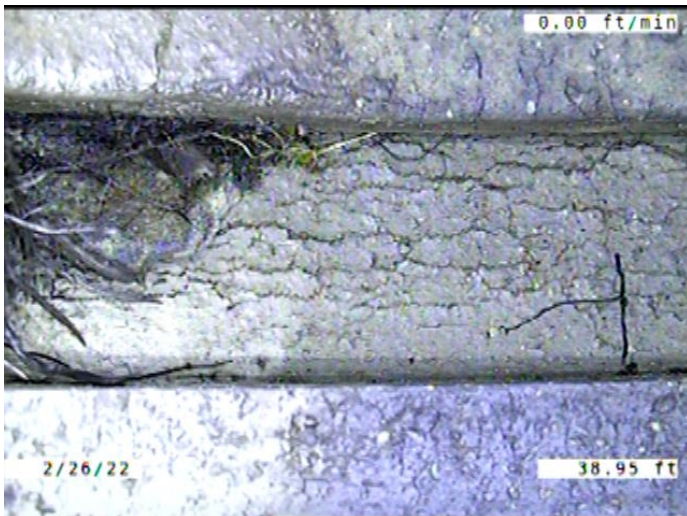
Code: **JAL**
Description: **Joint Angular Large**

Distance (ft): **39.0**
Structural Grade: **4**
O&M Grade: **0**
Clock Start/From:
Clock To:
1st Value:
2nd Value:
Value Percent:
Continuous Index:
Within 8" of Joint: **NO**
Remarks:

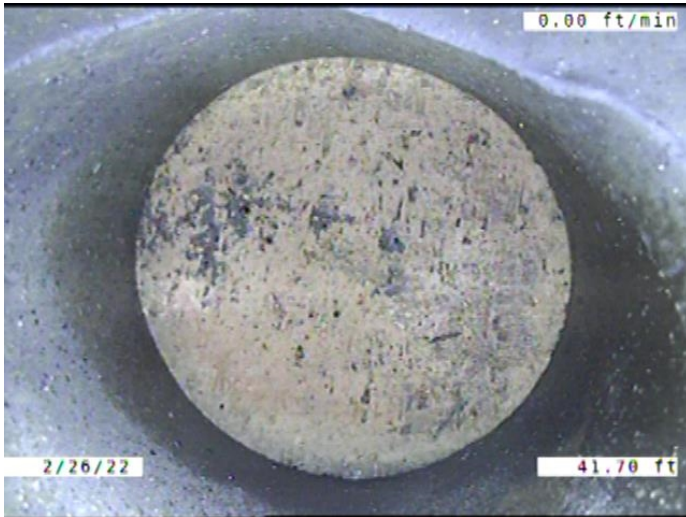
Code: **TFC**
 Description: **Tap Factory Capped**

Distance (ft): **41.7**
 Structural Grade: **0**
 O&M Grade: **0**
 Clock Start/From: **1**
 Clock To:
 1st Value: **6.000**
 2nd Value:
 Value Percent:
 Continuous Index:
 Within 8" of Joint: **YES**
 Remarks:

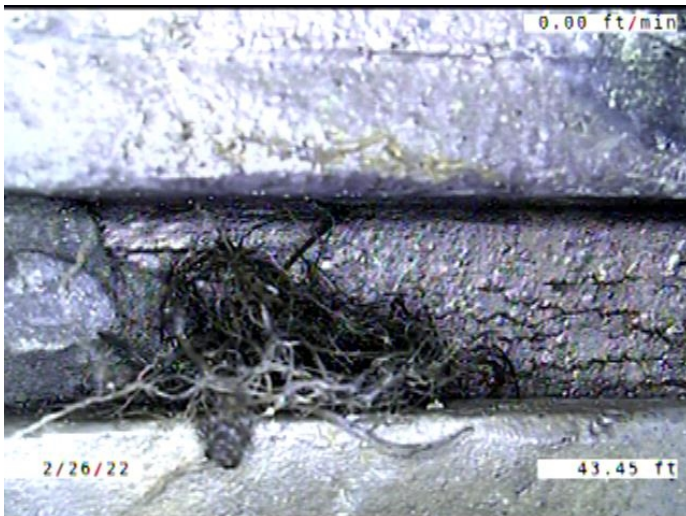
Code: **JAM**
 Description: **Joint Angular Medium**

Distance (ft): **43.5**
 Structural Grade: **3**
 O&M Grade: **0**
 Clock Start/From:
 Clock To:
 1st Value:
 2nd Value:
 Value Percent:
 Continuous Index:
 Within 8" of Joint: **NO**
 Remarks:

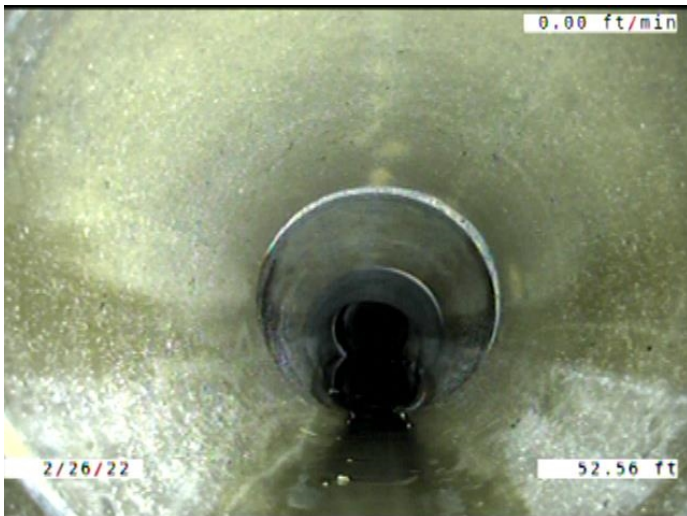
Code: **MWLS**
 Description: **Miscellaneous Water Level Sag**

Distance (ft): **52.6**
 Structural Grade: **2**
 O&M Grade: **0**
 Clock Start/From:
 Clock To:
 1st Value:
 2nd Value:
 Value Percent: **10.000**
 Continuous Index: **F04**
 Within 8" of Joint: **NO**
 Remarks:

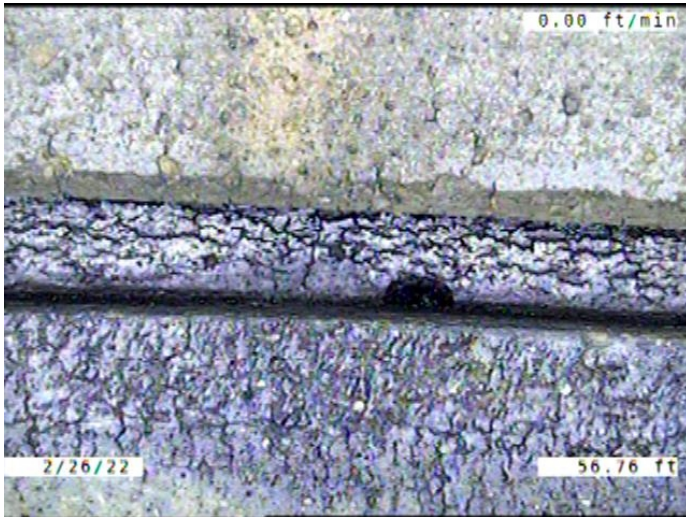
Code: **JAM**
 Description: **Joint Angular Medium**

Distance (ft): **56.8**
 Structural Grade: **3**
 O&M Grade: **0**
 Clock Start/From:
 Clock To:
 1st Value:
 2nd Value:
 Value Percent:
 Continuous Index:
 Within 8" of Joint: **NO**
 Remarks:

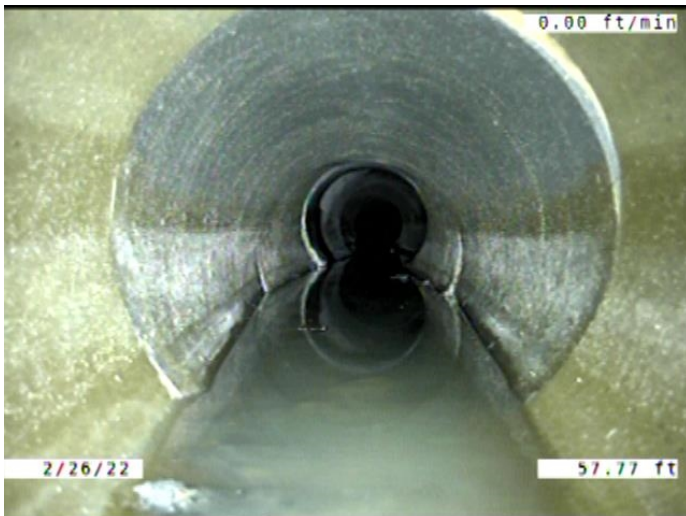
Code: **MWLS**
 Description: **Miscellaneous Water Level Sag**

Distance (ft): **57.8**
 Structural Grade: **2**
 O&M Grade: **0**
 Clock Start/From:
 Clock To:
 1st Value:
 2nd Value:
 Value Percent: **10.000**
 Continuous Index: **S05**
 Within 8" of Joint: **NO**
 Remarks:

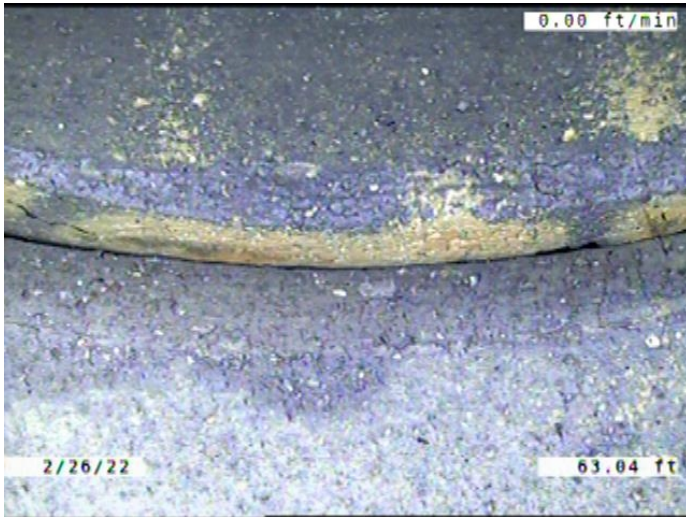
Code: **JOM**
Description: **Joint Offset Medium**

Distance (ft): **63.0**
Structural Grade: **3**
O&M Grade: **0**
Clock Start/From:
Clock To:
1st Value:
2nd Value:
Value Percent:
Continuous Index:
Within 8" of Joint: **NO**
Remarks:

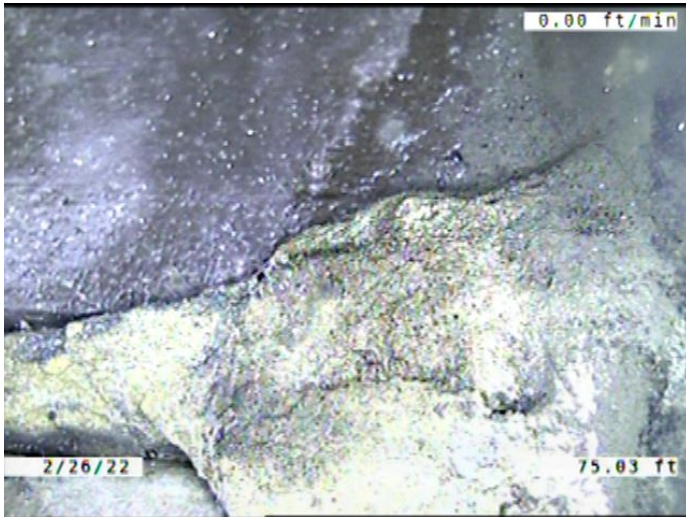
Code: **ISGT**
Description: **Intruding Sealing Material Grout**

Distance (ft): **75.0**
Structural Grade: **0**
O&M Grade: **2**
Clock Start/From: **3**
Clock To: **9**
1st Value:
2nd Value:
Value Percent: **5.000**
Continuous Index:
Within 8" of Joint: **NO**
Remarks:

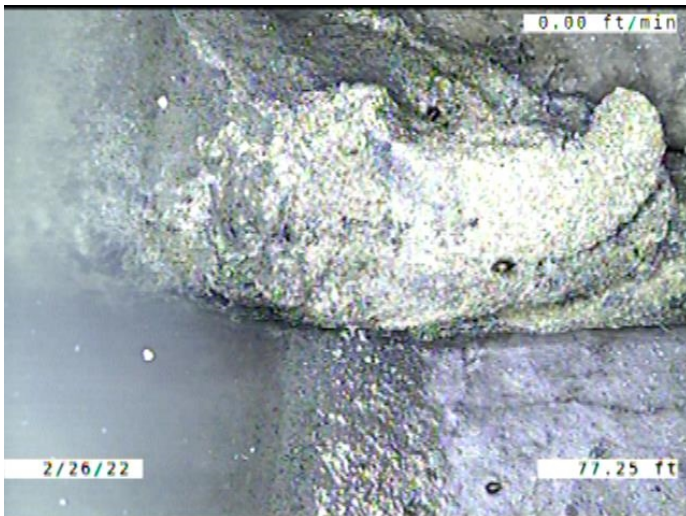
Code: **ISGT**
Description: **Intruding Sealing Material Grout**

Distance (ft): **77.3**
Structural Grade: **0**
O&M Grade: **2**
Clock Start/From: **3**
Clock To: **5**
1st Value:
2nd Value:
Value Percent: **5.000**
Continuous Index:
Within 8" of Joint: **NO**
Remarks:

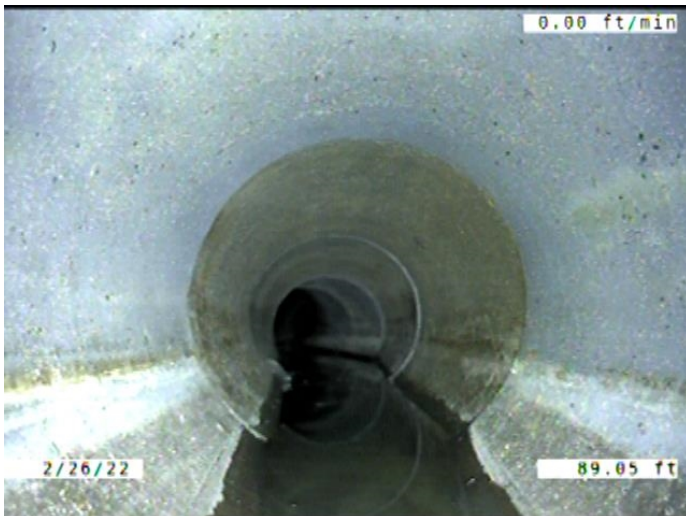
Code: **MWLS**
Description: **Miscellaneous Water Level Sag**

Distance (ft): **89.0**
Structural Grade: **2**
O&M Grade: **0**
Clock Start/From:
Clock To:
1st Value:
2nd Value:
Value Percent: **10.000**
Continuous Index: **F05**
Within 8" of Joint: **NO**
Remarks:

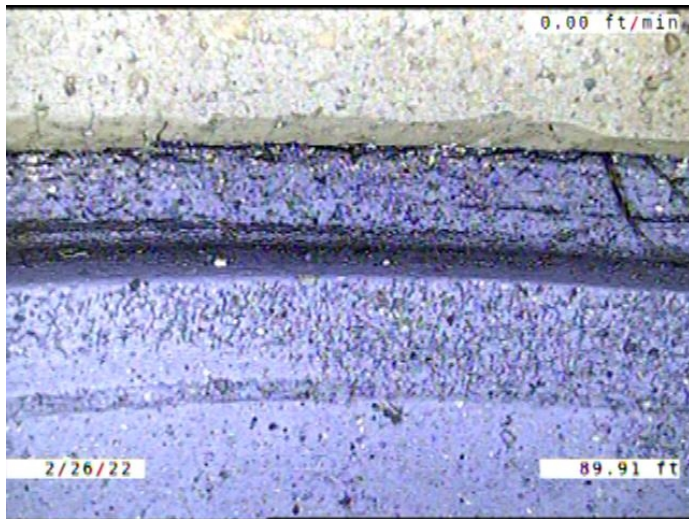
Code: **JAM**
 Description: **Joint Angular Medium**

Distance (ft): **89.9**
 Structural Grade: **3**
 O&M Grade: **0**
 Clock Start/From:
 Clock To:
 1st Value:
 2nd Value:
 Value Percent:
 Continuous Index:
 Within 8" of Joint: **NO**
 Remarks:

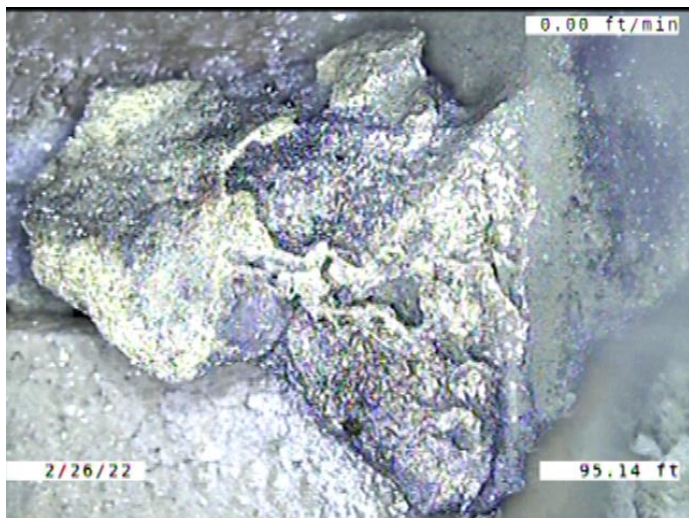
Code: **ISGT**
 Description: **Intruding Sealing Material Grout**

Distance (ft): **95.1**
 Structural Grade: **0**
 O&M Grade: **2**
 Clock Start/From: **7**
 Clock To: **8**
 1st Value:
 2nd Value:
 Value Percent: **5.000**
 Continuous Index:
 Within 8" of Joint: **NO**
 Remarks:

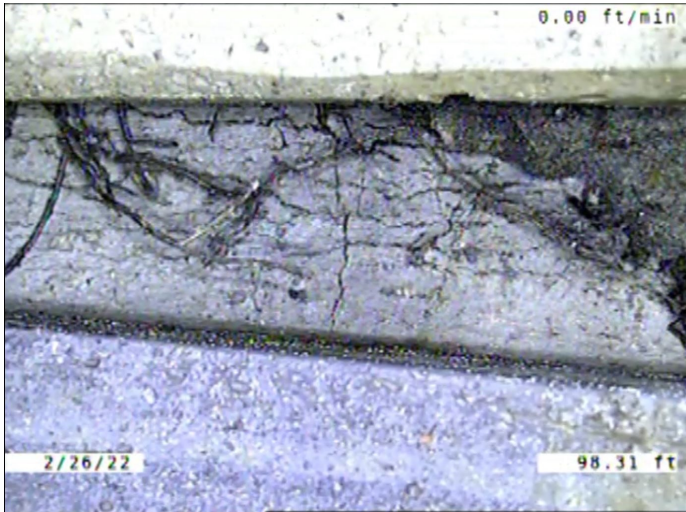
Code: **CM**
 Description: **Crack Multiple**

Distance (ft): **98.3**
 Structural Grade: **3**
 O&M Grade: **0**
 Clock Start/From: **3**
 Clock To: **4**
 1st Value:
 2nd Value:
 Value Percent:
 Continuous Index:
 Within 8" of Joint: **YES**
 Remarks:

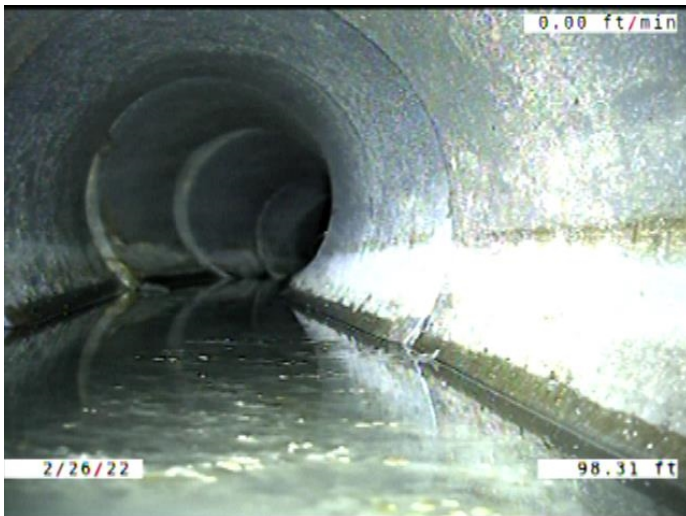
Code: **LL**
 Description: **Line Left**

Distance (ft): **98.3**
 Structural Grade: **0**
 O&M Grade: **1**
 Clock Start/From:
 Clock To:
 1st Value:
 2nd Value:
 Value Percent: **10.000**
 Continuous Index:
 Within 8" of Joint: **NO**
 Remarks:

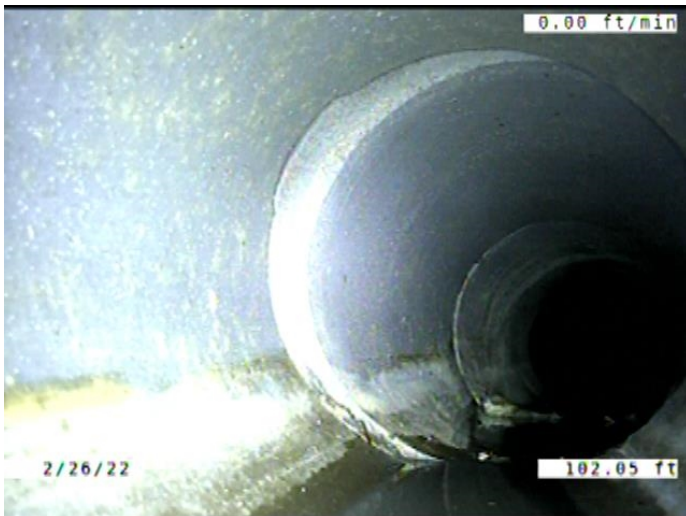
Code: **LR**
 Description: **Line Right**

Distance (ft): **102.1**
 Structural Grade: **0**
 O&M Grade: **1**
 Clock Start/From:
 Clock To:
 1st Value:
 2nd Value:
 Value Percent: **10.000**
 Continuous Index:
 Within 8" of Joint: **NO**
 Remarks:

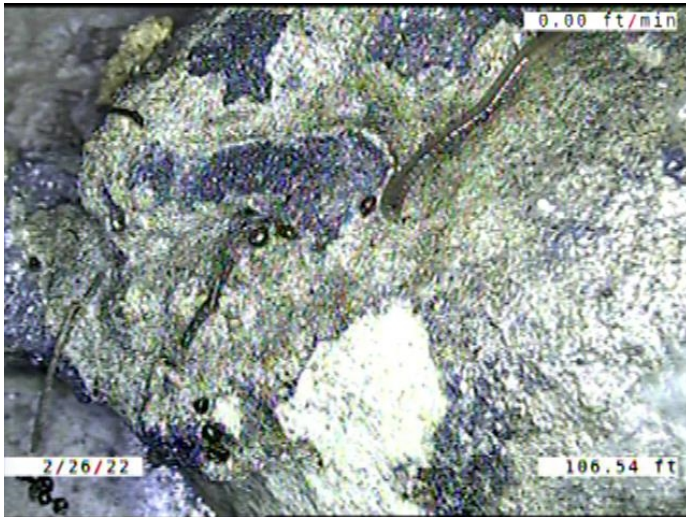
Code: **ISGT**
Description: **Intruding Sealing Material Grout**

Distance (ft): **106.5**
Structural Grade: **0**
O&M Grade: **2**
Clock Start/From: **3**
Clock To: **9**
1st Value:
2nd Value:
Value Percent: **5.000**
Continuous Index: **S07**
Within 8" of Joint: **NO**
Remarks:

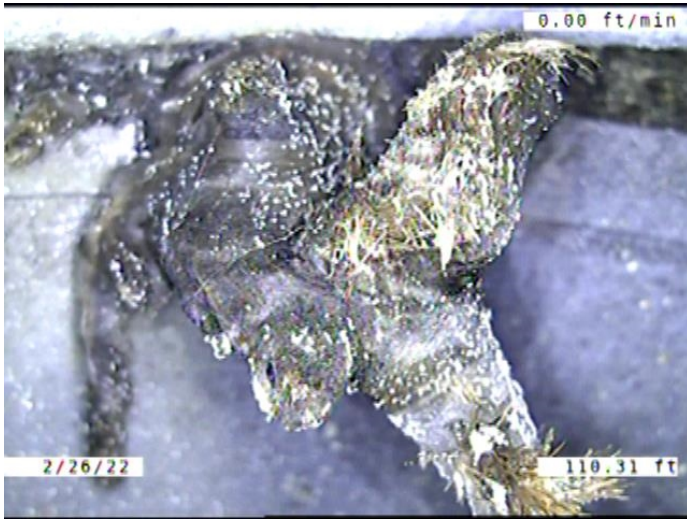
Code: **RTJ**
 Description: **Roots Tap Joint**

Distance (ft): **110.3**
 Structural Grade: **0**
 O&M Grade: **2**
 Clock Start/From: **10**
 Clock To: **11**
 1st Value:
 2nd Value:
 Value Percent: **5.000**
 Continuous Index:
 Within 8" of Joint: **YES**
 Remarks:

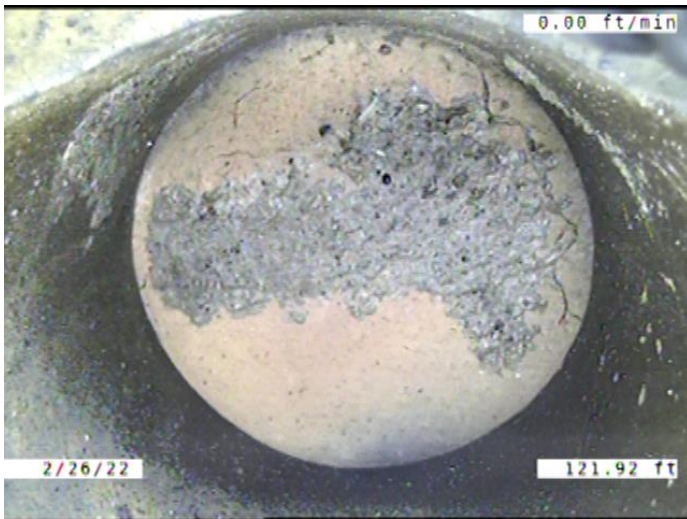
Code: **TFC**
 Description: **Tap Factory Capped**

Distance (ft): **121.9**
 Structural Grade: **0**
 O&M Grade: **0**
 Clock Start/From: **2**
 Clock To:
 1st Value: **6.000**
 2nd Value:
 Value Percent:
 Continuous Index:
 Within 8" of Joint: **YES**
 Remarks:

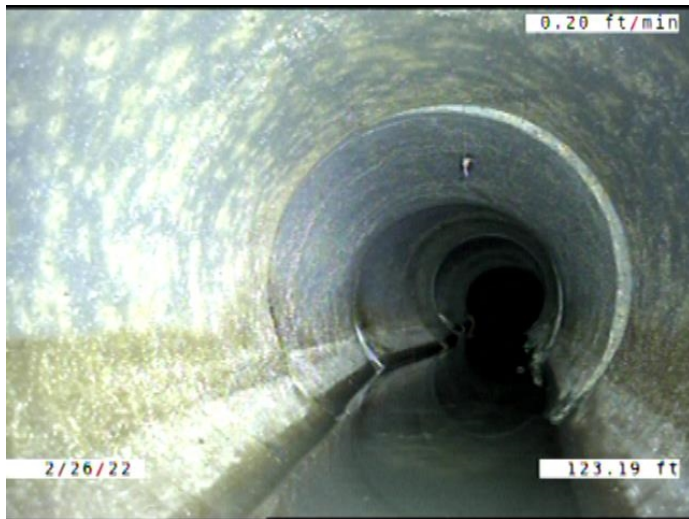
Code: **LR**
 Description: **Line Right**

Distance (ft): **123.2**
 Structural Grade: **0**
 O&M Grade: **1**
 Clock Start/From:
 Clock To:
 1st Value:
 2nd Value:
 Value Percent: **5.000**
 Continuous Index:
 Within 8" of Joint: **NO**
 Remarks:

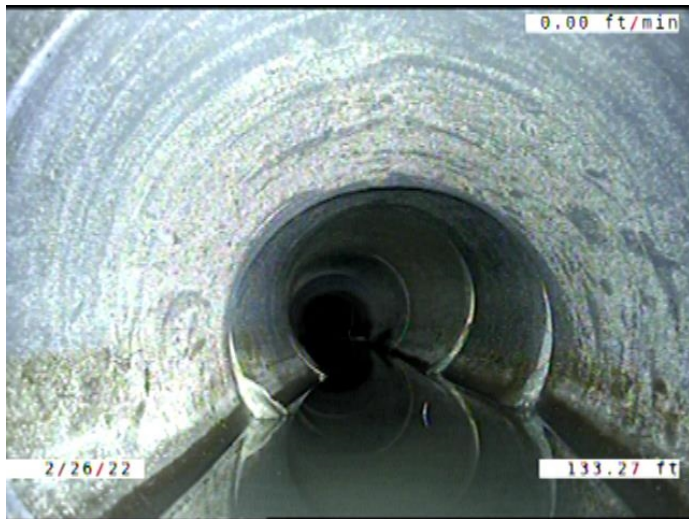
Code: **MWLS**
 Description: **Miscellaneous Water Level Sag**

Distance (ft): **133.3**
 Structural Grade: **2**
 O&M Grade: **0**
 Clock Start/From:
 Clock To:
 1st Value:
 2nd Value:
 Value Percent: **10.000**
 Continuous Index: **S08**
 Within 8" of Joint: **NO**
 Remarks:

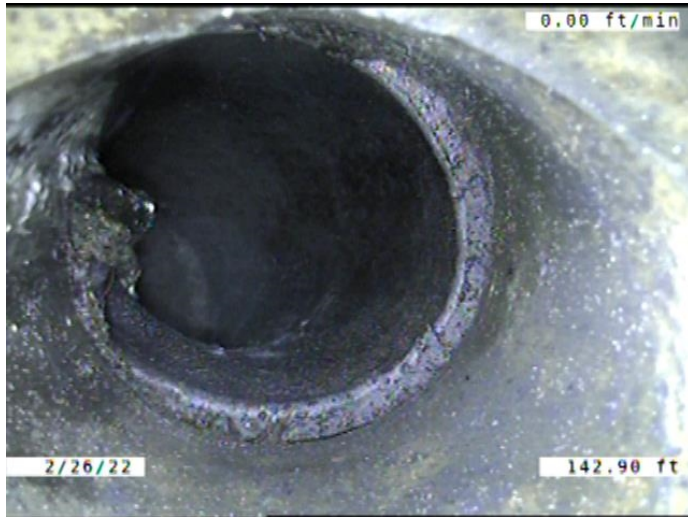
Code: **TF**
Description: **Tap Factory**

Distance (ft): **142.9**
Structural Grade: **0**
O&M Grade: **0**
Clock Start/From: **11**
Clock To:
1st Value: **6.000**
2nd Value:
Value Percent:
Continuous Index:
Within 8" of Joint: **YES**
Remarks: **SERVICE TO MAIN CONNECTION OFFSET**

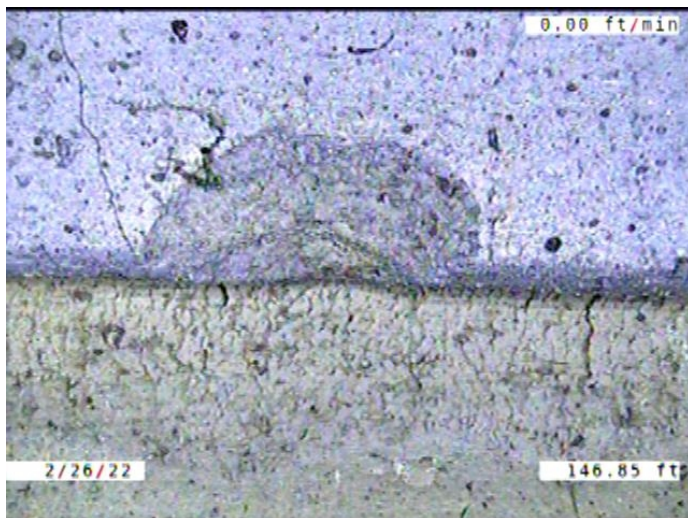
Code: **SZ**
Description: **Surface Damage Other**

Distance (ft): **146.9**
Structural Grade: **0**
O&M Grade: **0**
Clock Start/From: **12**
Clock To:
1st Value:
2nd Value:
Value Percent:
Continuous Index:
Within 8" of Joint: **YES**
Remarks: **A PIECE CHIPPED AWAY FROM THE JOINT**

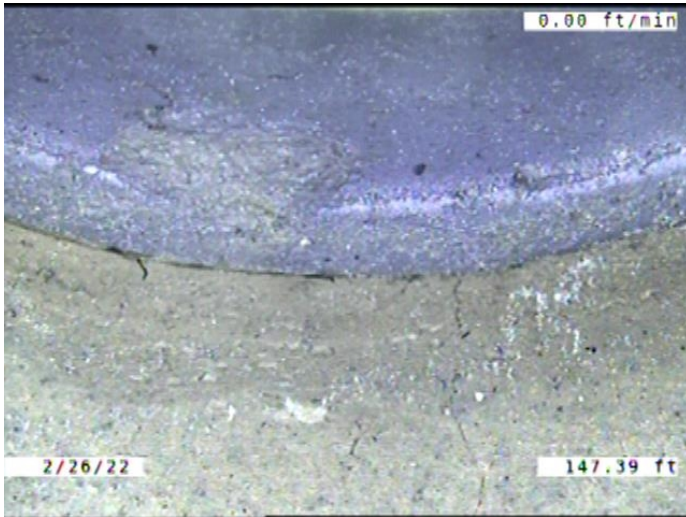
Code: **JOM**
 Description: **Joint Offset Medium**

Distance (ft): **147.4**
 Structural Grade: **3**
 O&M Grade: **0**
 Clock Start/From:
 Clock To:
 1st Value:
 2nd Value:
 Value Percent:
 Continuous Index:
 Within 8" of Joint: **NO**
 Remarks:

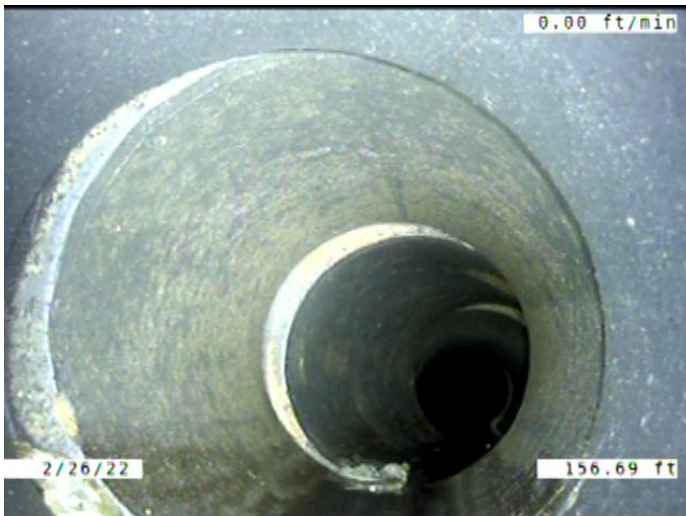
Code: **MWLS**
 Description: **Miscellaneous Water Level Sag**

Distance (ft): **156.7**
 Structural Grade: **2**
 O&M Grade: **0**
 Clock Start/From:
 Clock To:
 1st Value:
 2nd Value:
 Value Percent: **10.000**
 Continuous Index: **F08**
 Within 8" of Joint: **NO**
 Remarks:

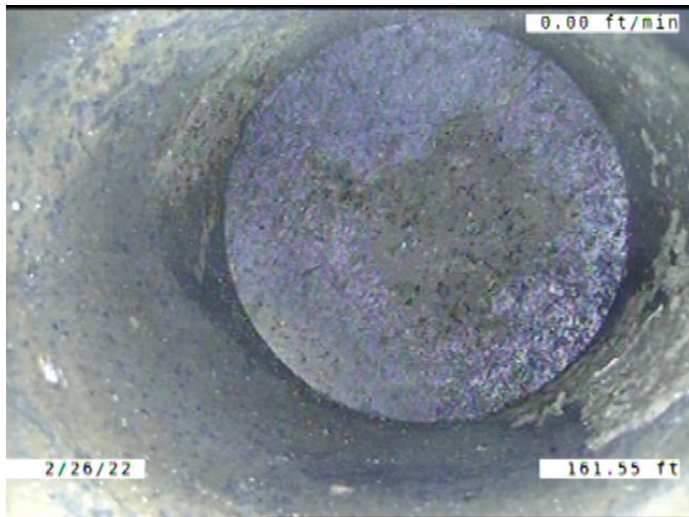
Code: **TFC**
 Description: **Tap Factory Capped**

Distance (ft): **161.6**
 Structural Grade: **0**
 O&M Grade: **0**
 Clock Start/From: **1**
 Clock To:
 1st Value: **6.000**
 2nd Value:
 Value Percent:
 Continuous Index:
 Within 8" of Joint: **YES**
 Remarks:

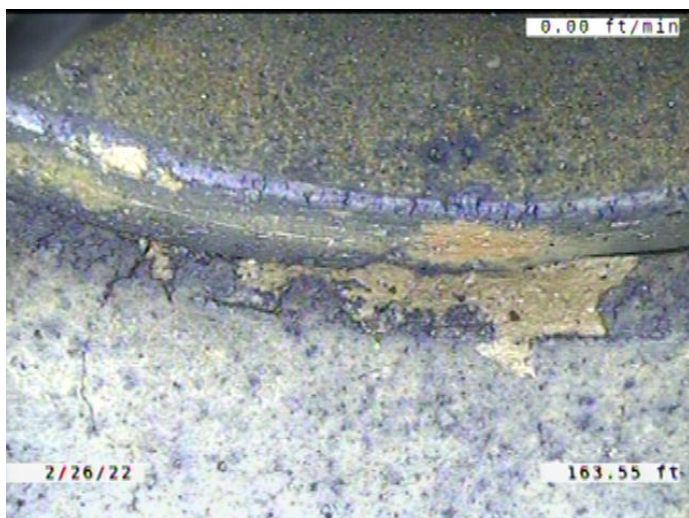
Code: **JOM**
 Description: **Joint Offset Medium**

Distance (ft): **163.5**
 Structural Grade: **3**
 O&M Grade: **0**
 Clock Start/From:
 Clock To:
 1st Value:
 2nd Value:
 Value Percent:
 Continuous Index:
 Within 8" of Joint: **NO**
 Remarks:

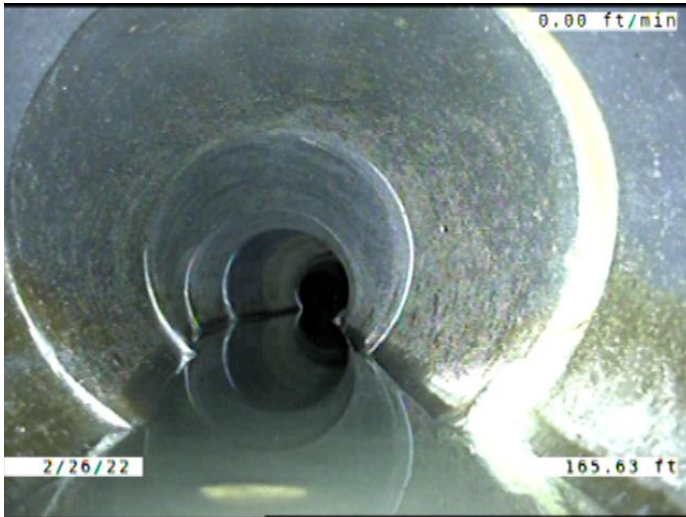
Code: **MWLS**
 Description: **Miscellaneous Water Level Sag**

Distance (ft): **165.6**
 Structural Grade: **2**
 O&M Grade: **0**
 Clock Start/From:
 Clock To:
 1st Value:
 2nd Value:
 Value Percent: **10.000**
 Continuous Index: **S09**
 Within 8" of Joint: **NO**
 Remarks:

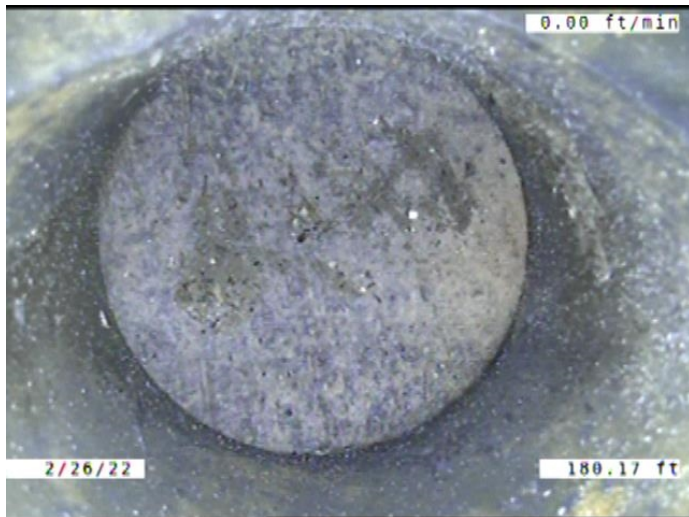
Code: **TFC**
 Description: **Tap Factory Capped**

Distance (ft): **180.2**
 Structural Grade: **0**
 O&M Grade: **0**
 Clock Start/From: **11**
 Clock To:
 1st Value: **6.000**
 2nd Value:
 Value Percent:
 Continuous Index:
 Within 8" of Joint: **YES**
 Remarks:

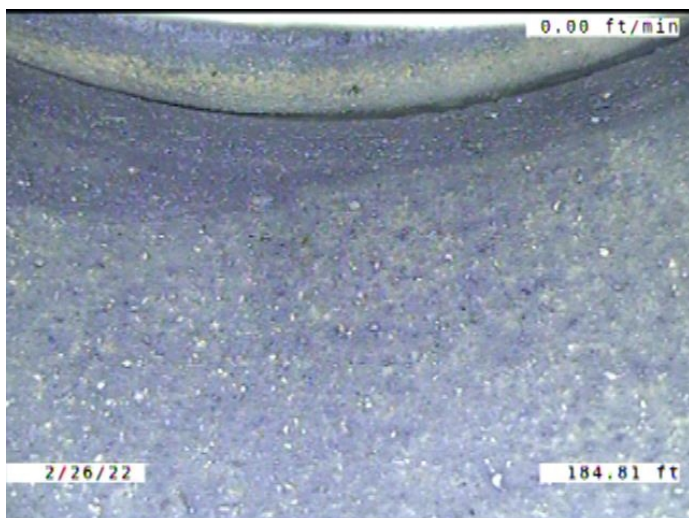
Code: **JOM**
 Description: **Joint Offset Medium**

Distance (ft): **184.8**
 Structural Grade: **3**
 O&M Grade: **0**
 Clock Start/From:
 Clock To:
 1st Value:
 2nd Value:
 Value Percent:
 Continuous Index:
 Within 8" of Joint: **NO**
 Remarks:

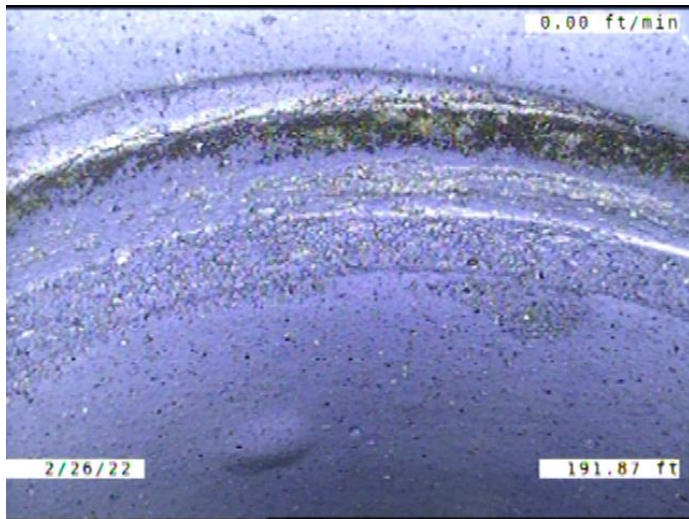
Code: **JOM**
Description: **Joint Offset Medium**

Distance (ft): **191.9**
Structural Grade: **3**
O&M Grade: **0**
Clock Start/From:
Clock To:
1st Value:
2nd Value:
Value Percent:
Continuous Index:
Within 8" of Joint: **NO**
Remarks:

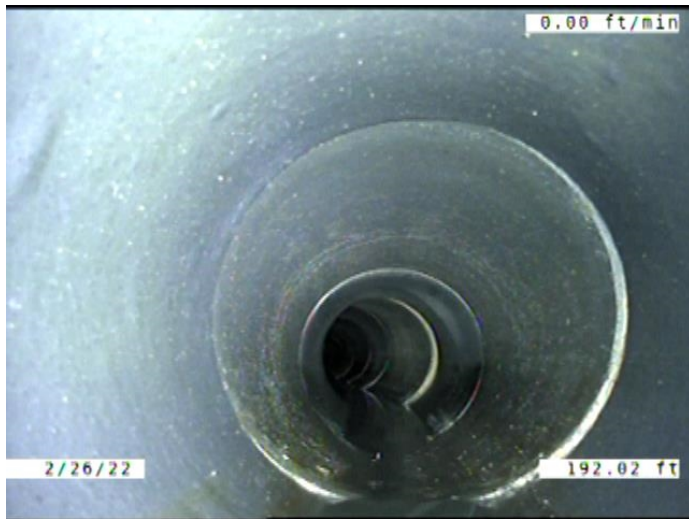
Code: **MWLS**
Description: **Miscellaneous Water Level Sag**

Distance (ft): **192.0**
Structural Grade: **2**
O&M Grade: **0**
Clock Start/From:
Clock To:
1st Value:
2nd Value:
Value Percent: **10.000**
Continuous Index: **F09**
Within 8" of Joint: **NO**
Remarks:

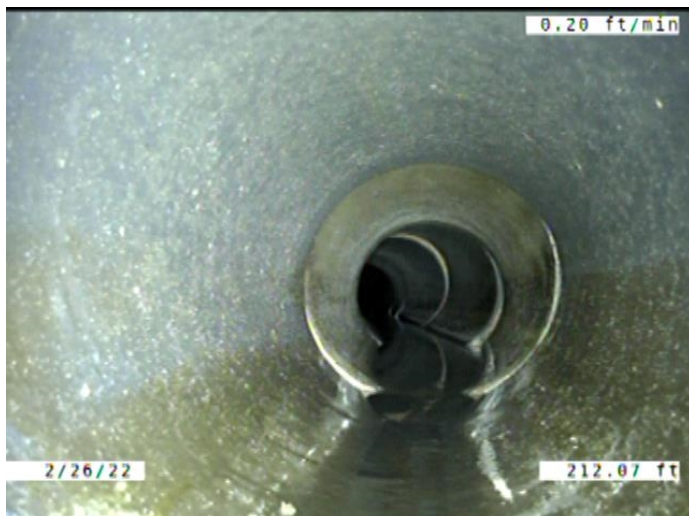
Code: **LR**
 Description: **Line Right**

Distance (ft): **212.0**
 Structural Grade: **0**
 O&M Grade: **1**
 Clock Start/From:
 Clock To:
 1st Value:
 2nd Value:
 Value Percent: **10.000**
 Continuous Index:
 Within 8" of Joint: **NO**
 Remarks:

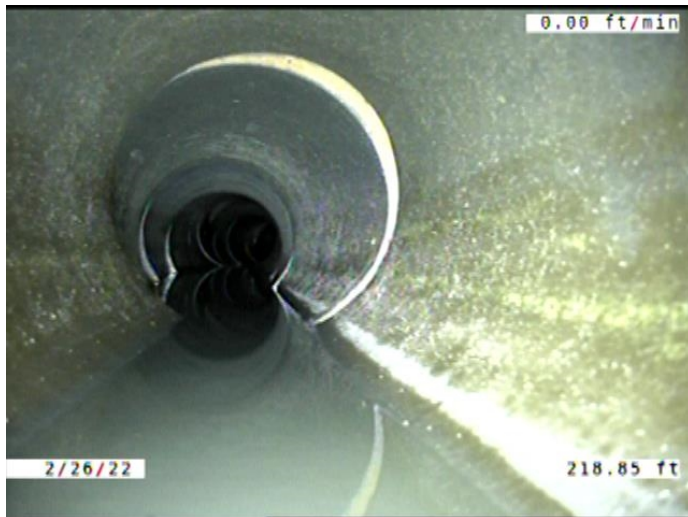
Code: **LL**
Description: **Line Left**

Distance (ft): **218.8**
Structural Grade: **0**
O&M Grade: **1**
Clock Start/From:
Clock To:
1st Value:
2nd Value:
Value Percent: **5.000**
Continuous Index:
Within 8" of Joint: **NO**
Remarks:

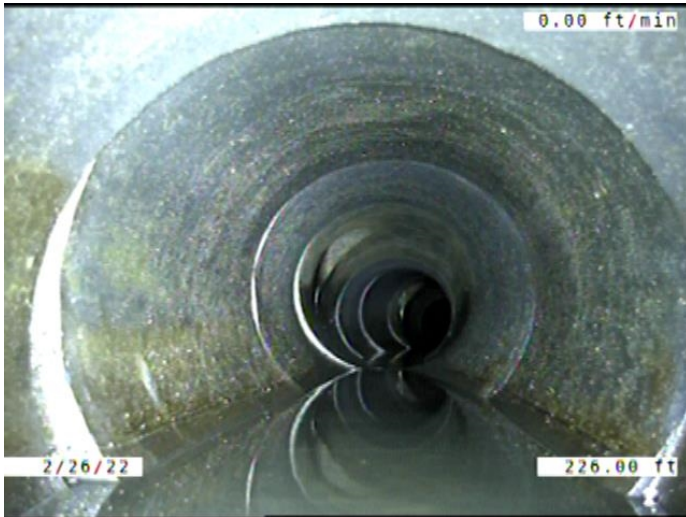
Code: **JOM**
Description: **Joint Offset Medium**

Distance (ft): **221.9**
Structural Grade: **3**
O&M Grade: **0**
Clock Start/From:
Clock To:
1st Value:
2nd Value:
Value Percent:
Continuous Index:
Within 8" of Joint: **NO**
Remarks:

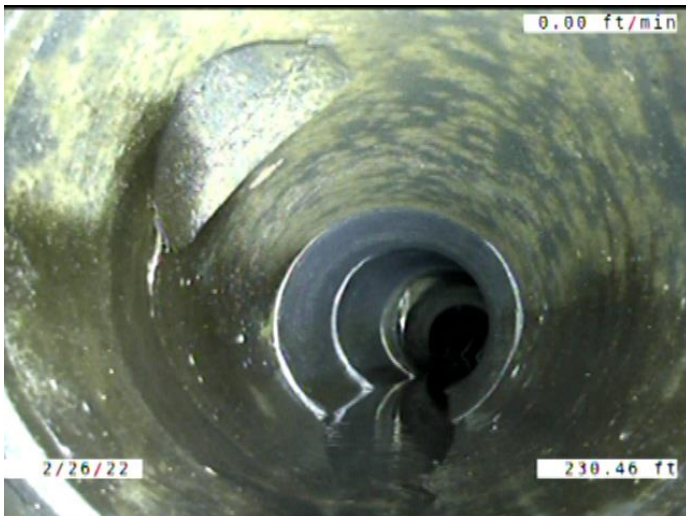
Code: **MWLS**
Description: **Miscellaneous Water Level Sag**

Distance (ft): **226.0**
Structural Grade: **2**
O&M Grade: **0**
Clock Start/From:
Clock To:
1st Value:
2nd Value:
Value Percent: **10.000**
Continuous Index: **S10**
Within 8" of Joint: **NO**
Remarks:

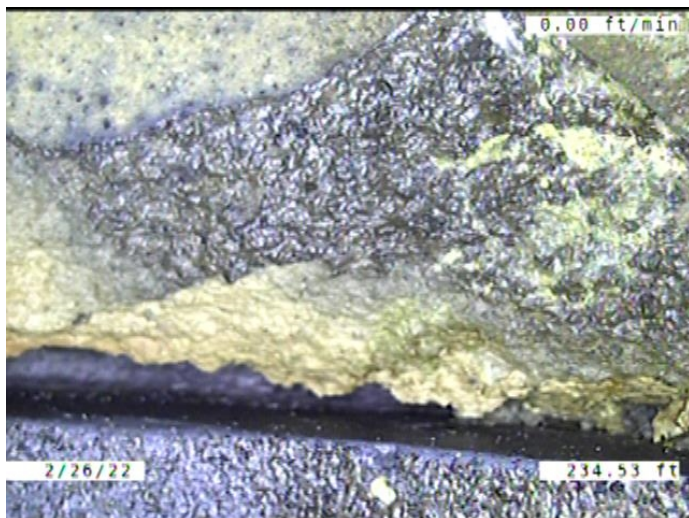
Code: **TFA**
 Description: **Tap Factory Activity**

Distance (ft): **232.7**
 Structural Grade: **0**
 O&M Grade: **0**
 Clock Start/From: **11**
 Clock To:
 1st Value: **6.000**
 2nd Value:
 Value Percent:
 Continuous Index:
 Within 8" of Joint: **YES**
 Remarks: **ROOTS GROWING FROM THE SERVICE TO MAIN CONNECTION .**

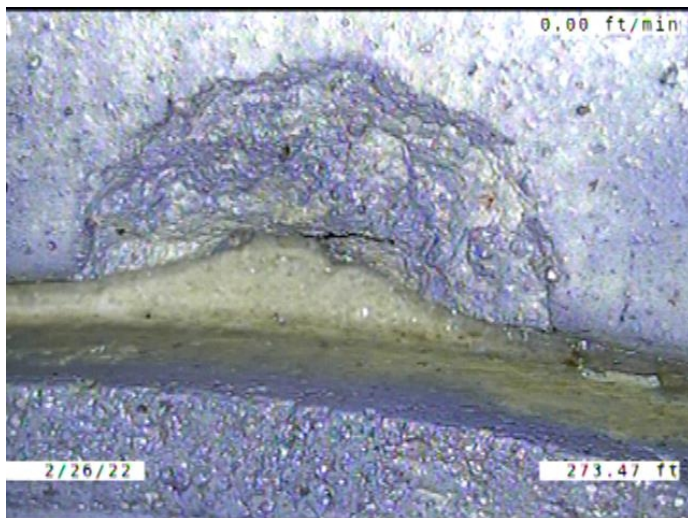
Code: **ISGT**
 Description: **Intruding Sealing Material Grout**

Distance (ft): **264.5**
 Structural Grade: **0**
 O&M Grade: **2**
 Clock Start/From: **3**
 Clock To: **9**
 1st Value:
 2nd Value:
 Value Percent: **5.000**
 Continuous Index: **F07**
 Within 8" of Joint: **NO**
 Remarks:

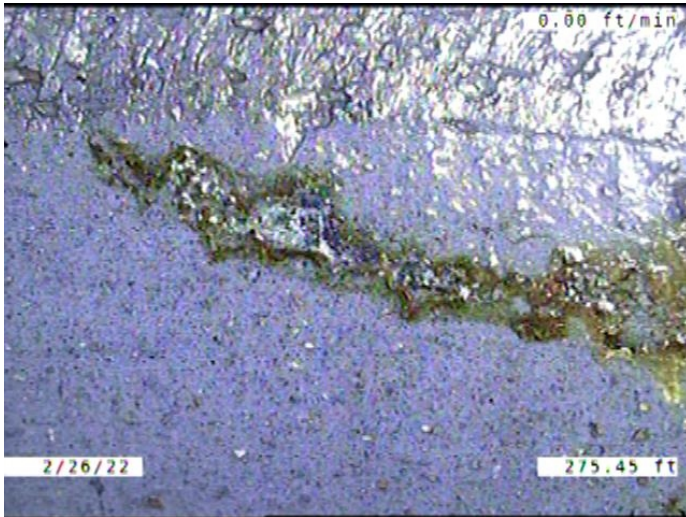
Code: **SZ**
 Description: **Surface Damage Other**

Distance (ft): **273.5**
 Structural Grade: **0**
 O&M Grade: **0**
 Clock Start/From: **3**
 Clock To:
 1st Value:
 2nd Value:
 Value Percent:
 Continuous Index:
 Within 8" of Joint: **YES**
 Remarks: **A PIECE CHIPPED AWAY FROM THE JOINT**

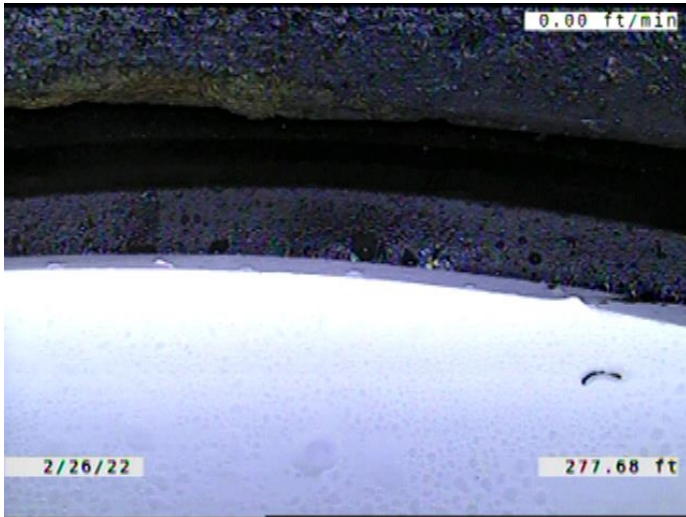
Code: **JOL**
 Description: **Joint Offset Large**

Distance (ft): **277.6**
 Structural Grade: **4**
 O&M Grade: **0**
 Clock Start/From:
 Clock To:
 1st Value: **2.000**
 2nd Value:
 Value Percent:
 Continuous Index:
 Within 8" of Joint: **NO**
 Remarks:

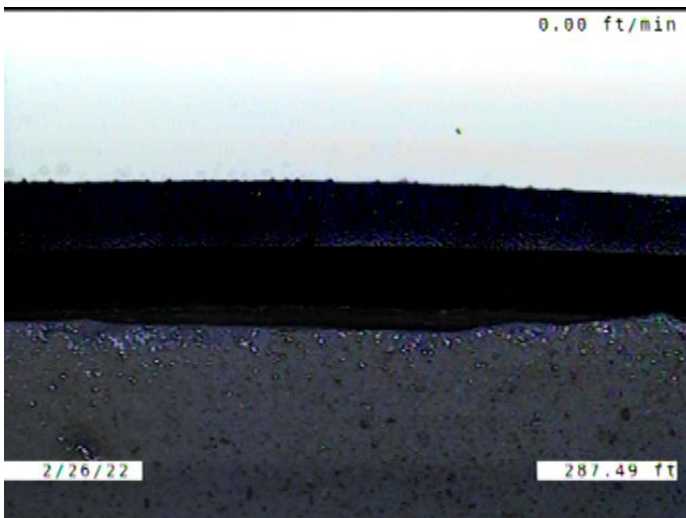
Code: **MMC**
Description: **Miscellaneous Material Change**

Distance (ft): **277.7**
Structural Grade: **0**
O&M Grade: **0**
Clock Start/From:
Clock To:
1st Value:
2nd Value:
Value Percent:
Continuous Index:
Within 8" of Joint: **NO**
Remarks: **VCP TO PVC**

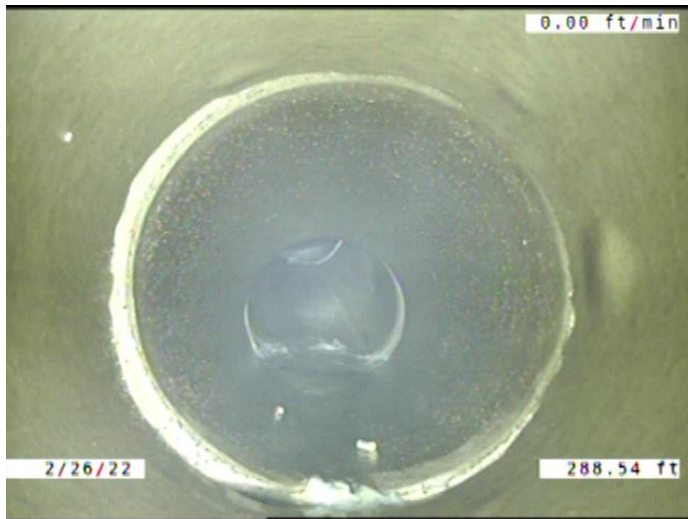
Code: **MMC**
Description: **Miscellaneous Material Change**

Distance (ft): **287.5**
Structural Grade: **0**
O&M Grade: **0**
Clock Start/From:
Clock To:
1st Value:
2nd Value:
Value Percent:
Continuous Index:
Within 8" of Joint: **NO**
Remarks: **PVC TO VCP**

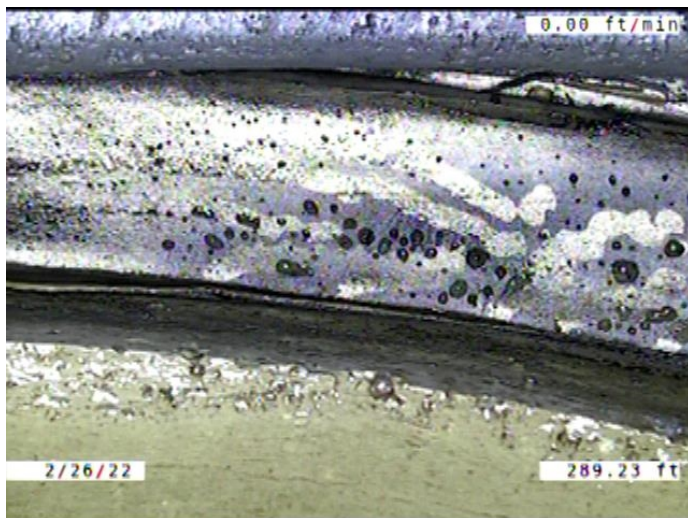
Code: **LD**
 Description: **Line Down**

Distance (ft): **288.5**
 Structural Grade: **0**
 O&M Grade: **2**
 Clock Start/From:
 Clock To:
 1st Value:
 2nd Value:
 Value Percent: **20.000**
 Continuous Index:
 Within 8" of Joint: **NO**
 Remarks:

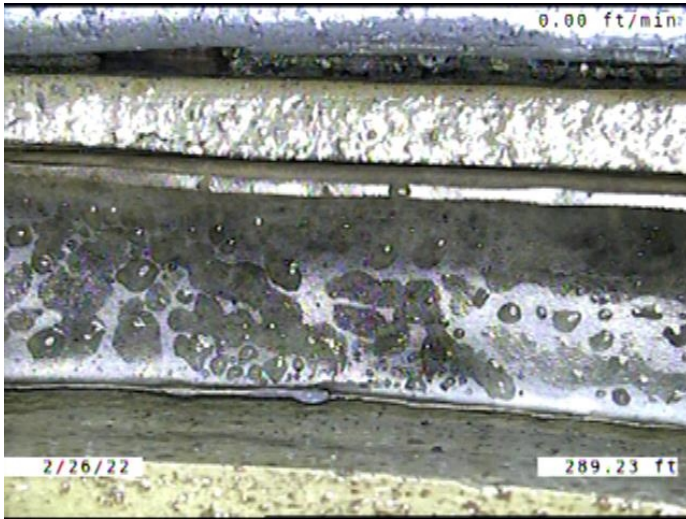
Code: **JAL**
 Description: **Joint Angular Large**

Distance (ft): **289.2**
 Structural Grade: **4**
 O&M Grade: **0**
 Clock Start/From:
 Clock To:
 1st Value:
 2nd Value:
 Value Percent:
 Continuous Index:
 Within 8" of Joint: **NO**
 Remarks:

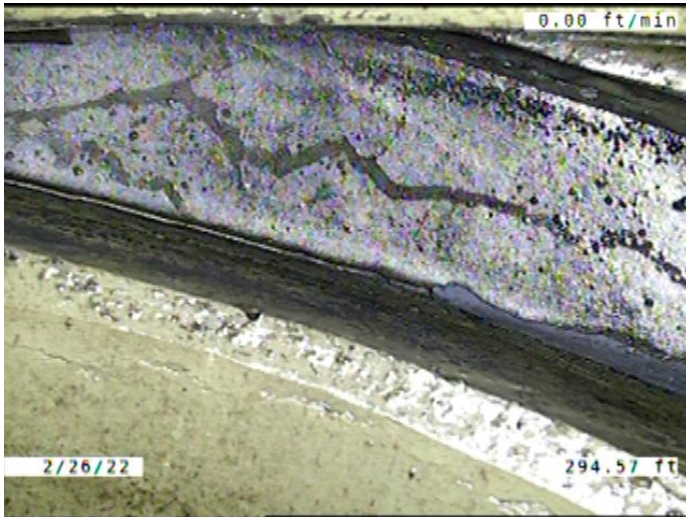
Code: **BSV**
 Description: **Broken Soil Visible**

Distance (ft): **294.6**
 Structural Grade: **5**
 O&M Grade: **0**
 Clock Start/From: **3**
 Clock To: **12**
 1st Value:
 2nd Value:
 Value Percent:
 Continuous Index:
 Within 8" of Joint: **YES**
 Remarks:

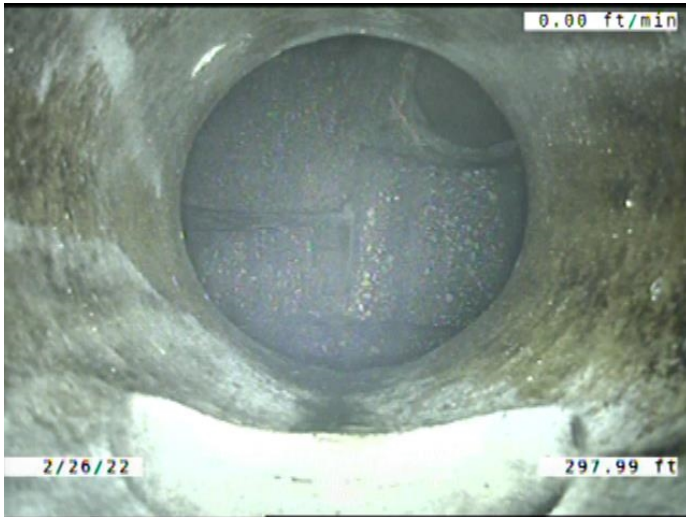
Code: **DSF**
 Description: **Deposits Settled Fine**

Distance (ft): **298.0**
 Structural Grade: **0**
 O&M Grade: **2**
 Clock Start/From: **5**
 Clock To: **7**
 1st Value:
 2nd Value:
 Value Percent: **5.000**
 Continuous Index: **F01**
 Within 8" of Joint: **YES**
 Remarks:

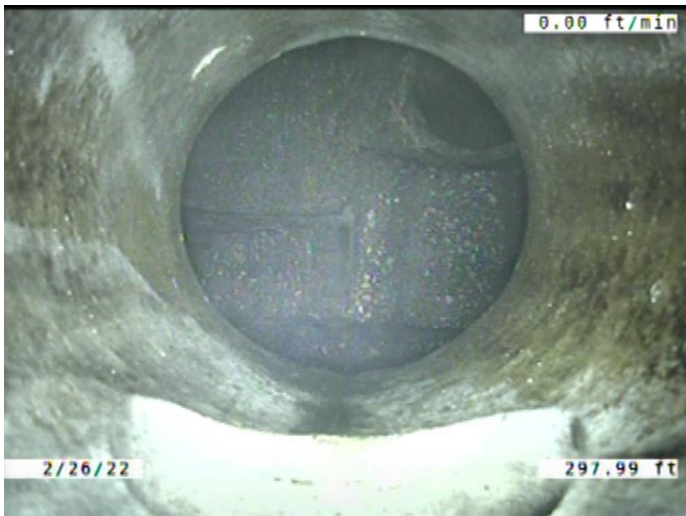
Code: **RFJ**
Description: **Roots Fine Joint**

Distance (ft): **298.0**
Structural Grade: **0**
O&M Grade: **1**
Clock Start/From: **9**
Clock To: **3**
1st Value:
2nd Value:
Value Percent:
Continuous Index: **F02**
Within 8" of Joint: **YES**
Remarks:

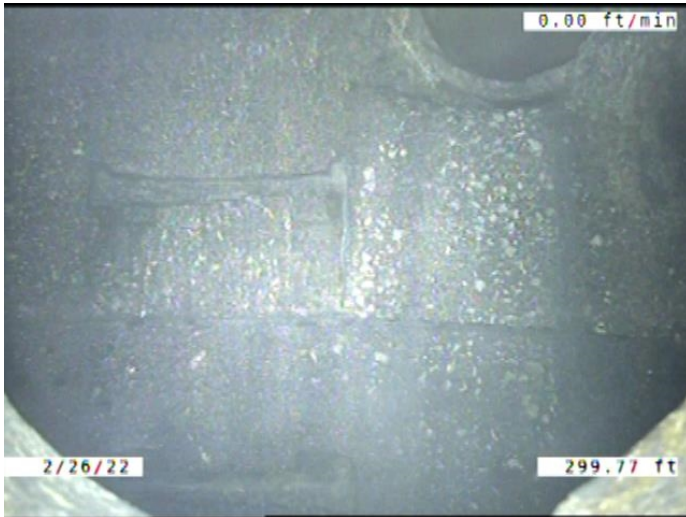
Code: **CM**
Description: **Crack Multiple**

Distance (ft): **298.0**
Structural Grade: **3**
O&M Grade: **0**
Clock Start/From: **12**
Clock To: **12**
1st Value:
2nd Value:
Value Percent:
Continuous Index: **F03**
Within 8" of Joint: **YES**
Remarks:
