Profile/Photo Observation Report

Date:	02/26/2022	Weather:		Coding:	PACP 7.0
Pipe Length (ft):	336.0	Owner:	City of Hobart	Pre Clean:	Heavy Cleaning
P.O.#:	YES502259	Surveyor:	S. Bucklin	PSR:	P-706-007.2-007.1
Customer:	City of Hobart, IN (Red	Clean Date:	02/21/2022	Shape:	C

Street:	South Linda Street	Flow Control:	Not Controlled
City:	Hobart, IN	Year Renewed:	
Location:	Local rural streets with light traffic, t	Tape/Media #:	
Purpose:	Routine Assessment	Dia/Height:	10"
Use:	Sanitary Sewage Pipe	Material:	VCP
Drain Area:		Lining:	None
Category:	NA		
Comment:			
Location Details:		Direction of Survey:	Downstream
US MH:	M-706-007.1	DS MH:	M-706-007.2
		Total Length Surveyed (ft):	335.5

O&M Index:	1.59	O&M Quick:	2M11	O&M Rating:	200.00
Structural Index:	2.41	Structural Quick:	443B	Structural Rating:	152.00
Overall Index:	1.86	Overall Quick:	443B	Overall Rating:	352.00

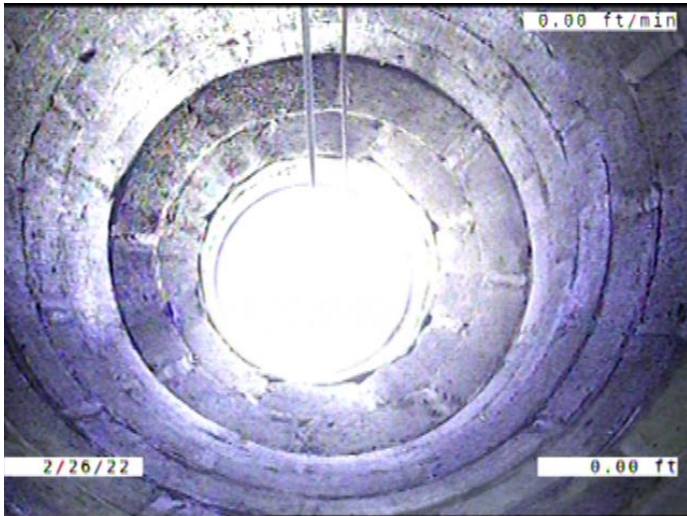
Code: **AMH**
Description: **Manhole**

Distance (ft): **.0**
Structural Grade: **0**
O&M Grade: **0**
Clock Start/From:
Clock To:
1st Value:
2nd Value:
Value Percent:
Continuous Index:
Within 8" of Joint: **NO**
Remarks: **M-706-007.1**

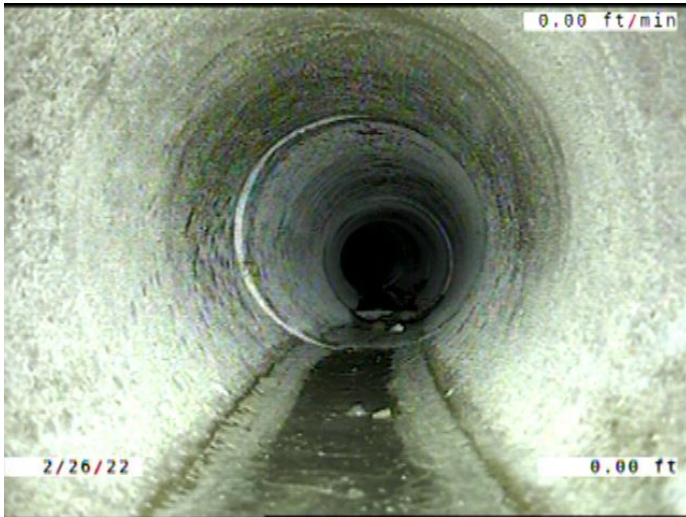
Code: **MWL**
 Description: **Miscellaneous Water Level**

Distance (ft): **.0**
 Structural Grade: **0**
 O&M Grade: **0**
 Clock Start/From:
 Clock To:
 1st Value:
 2nd Value:
 Value Percent: **5.000**
 Continuous Index:
 Within 8" of Joint: **NO**
 Remarks:

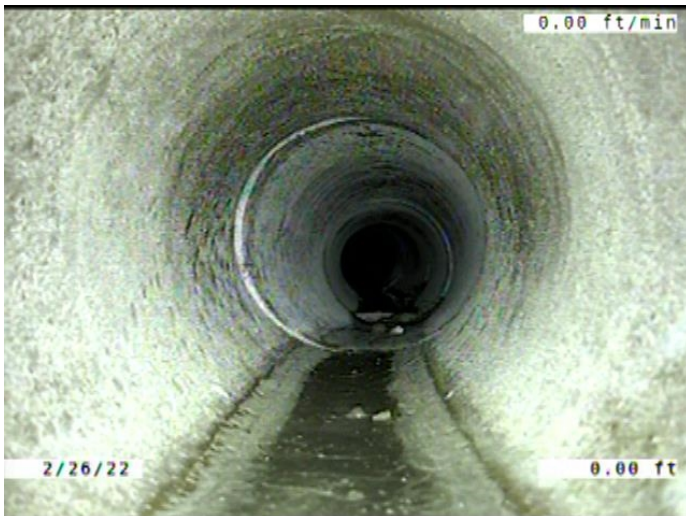
Code: **DSF**
 Description: **Deposits Settled Fine**

Distance (ft): **.0**
 Structural Grade: **0**
 O&M Grade: **2**
 Clock Start/From: **5**
 Clock To: **7**
 1st Value:
 2nd Value:
 Value Percent: **5.000**
 Continuous Index: **S01**
 Within 8" of Joint: **YES**
 Remarks:

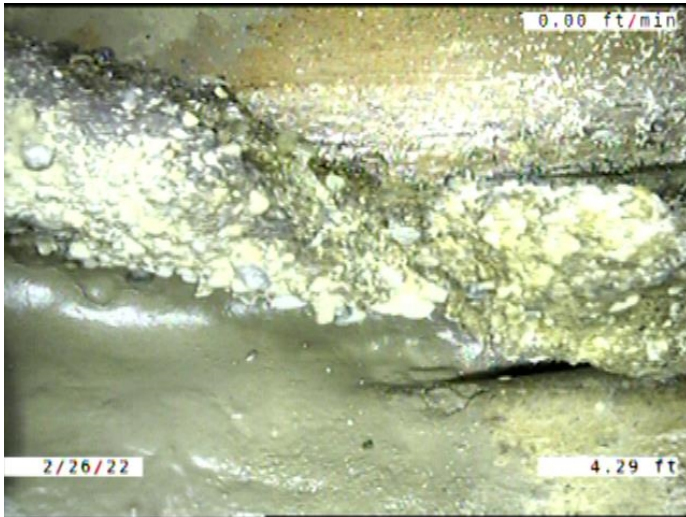
Code: **ISGT**
 Description: **Intruding Sealing Material Grout**

Distance (ft): **4.3**
 Structural Grade: **0**
 O&M Grade: **2**
 Clock Start/From: **4**
 Clock To: **8**
 1st Value:
 2nd Value:
 Value Percent: **5.000**
 Continuous Index:
 Within 8" of Joint: **NO**
 Remarks:

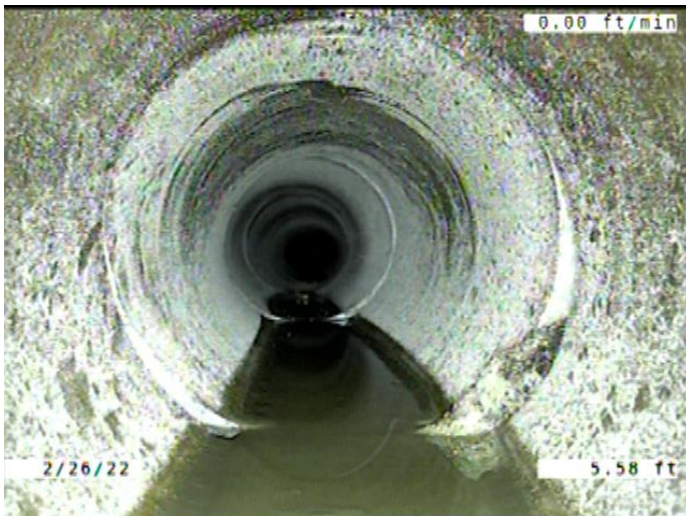
Code: **MWLS**
 Description: **Miscellaneous Water Level Sag**

Distance (ft): **5.6**
 Structural Grade: **2**
 O&M Grade: **0**
 Clock Start/From:
 Clock To:
 1st Value:
 2nd Value:
 Value Percent: **5.000**
 Continuous Index:
 Within 8" of Joint: **NO**
 Remarks:

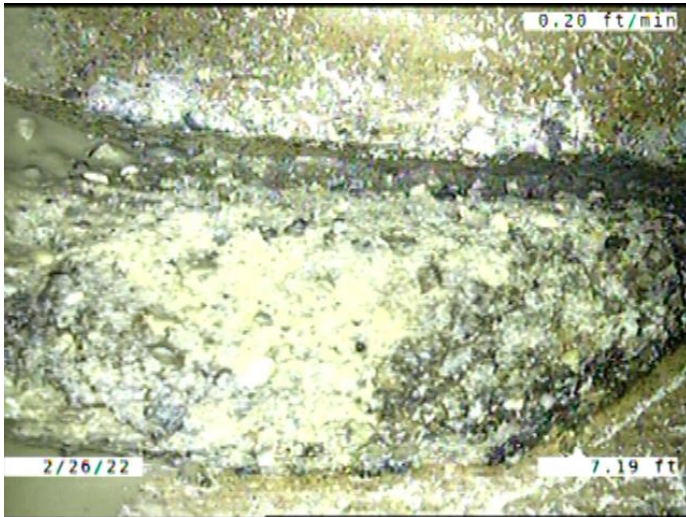
Code: **ISGT**
 Description: **Intruding Sealing Material Grout**

Distance (ft): **7.2**
 Structural Grade: **0**
 O&M Grade: **2**
 Clock Start/From: **4**
 Clock To: **6**
 1st Value:
 2nd Value:
 Value Percent: **5.000**
 Continuous Index:
 Within 8" of Joint: **NO**
 Remarks:

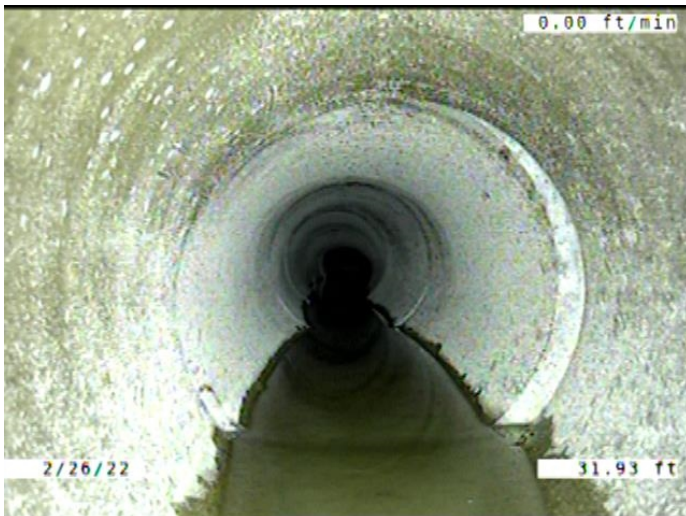
Code: **MWLS**
 Description: **Miscellaneous Water Level Sag**

Distance (ft): **31.9**
 Structural Grade: **2**
 O&M Grade: **0**
 Clock Start/From:
 Clock To:
 1st Value:
 2nd Value:
 Value Percent: **15.000**
 Continuous Index: **S02**
 Within 8" of Joint: **NO**
 Remarks:

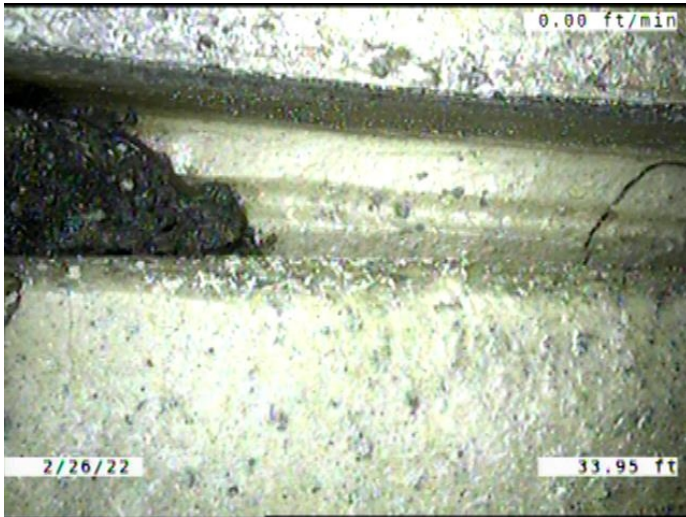
Code: **JAM**
 Description: **Joint Angular Medium**

Distance (ft): **33.9**
 Structural Grade: **3**
 O&M Grade: **0**
 Clock Start/From:
 Clock To:
 1st Value:
 2nd Value:
 Value Percent:
 Continuous Index:
 Within 8" of Joint: **NO**
 Remarks:

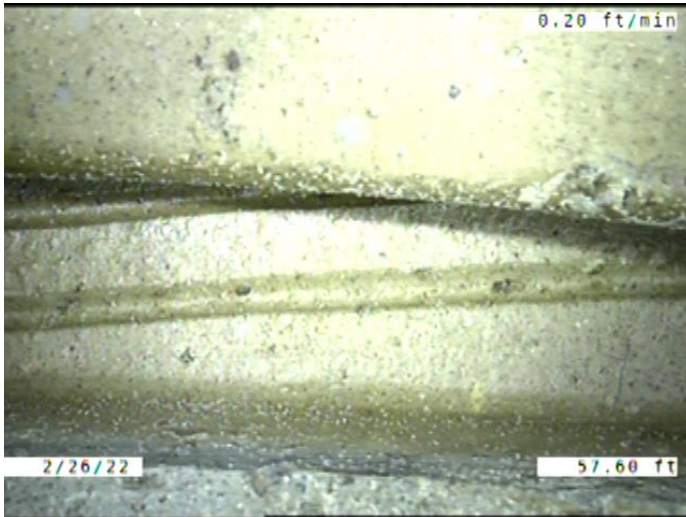
Code: **JAL**
 Description: **Joint Angular Large**

Distance (ft): **57.6**
 Structural Grade: **4**
 O&M Grade: **0**
 Clock Start/From:
 Clock To:
 1st Value:
 2nd Value:
 Value Percent:
 Continuous Index:
 Within 8" of Joint: **NO**
 Remarks:

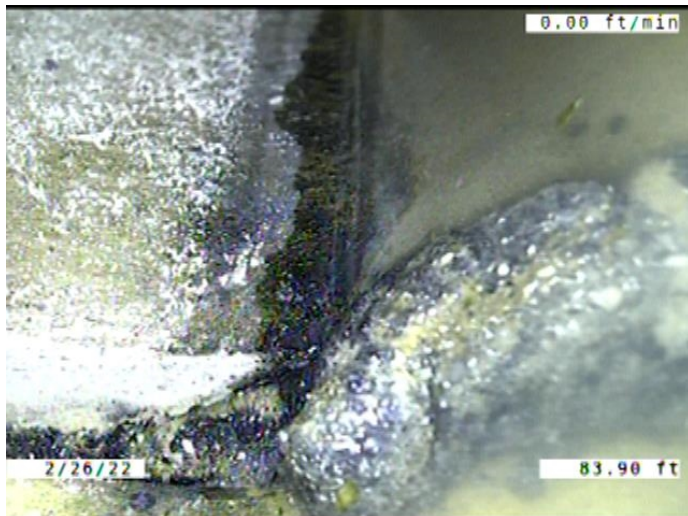
Code: **ISGT**
 Description: **Intruding Sealing Material Grout**

Distance (ft): **83.9**
 Structural Grade: **0**
 O&M Grade: **2**
 Clock Start/From: **6**
 Clock To: **8**
 1st Value:
 2nd Value:
 Value Percent: **5.000**
 Continuous Index:
 Within 8" of Joint: **NO**
 Remarks:

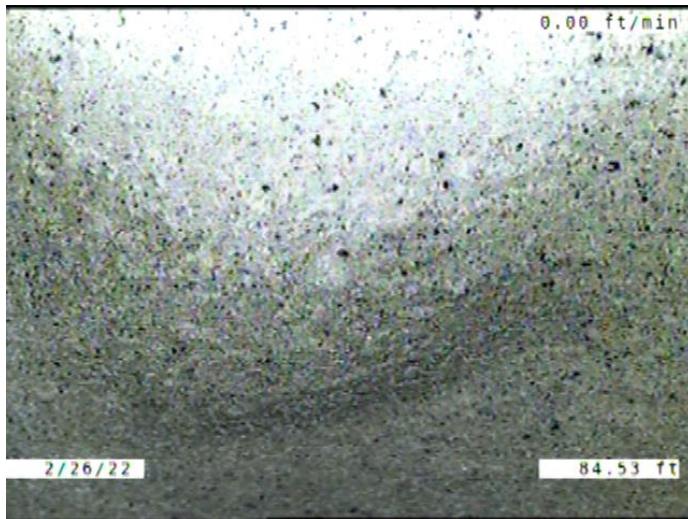
Code: **MGO**
 Description: **Miscellaneous General Observation**

Distance (ft): **84.5**
 Structural Grade: **0**
 O&M Grade: **0**
 Clock Start/From:
 Clock To:
 1st Value:
 2nd Value:
 Value Percent:
 Continuous Index:
 Within 8" of Joint: **NO**
 Remarks: **MANUFACTURE DEFECT. BUBBLE ON THE INSIDE OF THE PIPE. ROUGHLY 2**

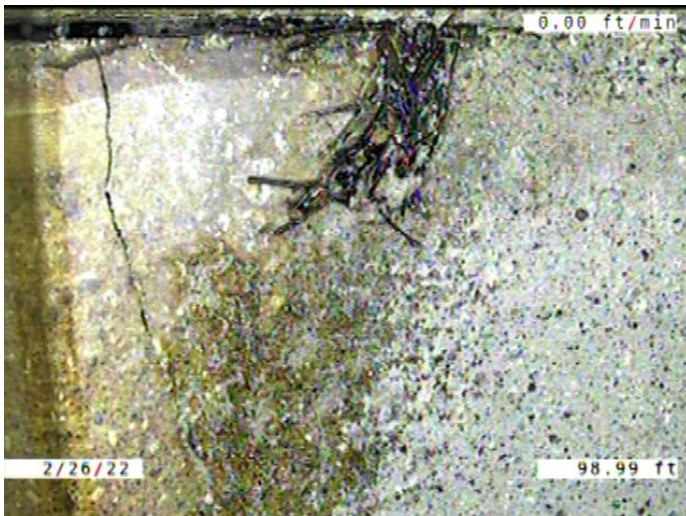
Code: **CL**
 Description: **Crack Longitudinal**

Distance (ft): **99.0**
 Structural Grade: **2**
 O&M Grade: **0**
 Clock Start/From: **9**
 Clock To:
 1st Value:
 2nd Value:
 Value Percent:
 Continuous Index:
 Within 8" of Joint: **YES**
 Remarks:

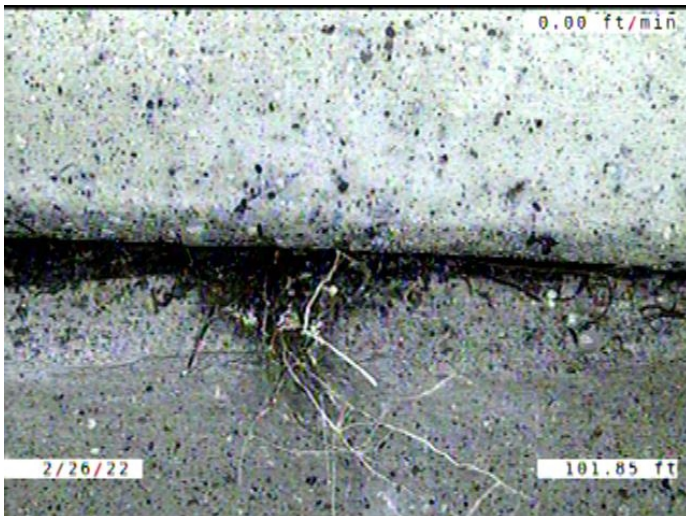
Code: **RFJ**
 Description: **Roots Fine Joint**

Distance (ft): **101.8**
 Structural Grade: **0**
 O&M Grade: **1**
 Clock Start/From: **10**
 Clock To: **3**
 1st Value:
 2nd Value:
 Value Percent:
 Continuous Index:
 Within 8" of Joint: **YES**
 Remarks:

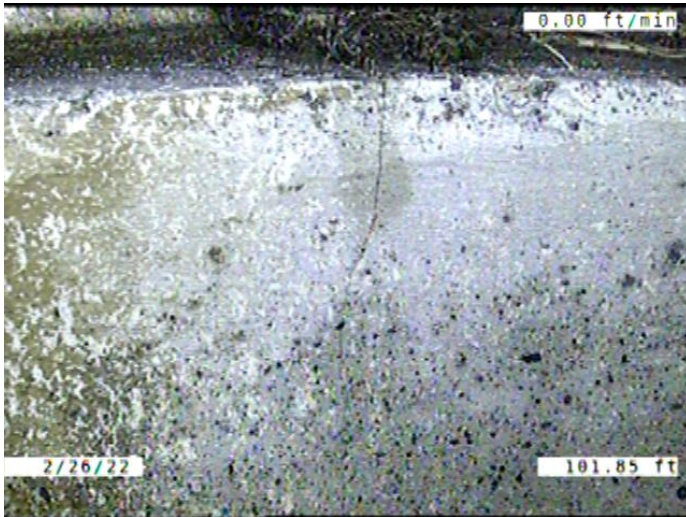
Code: **CL**
Description: **Crack Longitudinal**

Distance (ft): **101.9**
Structural Grade: **2**
O&M Grade: **0**
Clock Start/From: **10**
Clock To:
1st Value:
2nd Value:
Value Percent:
Continuous Index:
Within 8" of Joint: **YES**
Remarks:

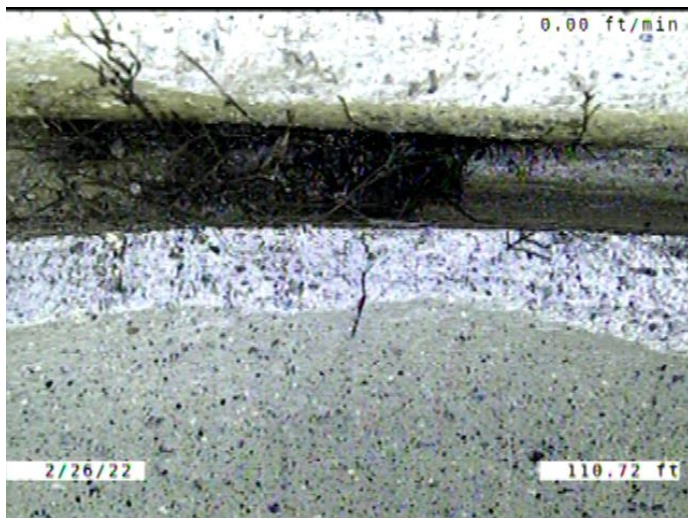
Code: **RFJ**
 Description: **Roots Fine Joint**

Distance (ft): **110.7**
 Structural Grade: **0**
 O&M Grade: **1**
 Clock Start/From: **11**
 Clock To: **12**
 1st Value:
 2nd Value:
 Value Percent:
 Continuous Index:
 Within 8" of Joint: **YES**
 Remarks:

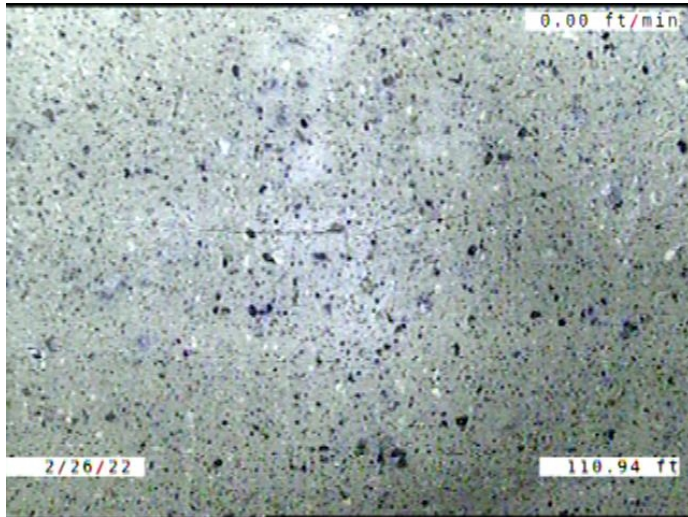
Code: **CM**
Description: **Crack Multiple**

Distance (ft): **110.9**
Structural Grade: **3**
O&M Grade: **0**
Clock Start/From: **10**
Clock To: **12**
1st Value:
2nd Value:
Value Percent:
Continuous Index:
Within 8" of Joint: **YES**
Remarks:

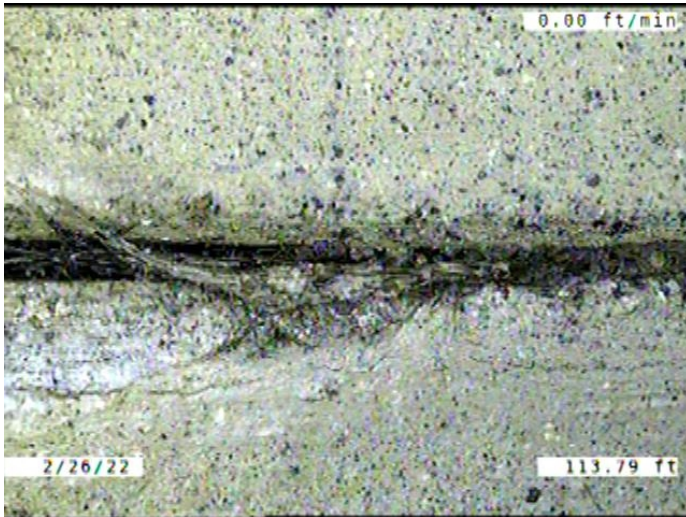
Code: **RFJ**
Description: **Roots Fine Joint**

Distance (ft): **113.8**
Structural Grade: **0**
O&M Grade: **1**
Clock Start/From: **8**
Clock To: **4**
1st Value:
2nd Value:
Value Percent:
Continuous Index: **S04**
Within 8" of Joint: **YES**
Remarks:

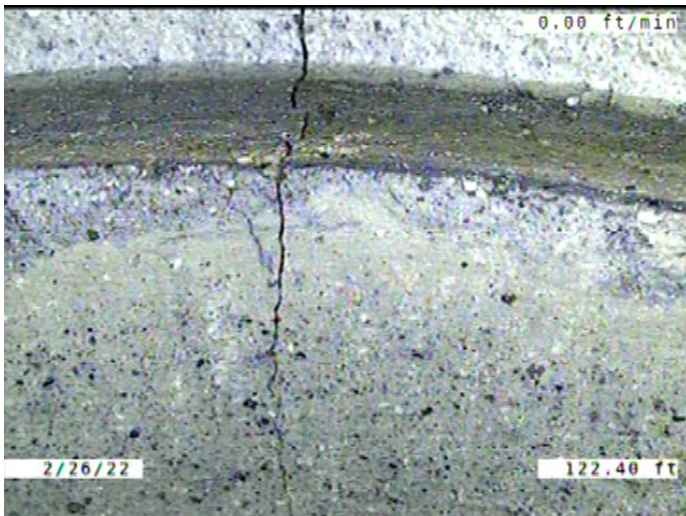
Code: **CL**
Description: **Crack Longitudinal**

Distance (ft): **122.4**
Structural Grade: **2**
O&M Grade: **0**
Clock Start/From: **2**
Clock To:
1st Value:
2nd Value:
Value Percent:
Continuous Index:
Within 8" of Joint: **YES**
Remarks:

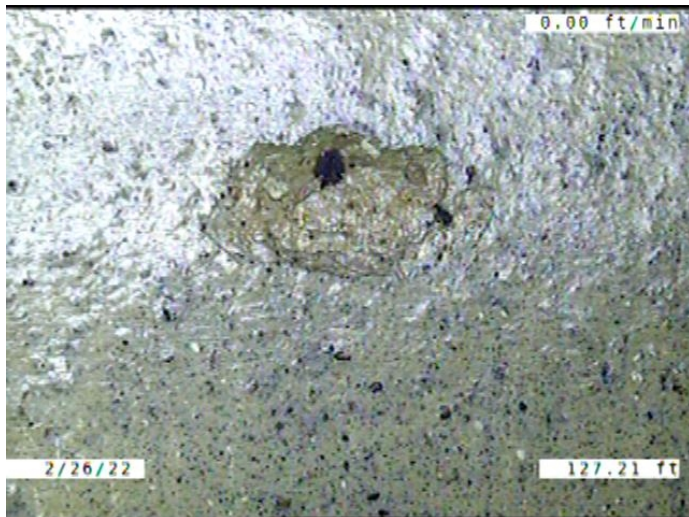
Code: **SSS**
 Description: **Surface Damage Surface Spalling**

Distance (ft): **127.2**
 Structural Grade: **2**
 O&M Grade: **0**
 Clock Start/From: **10**
 Clock To:
 1st Value:
 2nd Value:
 Value Percent:
 Continuous Index:
 Within 8" of Joint: **NO**
 Remarks:

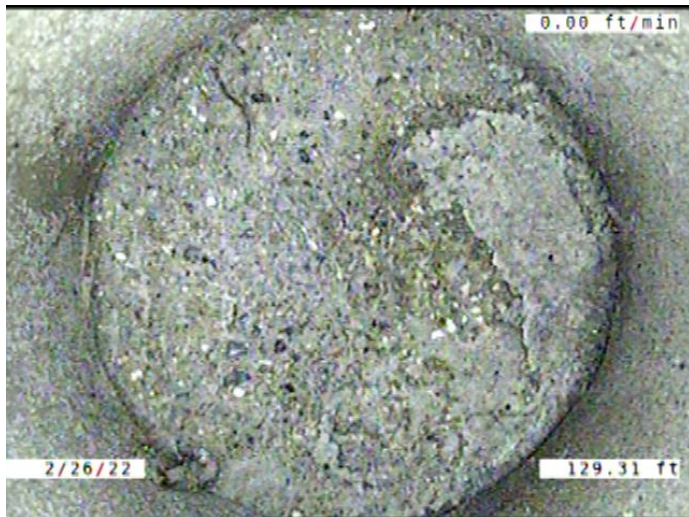
Code: **TFC**
Description: **Tap Factory Capped**

Distance (ft): **129.3**
Structural Grade: **0**
O&M Grade: **0**
Clock Start/From: **10**
Clock To:
1st Value: **6.000**
2nd Value:
Value Percent:
Continuous Index:
Within 8" of Joint: **YES**
Remarks:

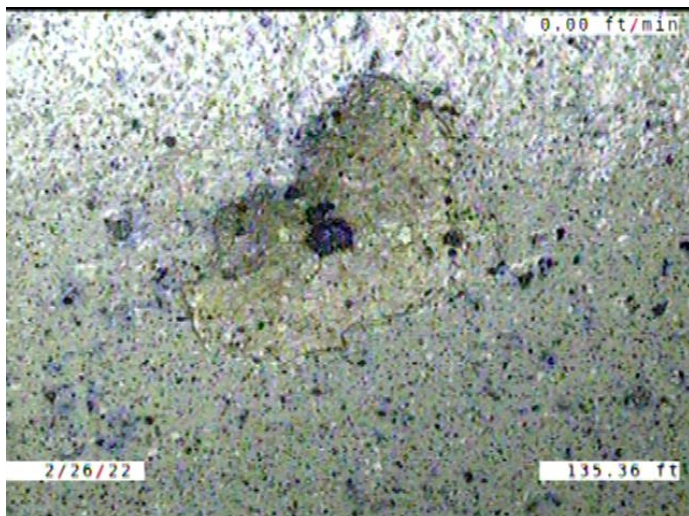
Code: **SSS**
Description: **Surface Damage Surface Spalling**

Distance (ft): **135.4**
Structural Grade: **2**
O&M Grade: **0**
Clock Start/From: **10**
Clock To:
1st Value:
2nd Value:
Value Percent:
Continuous Index:
Within 8" of Joint: **NO**
Remarks:

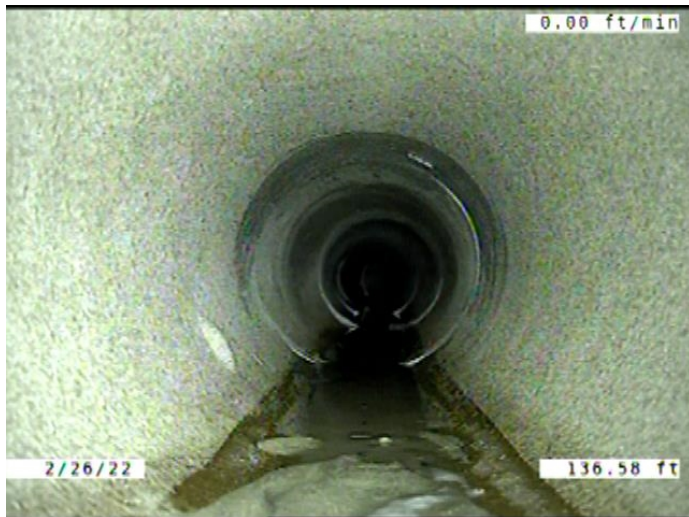
Code: **MWLS**
 Description: **Miscellaneous Water Level Sag**

Distance (ft): **136.6**
 Structural Grade: **2**
 O&M Grade: **0**
 Clock Start/From:
 Clock To:
 1st Value:
 2nd Value:
 Value Percent: **10.000**
 Continuous Index: **F03**
 Within 8" of Joint: **NO**
 Remarks:

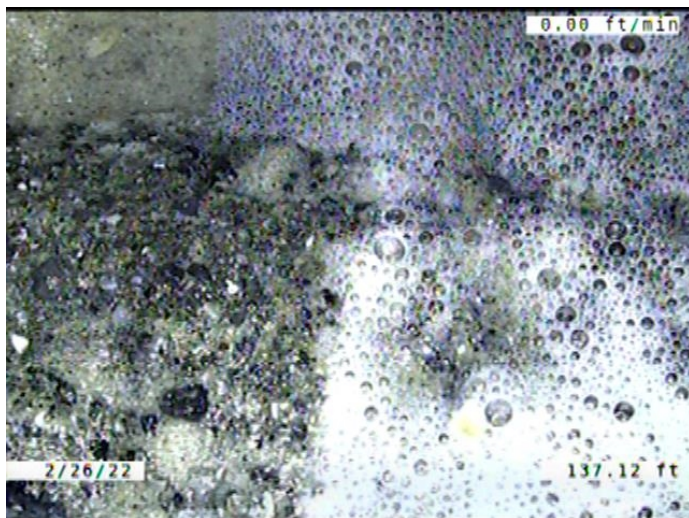
Code: **ISGT**
 Description: **Intruding Sealing Material Grout**

Distance (ft): **137.1**
 Structural Grade: **0**
 O&M Grade: **2**
 Clock Start/From: **4**
 Clock To: **8**
 1st Value:
 2nd Value:
 Value Percent: **5.000**
 Continuous Index:
 Within 8" of Joint: **NO**
 Remarks:

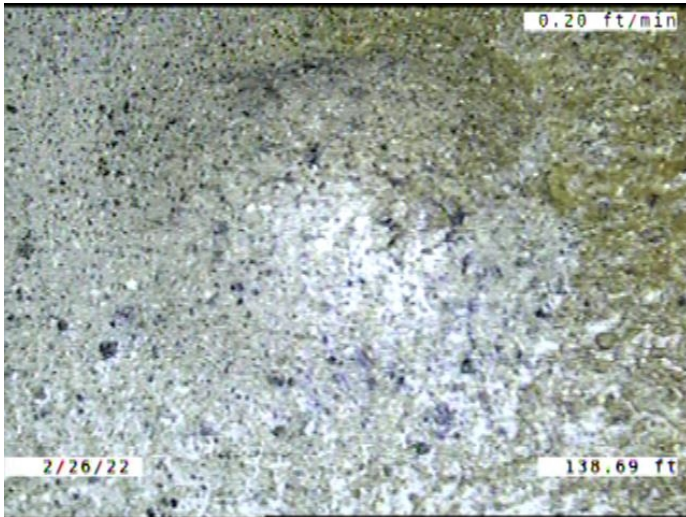
Code: **MGO**
Description: **Miscellaneous General Observation**

Distance (ft): **138.7**
Structural Grade: **0**
O&M Grade: **0**
Clock Start/From:
Clock To:
1st Value:
2nd Value:
Value Percent:
Continuous Index:
Within 8" of Joint: **NO**
Remarks: **MANUFACTURE DEFECT. BUBBLE ON THE INSIDE OF THE PIPE. ROUGHLY 8**

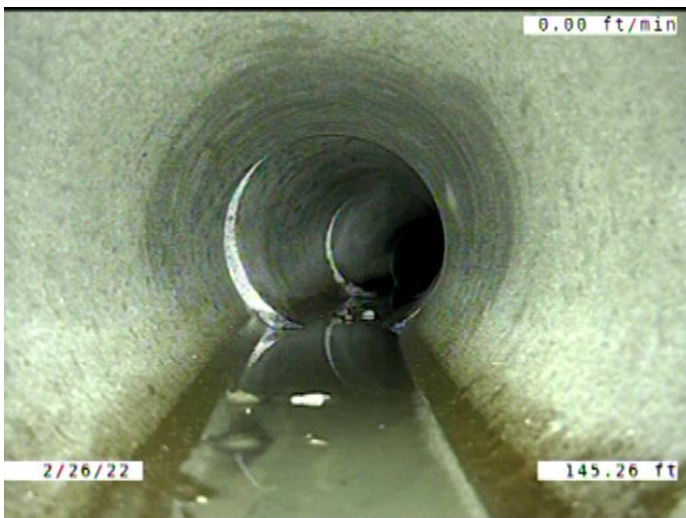
Code: **LL**
Description: **Line Left**

Distance (ft): **145.2**
Structural Grade: **0**
O&M Grade: **1**
Clock Start/From:
Clock To:
1st Value:
2nd Value:
Value Percent: **5.000**
Continuous Index:
Within 8" of Joint: **NO**
Remarks:

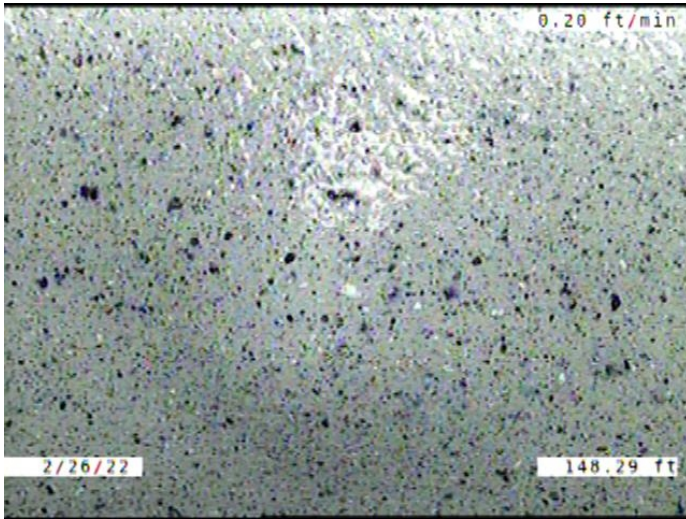
Code: **MGO**
Description: **Miscellaneous General Observation**

Distance (ft): **148.3**
Structural Grade: **0**
O&M Grade: **0**
Clock Start/From:
Clock To:
1st Value:
2nd Value:
Value Percent:
Continuous Index:
Within 8" of Joint: **NO**
Remarks: **MANUFACTURE DEFECT. BUBBLE ON THE INSIDE OF THE PIPE. ROUGHLY 2**

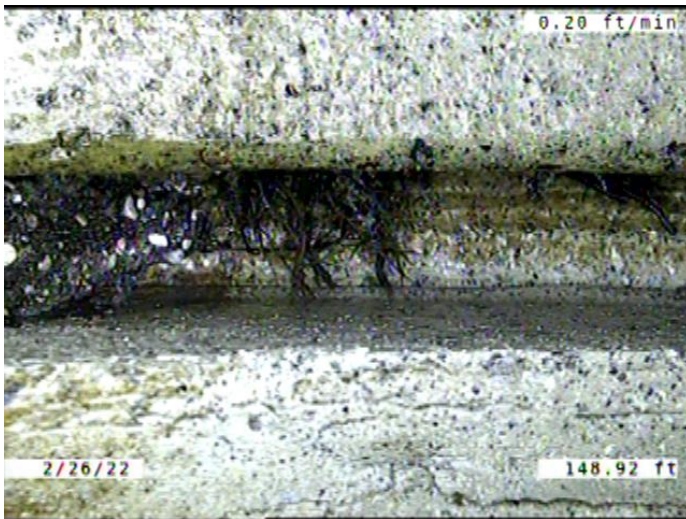
Code: **JAM**
Description: **Joint Angular Medium**

Distance (ft): **148.9**
Structural Grade: **3**
O&M Grade: **0**
Clock Start/From:
Clock To:
1st Value:
2nd Value:
Value Percent:
Continuous Index:
Within 8" of Joint: **NO**
Remarks:

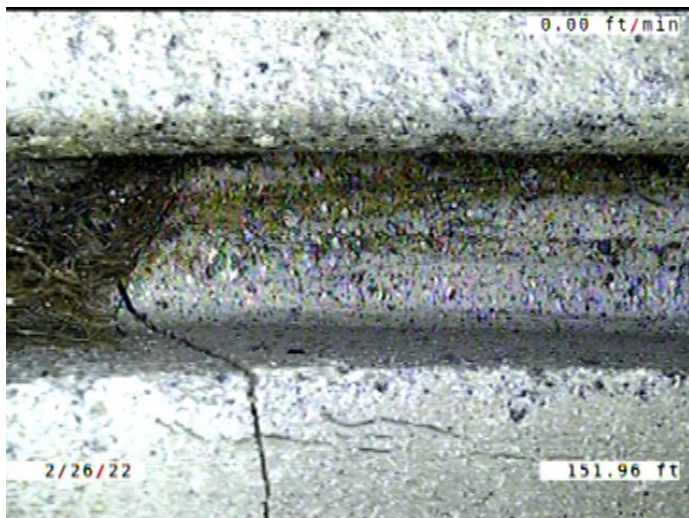
Code: **JAM**
 Description: **Joint Angular Medium**

Distance (ft): **152.0**
 Structural Grade: **3**
 O&M Grade: **0**
 Clock Start/From:
 Clock To:
 1st Value:
 2nd Value:
 Value Percent:
 Continuous Index:
 Within 8" of Joint: **NO**
 Remarks:

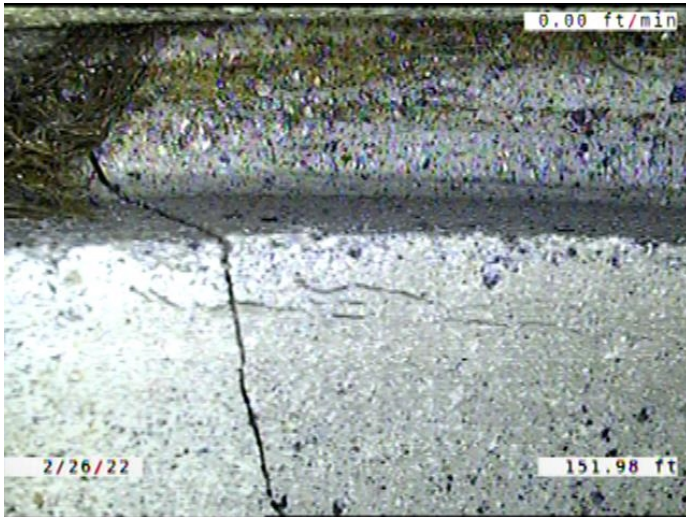
Code: **FS**
Description: **Fracture Spiral**

Distance (ft): **152.0**
Structural Grade: **3**
O&M Grade: **0**
Clock Start/From: **9**
Clock To: **12**
1st Value:
2nd Value:
Value Percent:
Continuous Index:
Within 8" of Joint: **YES**
Remarks:

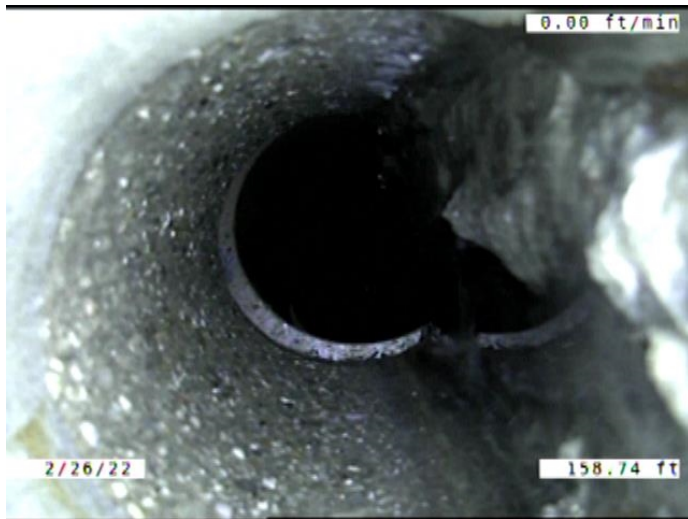
Code: **TF**
 Description: **Tap Factory**

Distance (ft): **158.7**
 Structural Grade: **0**
 O&M Grade: **0**
 Clock Start/From: **3**
 Clock To:
 1st Value: **6.000**
 2nd Value:
 Value Percent:
 Continuous Index:
 Within 8" of Joint: **YES**
 Remarks:

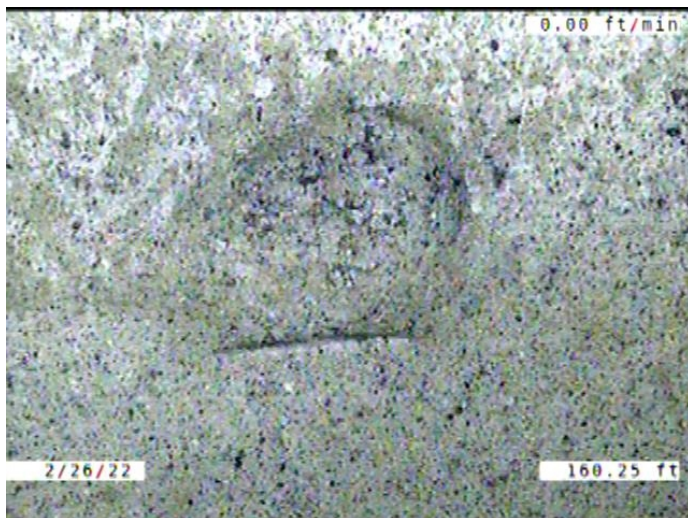
Code: **MGO**
 Description: **Miscellaneous General Observation**

Distance (ft): **160.2**
 Structural Grade: **0**
 O&M Grade: **0**
 Clock Start/From:
 Clock To:
 1st Value:
 2nd Value:
 Value Percent:
 Continuous Index:
 Within 8" of Joint: **NO**
 Remarks: **MANUFACTURE DEFECT. BUBBLE ON THE INSIDE OF THE PIPE. ROUGHLY 2**

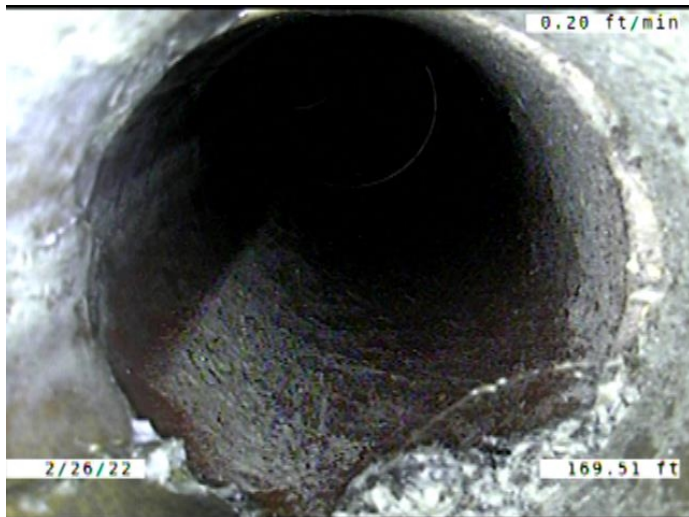
Code: **TF**
Description: **Tap Factory**

Distance (ft): **169.5**
Structural Grade: **0**
O&M Grade: **0**
Clock Start/From: **10**
Clock To:
1st Value: **6.000**

2nd Value:
Value Percent:
Continuous Index:
Within 8" of Joint: **YES**
Remarks: **ROOTS GROWING FROM THE TAP TO MAIN CONNECTION INTO THE MAIN**

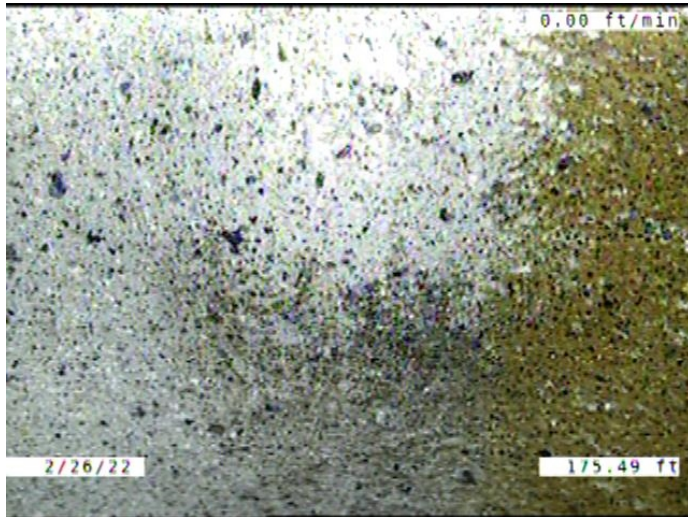
Code: **MGO**
Description: **Miscellaneous General Observation**

Distance (ft): **175.5**
Structural Grade: **0**
O&M Grade: **0**
Clock Start/From:
Clock To:
1st Value:
2nd Value:
Value Percent:
Continuous Index:
Within 8" of Joint: **NO**
Remarks: **MANUFACTURE DEFECT. BUBBLE ON THE INSIDE OF THE PIPE. ROUGHLY 4**

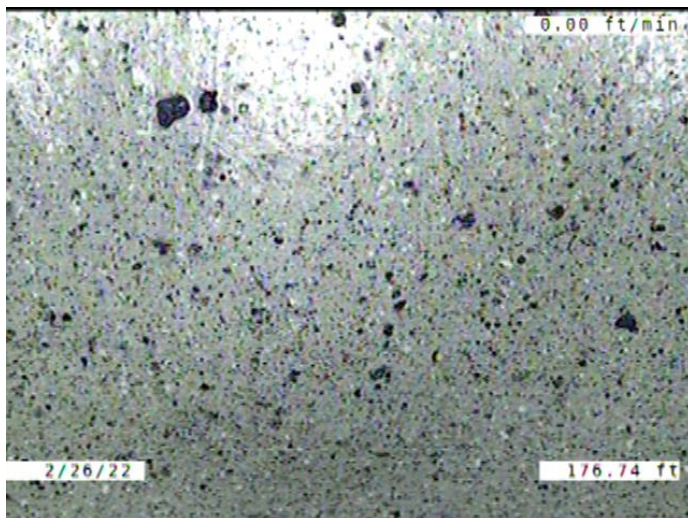
Code: **MGO**
Description: **Miscellaneous General Observation**

Distance (ft): **176.7**
Structural Grade: **0**
O&M Grade: **0**
Clock Start/From:
Clock To:
1st Value:
2nd Value:
Value Percent:
Continuous Index:
Within 8" of Joint: **NO**
Remarks: **MANUFACTURE DEFECT. BUBBLE ON THE INSIDE OF THE PIPE. ROUGHLY 1**

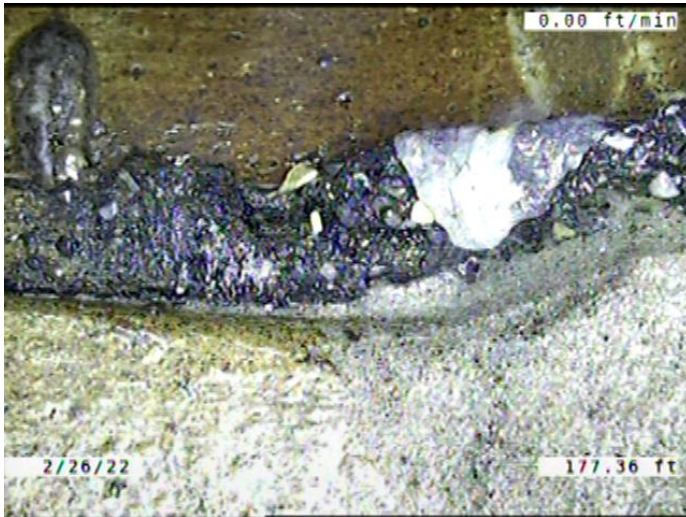
Code: **ISGT**
Description: **Intruding Sealing Material Grout**

Distance (ft): **177.4**
Structural Grade: **0**
O&M Grade: **2**
Clock Start/From: **4**
Clock To: **8**
1st Value:
2nd Value:
Value Percent: **5.000**
Continuous Index:
Within 8" of Joint: **NO**
Remarks:

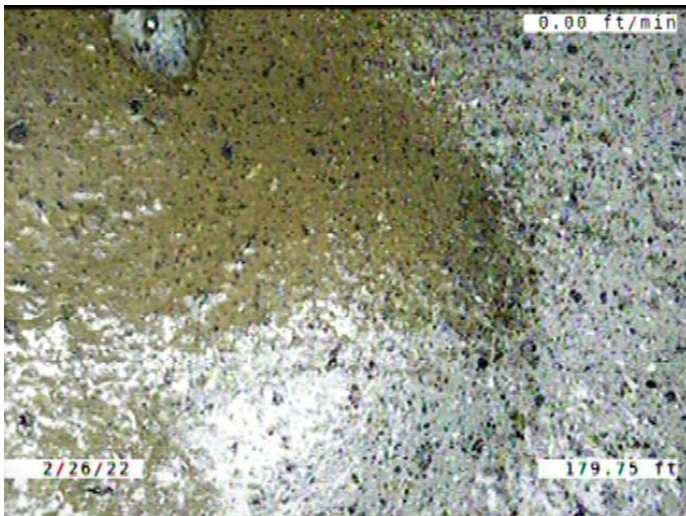
Code: **MGO**
Description: **Miscellaneous General Observation**

Distance (ft): **179.7**
Structural Grade: **0**
O&M Grade: **0**
Clock Start/From:
Clock To:
1st Value:
2nd Value:
Value Percent:
Continuous Index:
Within 8" of Joint: **NO**
Remarks: **MANUFACTURE DEFECT. BUBBLE ON THE INSIDE OF THE PIPE. ROUGHLY 4**

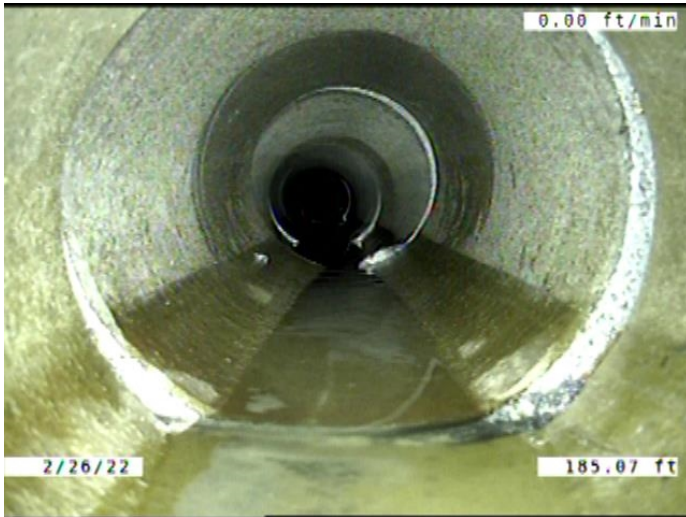
Code: **MWLS**
Description: **Miscellaneous Water Level Sag**

Distance (ft): **185.1**
Structural Grade: **2**
O&M Grade: **0**
Clock Start/From:
Clock To:
1st Value:
2nd Value:
Value Percent: **5.000**
Continuous Index:
Within 8" of Joint: **NO**
Remarks:

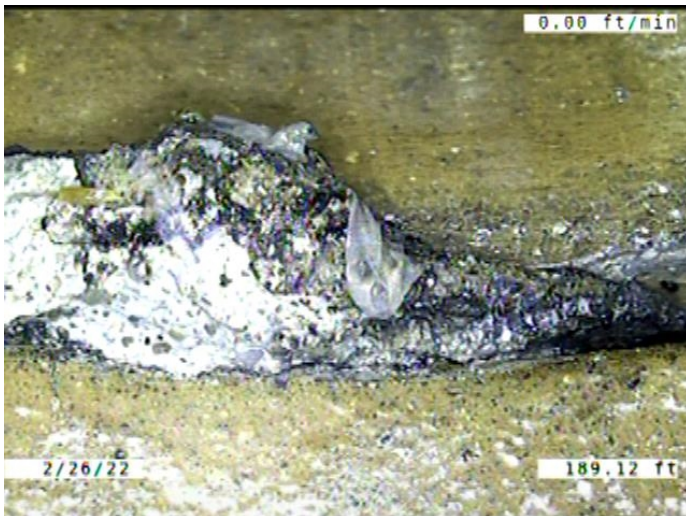
Code: **ISGT**
Description: **Intruding Sealing Material Grout**

Distance (ft): **189.1**
Structural Grade: **0**
O&M Grade: **2**
Clock Start/From: **4**
Clock To: **5**
1st Value:
2nd Value:
Value Percent: **5.000**
Continuous Index:
Within 8" of Joint: **NO**
Remarks:

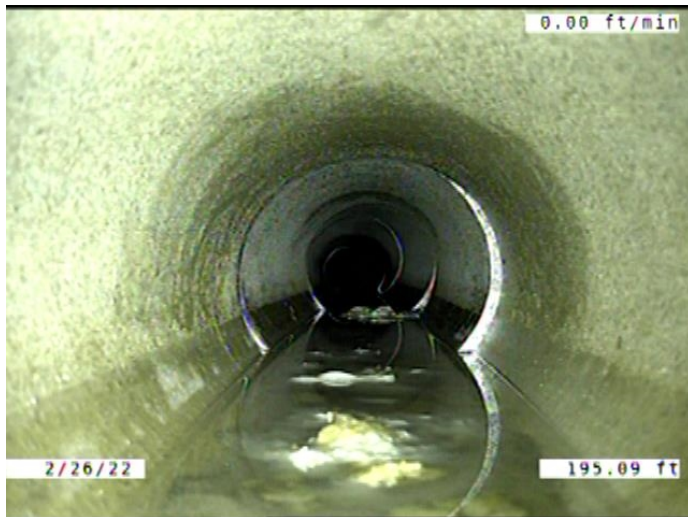
Code: **MGO**
Description: **Miscellaneous General Observation**

Distance (ft): **193.3**
Structural Grade: **0**
O&M Grade: **0**
Clock Start/From:
Clock To:
1st Value:
2nd Value:
Value Percent:
Continuous Index:
Within 8" of Joint: **NO**
Remarks: **MANUFACTURE DEFECT. BUBBLE ON THE INSIDE OF THE PIPE. ROUGHLY 1**

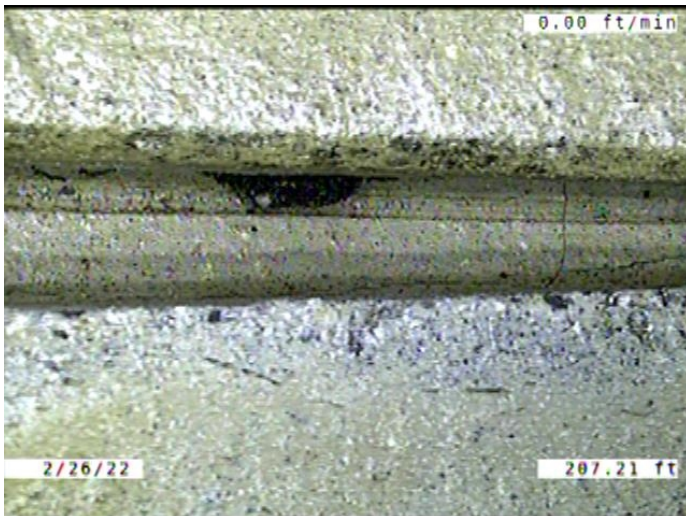
Code: **JAM**
Description: **Joint Angular Medium**

Distance (ft): **207.2**
Structural Grade: **3**
O&M Grade: **0**
Clock Start/From:
Clock To:
1st Value:
2nd Value:
Value Percent:
Continuous Index:
Within 8" of Joint: **NO**
Remarks:

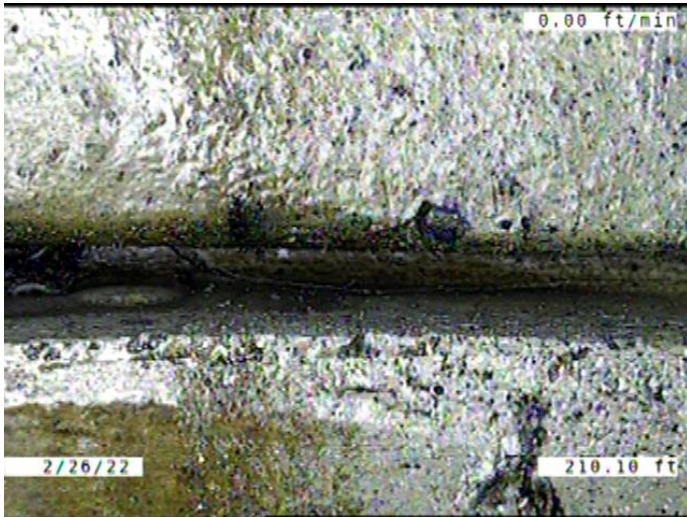
Code: **CM**
Description: **Crack Multiple**

Distance (ft): **207.2**
Structural Grade: **3**
O&M Grade: **0**
Clock Start/From: **9**
Clock To: **11**
1st Value:
2nd Value:
Value Percent:
Continuous Index:
Within 8" of Joint: **YES**
Remarks:

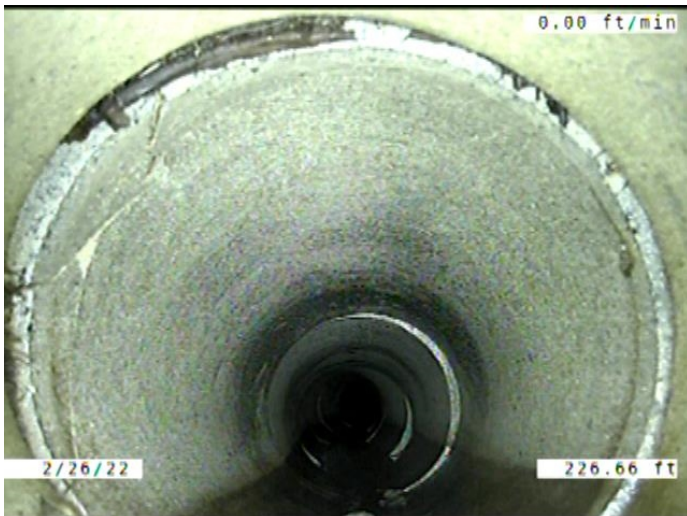
Code: **CS**
 Description: **Crack Spiral**

Distance (ft): **210.1**
 Structural Grade: **2**
 O&M Grade: **0**
 Clock Start/From: **9**
 Clock To: **11**
 1st Value:
 2nd Value:
 Value Percent:
 Continuous Index:
 Within 8" of Joint: **YES**
 Remarks:

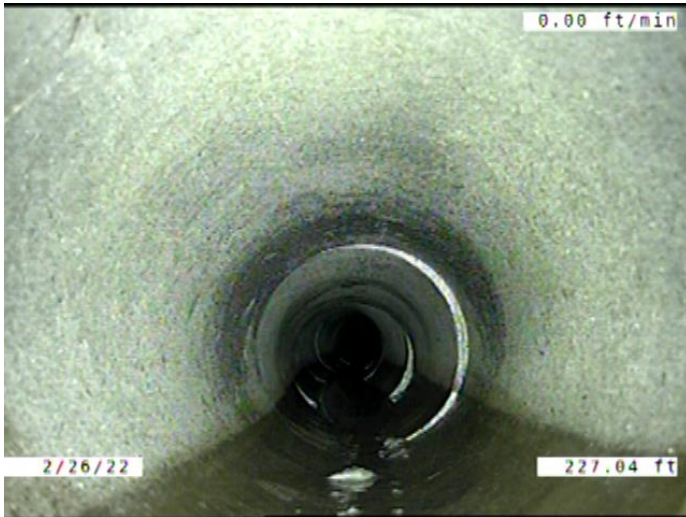
Code: **MWLS**
 Description: **Miscellaneous Water Level Sag**

Distance (ft): **226.7**
 Structural Grade: **2**
 O&M Grade: **0**
 Clock Start/From:
 Clock To:
 1st Value:
 2nd Value:
 Value Percent: **25.000**
 Continuous Index: **F06**
 Within 8" of Joint: **NO**
 Remarks:

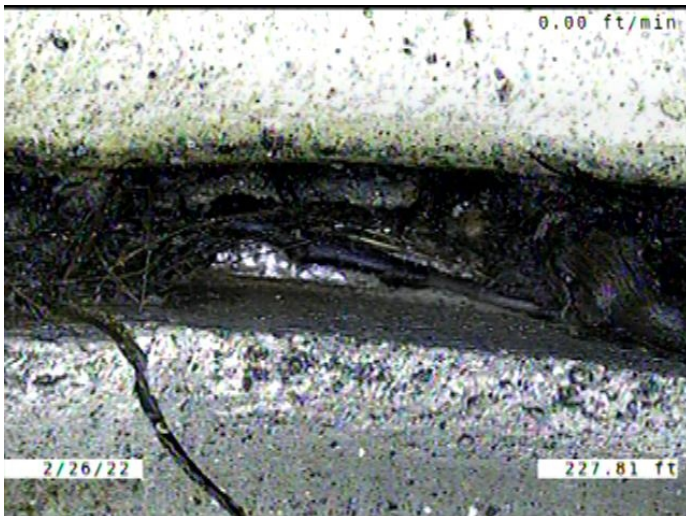
Code: **LLU**
Description: **Line Left Up**

Distance (ft): **227.0**
Structural Grade: **0**
O&M Grade: **1**
Clock Start/From:
Clock To:
1st Value:
2nd Value:
Value Percent: **5.000**
Continuous Index:
Within 8" of Joint: **NO**
Remarks:

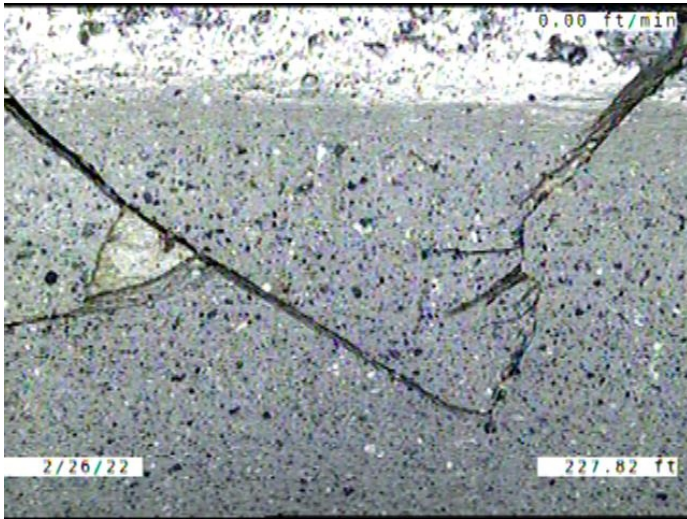
Code: **JAM**
Description: **Joint Angular Medium**

Distance (ft): **227.8**
Structural Grade: **3**
O&M Grade: **0**
Clock Start/From:
Clock To:
1st Value:
2nd Value:
Value Percent:
Continuous Index:
Within 8" of Joint: **NO**
Remarks:

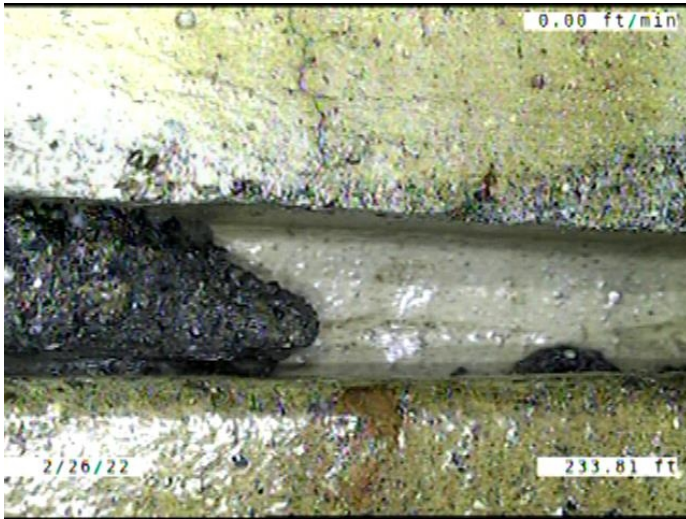
Code: **MWLS**
 Description: **Miscellaneous Water Level Sag**

Distance (ft): **232.5**
 Structural Grade: **2**
 O&M Grade: **0**
 Clock Start/From:
 Clock To:
 1st Value:
 2nd Value:
 Value Percent: **5.000**
 Continuous Index:
 Within 8" of Joint: **NO**
 Remarks:

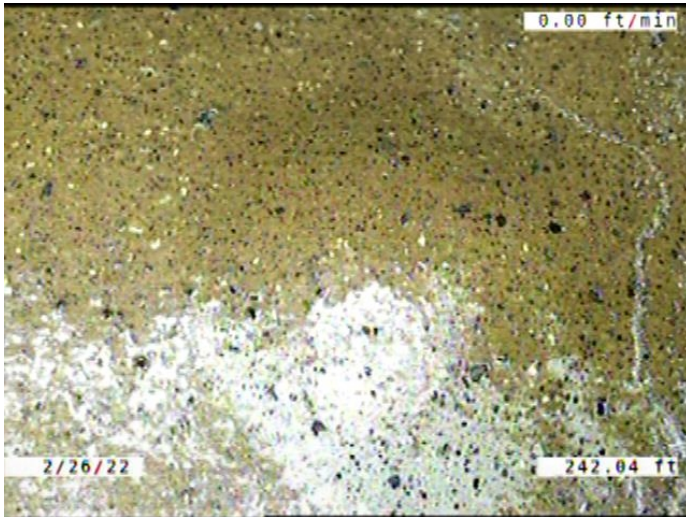
Code: **JAM**
Description: **Joint Angular Medium**

Distance (ft): **239.7**
Structural Grade: **3**
O&M Grade: **0**
Clock Start/From:
Clock To:
1st Value:
2nd Value:
Value Percent:
Continuous Index:
Within 8" of Joint: **NO**
Remarks:

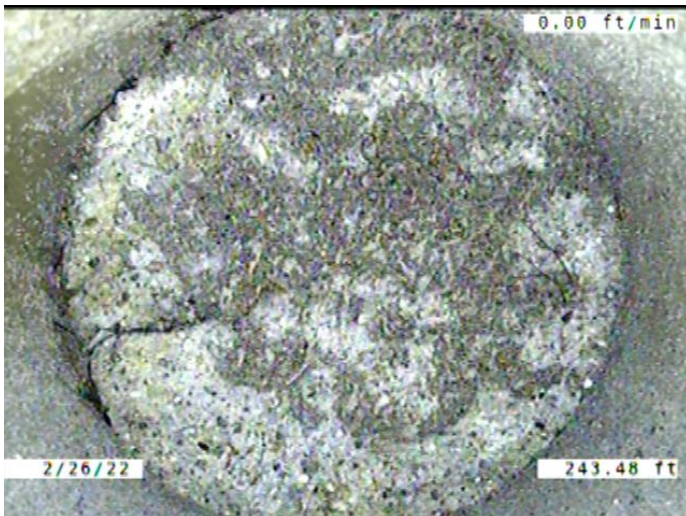
Code: **MGO**
Description: **Miscellaneous General Observation**

Distance (ft): **242.0**
Structural Grade: **0**
O&M Grade: **0**
Clock Start/From:
Clock To:
1st Value:
2nd Value:
Value Percent:
Continuous Index:
Within 8" of Joint: **NO**
Remarks: **MANUFACTURE DEFECT. BUBBLE ON THE INSIDE OF THE PIPE. ROUGHLY 8**

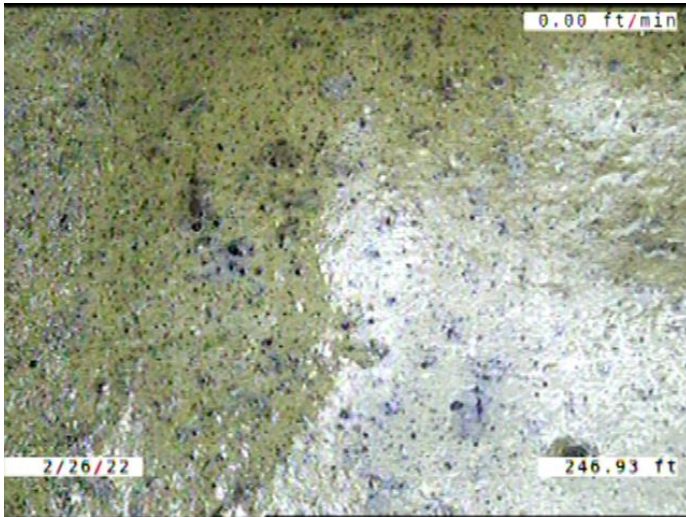
Code: **TFC**
Description: **Tap Factory Capped**

Distance (ft): **243.5**
Structural Grade: **0**
O&M Grade: **0**
Clock Start/From: **10**
Clock To:
1st Value: **6.000**
2nd Value:
Value Percent:
Continuous Index:
Within 8" of Joint: **YES**
Remarks: **ROOTS GROWING AROUND THE CAP**

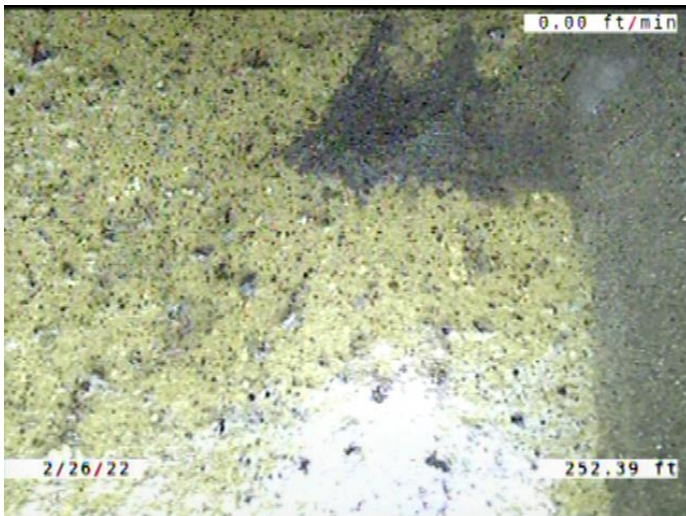
Code: **MGO**
Description: **Miscellaneous General Observation**

Distance (ft): **246.9**
Structural Grade: **0**
O&M Grade: **0**
Clock Start/From:
Clock To:
1st Value:
2nd Value:
Value Percent:
Continuous Index:
Within 8" of Joint: **NO**
Remarks: **MANUFACTURE DEFECT. BUBBLE ON THE INSIDE OF THE PIPE. ROUGHLY 8**

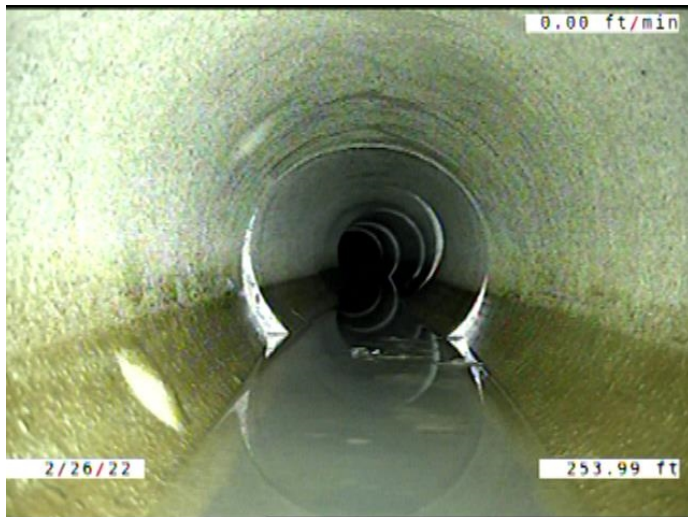
Code: **MGO**
Description: **Miscellaneous General Observation**

Distance (ft): **252.4**
Structural Grade: **0**
O&M Grade: **0**
Clock Start/From:
Clock To:
1st Value:
2nd Value:
Value Percent:
Continuous Index:
Within 8" of Joint: **NO**
Remarks: **MANUFACTURE DEFECT. BUBBLE ON THE INSIDE OF THE PIPE. ROUGHLY 1**

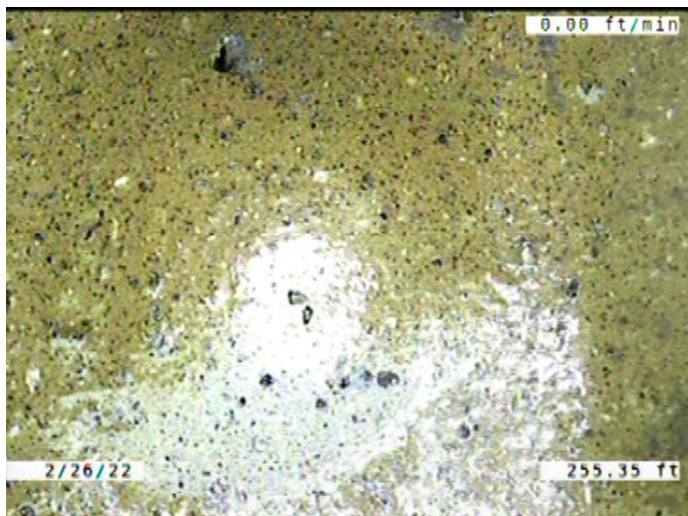
Code: **MWLS**
 Description: **Miscellaneous Water Level Sag**

Distance (ft): **254.0**
 Structural Grade: **2**
 O&M Grade: **0**
 Clock Start/From:
 Clock To:
 1st Value:
 2nd Value:
 Value Percent: **10.000**
 Continuous Index: **S07**
 Within 8" of Joint: **NO**
 Remarks:
