Profile/Photo Observation Report

Date:	02/26/2022	Weather:		Coding:	PACP 7.0
Pipe Length (ft):	336.0	Owner:	City of Hobart	Pre Clean:	Heavy Cleaning
P.O.#:	YES502259	Surveyor:	S. Bucklin	PSR:	P-706-007.2-007.1
Customer:	City of Hobart, IN (Red	Clean Date:	02/21/2022	Shape:	C

Street:	South Linda Street	Flow Control:	Not Controlled
City:	Hobart, IN	Year Renewed:	
Location:	Local rural streets with light traffic, t	Tape/Media #:	
Purpose:	Routine Assessment	Dia/Height:	10"
Use:	Sanitary Sewage Pipe	Material:	VCP
Drain Area:		Lining:	None
Category:	NA		
Comment:			
Location Details:		Direction of Survey:	Downstream
US MH:	M-706-007.1	DS MH:	M-706-007.2
		Total Length Surveyed (ft):	335.5

O&M Index:	1.59	O&M Quick:	2M11	O&M Rating:	200.00
Structural Index:	2.41	Structural Quick:	443B	Structural Rating:	152.00
Overall Index:	1.86	Overall Quick:	443B	Overall Rating:	352.00

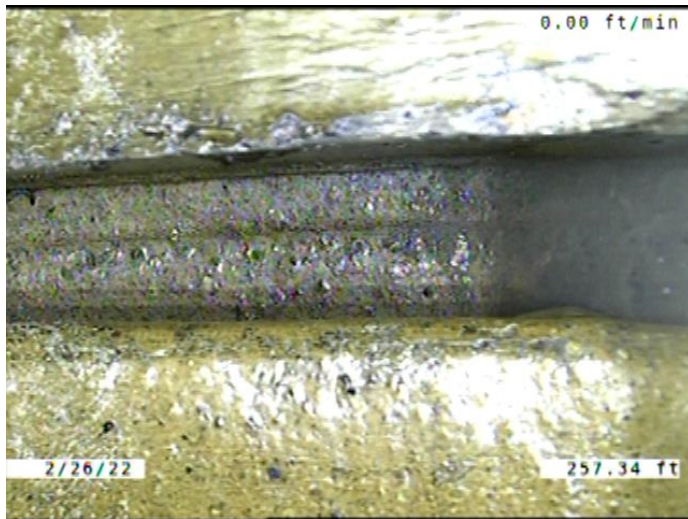
Code: **MGO**
 Description: **Miscellaneous General Observation**

Distance (ft): **255.4**
 Structural Grade: **0**
 O&M Grade: **0**
 Clock Start/From:
 Clock To:
 1st Value:
 2nd Value:
 Value Percent:
 Continuous Index:
 Within 8" of Joint: **NO**
 Remarks: **MANUFACTURE DEFECT. BUBBLE ON THE INSIDE OF THE PIPE. ROUGHLY 1**

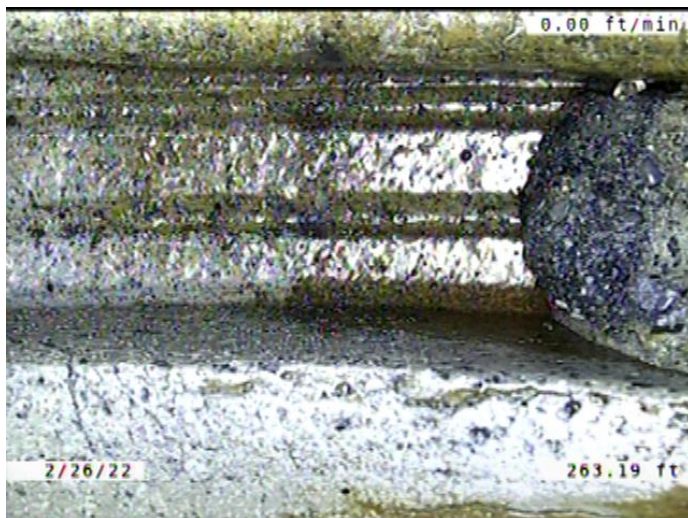
Code: **JAM**
 Description: **Joint Angular Medium**

Distance (ft): **257.3**
 Structural Grade: **3**
 O&M Grade: **0**
 Clock Start/From:
 Clock To:
 1st Value:
 2nd Value:
 Value Percent:
 Continuous Index:
 Within 8" of Joint: **NO**
 Remarks:

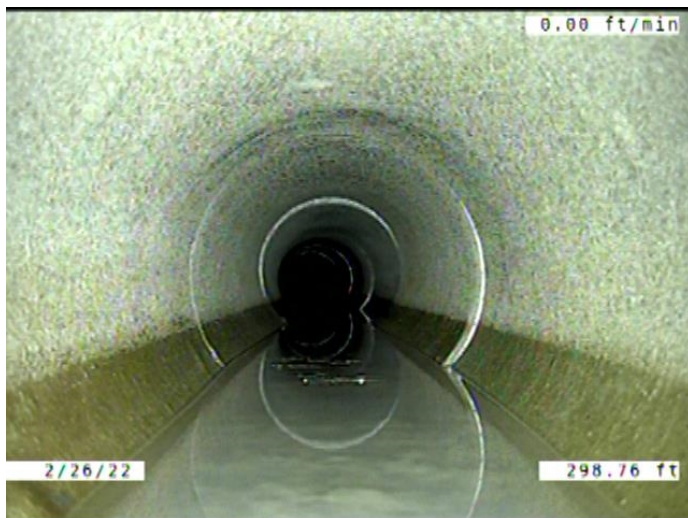
Code: **MWLS**
 Description: **Miscellaneous Water Level Sag**

Distance (ft): **279.2**
 Structural Grade: **2**
 O&M Grade: **0**
 Clock Start/From:
 Clock To:
 1st Value:
 2nd Value:
 Value Percent: **10.000**
 Continuous Index: **F07**
 Within 8" of Joint: **NO**
 Remarks:

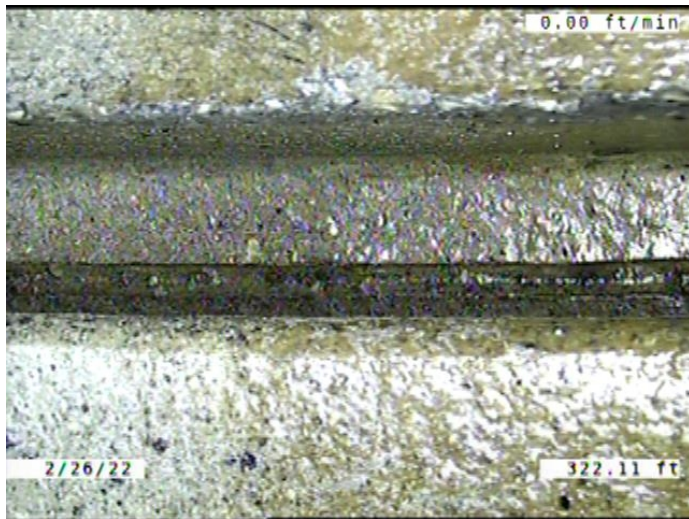
Code: **MGO**
 Description: **Miscellaneous General Observation**

Distance (ft): **298.8**
 Structural Grade: **0**
 O&M Grade: **0**
 Clock Start/From:
 Clock To:
 1st Value:
 2nd Value:
 Value Percent:
 Continuous Index:
 Within 8" of Joint: **NO**
 Remarks: **MANUFACTURE DEFECT. BUBBLE ON THE INSIDE OF THE PIPE. ROUGHLY**

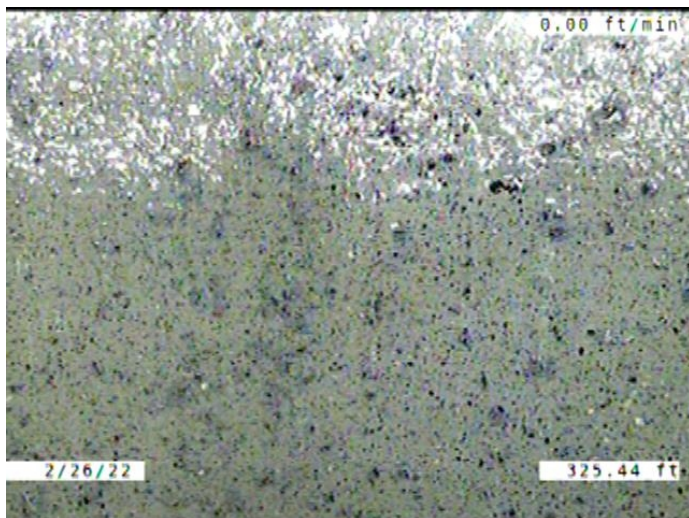
Code: **JAM**
Description: **Joint Angular Medium**

Distance (ft): **322.1**
Structural Grade: **3**
O&M Grade: **0**
Clock Start/From:
Clock To:
1st Value:
2nd Value:
Value Percent:
Continuous Index:
Within 8" of Joint: **NO**
Remarks:

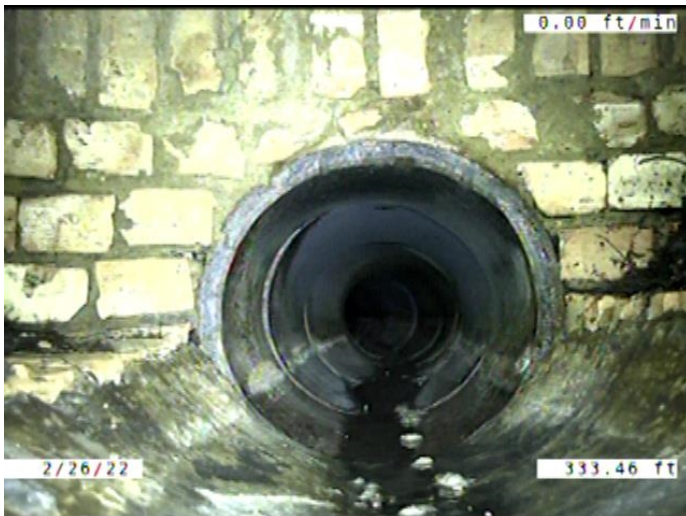
Code: **DSF**
Description: **Deposits Settled Fine**

Distance (ft): **333.5**
Structural Grade: **0**
O&M Grade: **2**
Clock Start/From: **5**
Clock To: **7**
1st Value:
2nd Value:
Value Percent: **5.000**
Continuous Index: **F01**
Within 8" of Joint: **YES**
Remarks:
