# Profile/Photo Observation Report

Date:	<b>02/24/2022</b>	Weather:		Coding:	<b>PACP 7.0</b>
Pipe Length (ft):	<b>301.0</b>	Owner:	<b>City of Hobart</b>	Pre Clean:	<b>Heavy Cleaning</b>
P.O.#:	<b>YES502259</b>	Surveyor:	<b>S. Bucklin</b>	PSR:	<b>P-706-008.1-008</b>
Customer:	<b>City of Hobart, IN (Red</b>	Clean Date:	<b>02/19/2022</b>	Shape:	<b>C</b>

Street:	<b>South Garfield Street</b>	Flow Control:	<b>Not Controlled</b>
City:	<b>Hobart, IN</b>	Year Renewed:	
Location:	<b>Local rural streets with light traffic, t</b>	Tape/Media #:	
Purpose:	<b>Routine Assessment</b>	Dia/Height:	<b>8"</b>
Use:	<b>Sanitary Sewage Pipe</b>	Material:	<b>VCP</b>
Drain Area:		Lining:	<b>None</b>
Category:	<b>NA</b>		
Comment:			
Location Details:		Direction of Survey:	<b>Downstream</b>
US MH:	<b>M-706-008.1</b>	DS MH:	<b>M-706-008</b>
		Total Length Surveyed (ft):	<b>300.0</b>

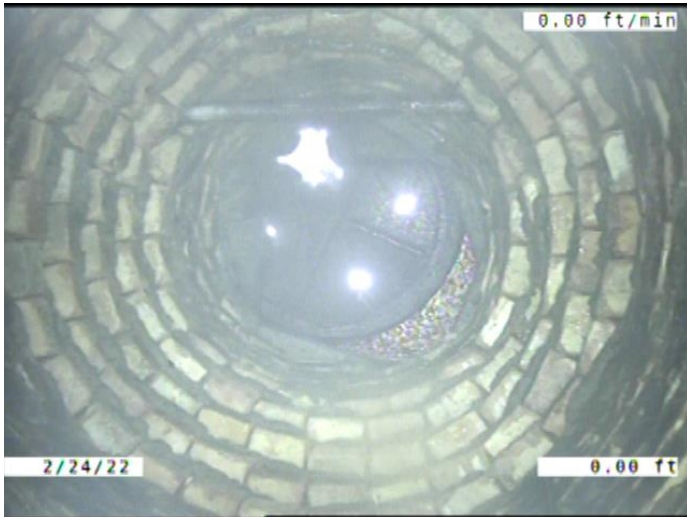
Code: **AMH**  
 Description: **Manhole**

Distance (ft): **.0**  
 Structural Grade: **0**  
 O&M Grade: **0**  
 Clock Start/From:  
 Clock To:  
 1st Value:  
 2nd Value:  
 Value Percent:  
 Continuous Index:  
 Within 8" of Joint: **NO**  
 Remarks: **M-706-008.1**

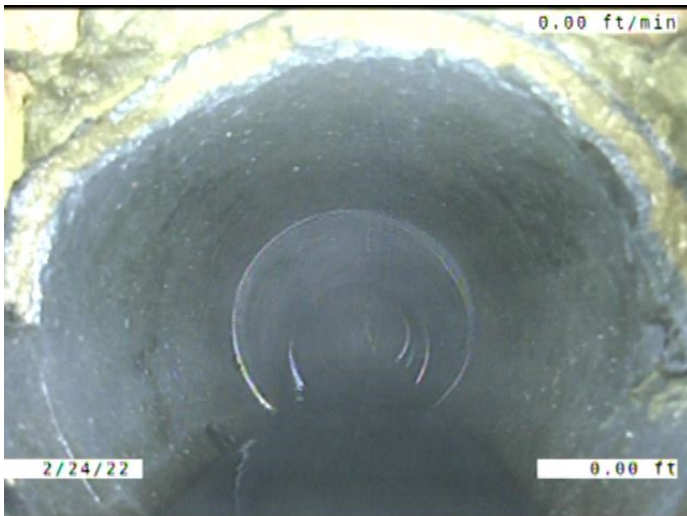
Code: **MWL**  
 Description: **Miscellaneous Water Level**

Distance (ft): **.0**  
 Structural Grade: **0**  
 O&M Grade: **0**  
 Clock Start/From:  
 Clock To:  
 1st Value:  
 2nd Value:  
 Value Percent: **10.000**  
 Continuous Index:  
 Within 8" of Joint: **NO**  
 Remarks:

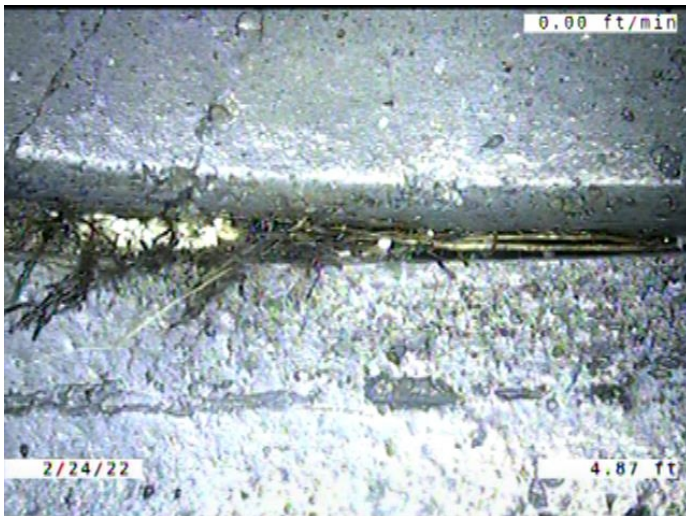
Code: **RFJ**  
Description: **Roots Fine Joint**

Distance (ft): **4.9**  
Structural Grade: **0**  
O&M Grade: **1**  
Clock Start/From: **8**  
Clock To: **4**  
1st Value:  
2nd Value:  
Value Percent:  
Continuous Index: **S02**  
Within 8" of Joint: **YES**  
Remarks:

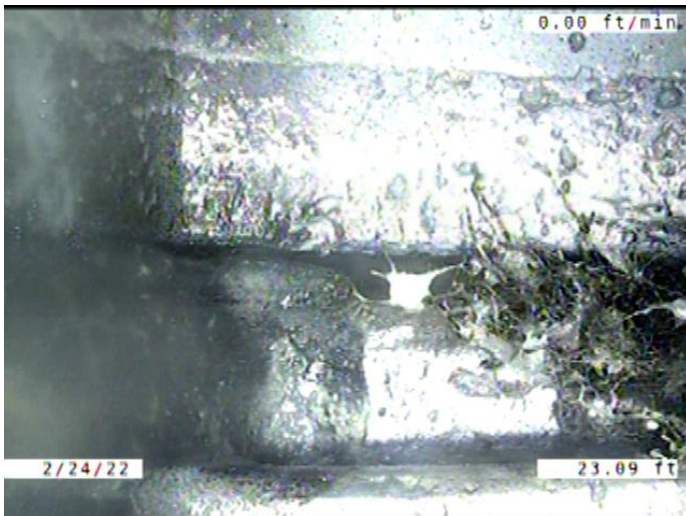
Code: **JAM**  
 Description: **Joint Angular Medium**

Distance (ft): **23.1**  
 Structural Grade: **3**  
 O&M Grade: **0**  
 Clock Start/From:  
 Clock To:  
 1st Value:  
 2nd Value:  
 Value Percent:  
 Continuous Index:  
 Within 8" of Joint: **NO**  
 Remarks:

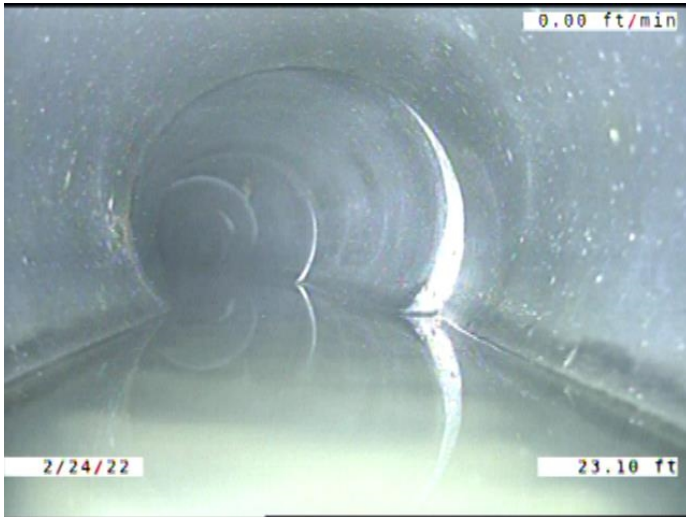
Code: **LL**  
Description: **Line Left**

Distance (ft): **23.1**  
Structural Grade: **0**  
O&M Grade: **1**  
Clock Start/From:  
Clock To:  
1st Value:  
2nd Value:  
Value Percent: **10.000**  
Continuous Index:  
Within 8" of Joint: **NO**  
Remarks:

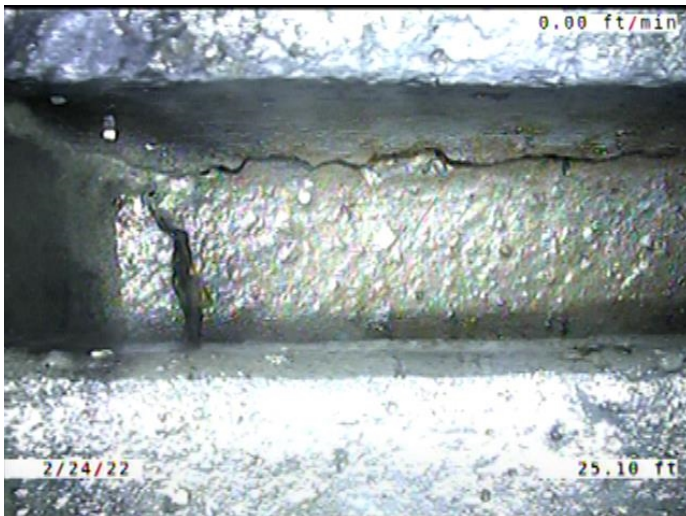
Code: **JAM**  
Description: **Joint Angular Medium**

Distance (ft): **25.1**  
Structural Grade: **3**  
O&M Grade: **0**  
Clock Start/From:  
Clock To:  
1st Value:  
2nd Value:  
Value Percent:  
Continuous Index:  
Within 8" of Joint: **NO**  
Remarks:

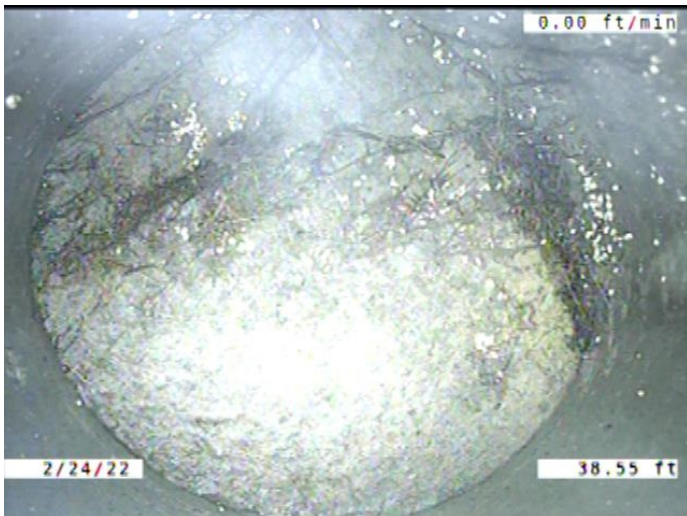
Code: **TFC**  
 Description: **Tap Factory Capped**

Distance (ft): **38.5**  
 Structural Grade: **0**  
 O&M Grade: **0**  
 Clock Start/From: **1**  
 Clock To:  
 1st Value: **6.000**  
 2nd Value:  
 Value Percent:  
 Continuous Index:  
 Within 8" of Joint: **YES**  
 Remarks:

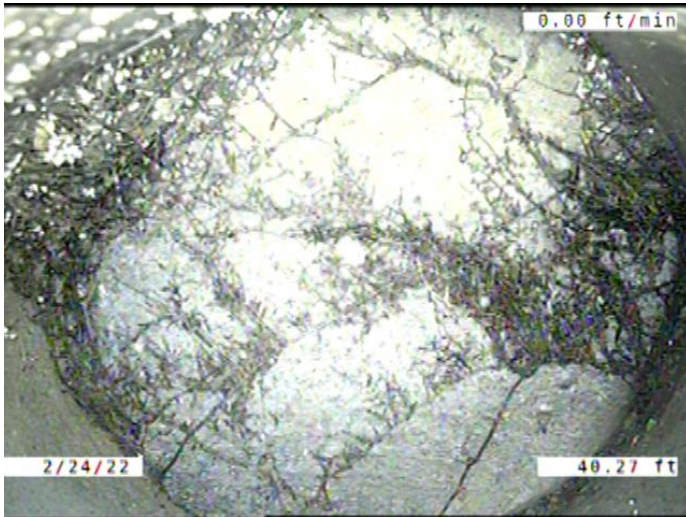
Code:	<b>TFC</b>
Description:	<b>Tap Factory Capped</b>
Distance (ft):	<b>40.3</b>
Structural Grade:	<b>0</b>
O&M Grade:	<b>0</b>
Clock Start/From:	<b>11</b>
Clock To:	
1st Value:	<b>6.000</b>
2nd Value:	
Value Percent:	
Continuous Index:	
Within 8" of Joint:	<b>YES</b>
Remarks:	<b>ROOTS GROWING AROUND THE CAP</b>

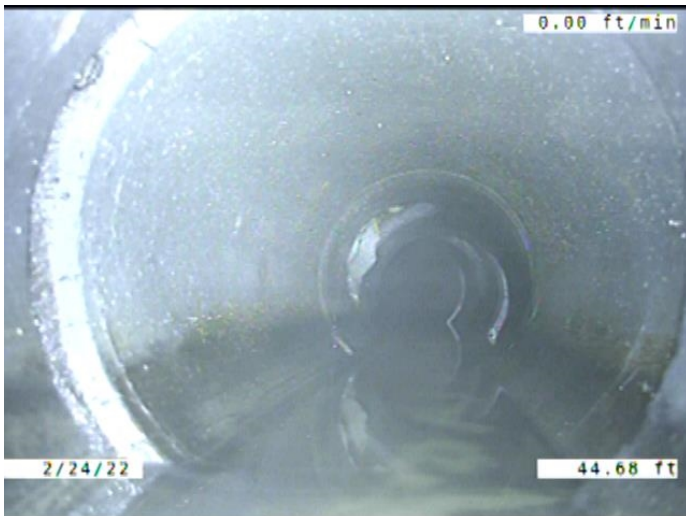
Code:	<b>LR</b>
Description:	<b>Line Right</b>
Distance (ft):	<b>44.7</b>
Structural Grade:	<b>0</b>
O&M Grade:	<b>1</b>
Clock Start/From:	
Clock To:	
1st Value:	
2nd Value:	
Value Percent:	<b>5.000</b>
Continuous Index:	
Within 8" of Joint:	<b>NO</b>
Remarks:

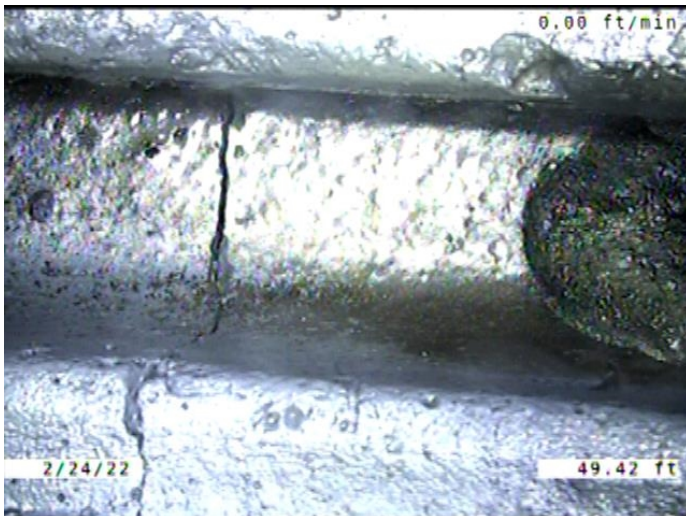
Code: **JAL**  
Description: **Joint Angular Large**

Distance (ft): **49.4**  
Structural Grade: **4**  
O&M Grade: **0**  
Clock Start/From:  
Clock To:  
1st Value:  
2nd Value:  
Value Percent:  
Continuous Index:  
Within 8" of Joint: **NO**  
Remarks:

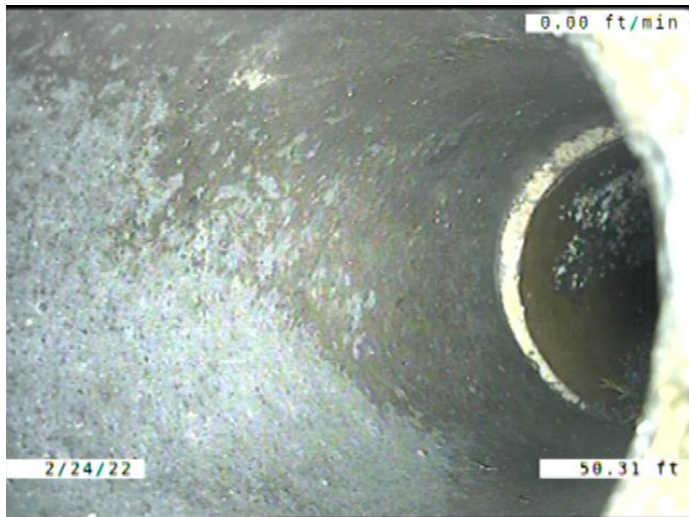
Code: **TB**  
 Description: **Tap Break-in/Hammer**

Distance (ft): **50.3**  
 Structural Grade: **0**  
 O&M Grade: **0**  
 Clock Start/From: **2**  
 Clock To:  
 1st Value: **6.000**  
 2nd Value:  
 Value Percent:  
 Continuous Index:  
 Within 8" of Joint: **YES**  
 Remarks:

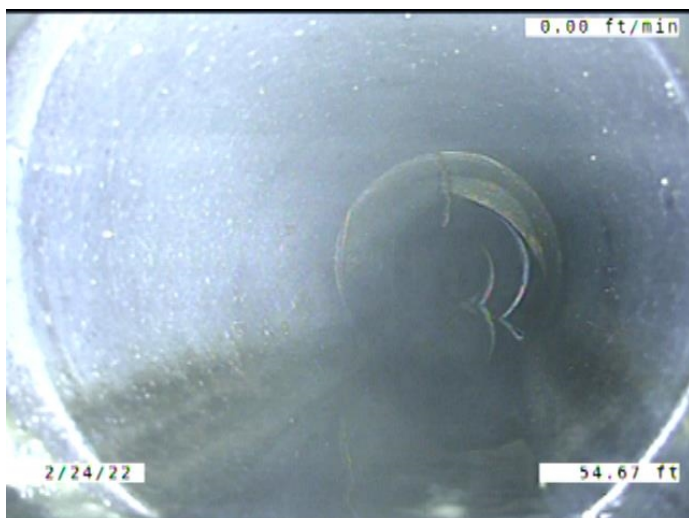
Code: **LR**  
 Description: **Line Right**

Distance (ft): **54.7**  
 Structural Grade: **0**  
 O&M Grade: **1**  
 Clock Start/From:  
 Clock To:  
 1st Value:  
 2nd Value:  
 Value Percent: **10.000**  
 Continuous Index:  
 Within 8" of Joint: **NO**  
 Remarks:

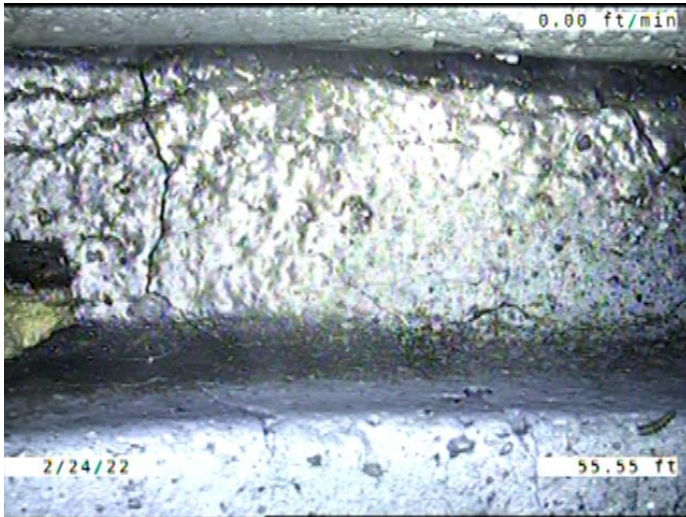
Code: **JAL**  
Description: **Joint Angular Large**

Distance (ft): **55.5**  
Structural Grade: **4**  
O&M Grade: **0**  
Clock Start/From:  
Clock To:  
1st Value:  
2nd Value:  
Value Percent:  
Continuous Index:  
Within 8" of Joint: **NO**  
Remarks:

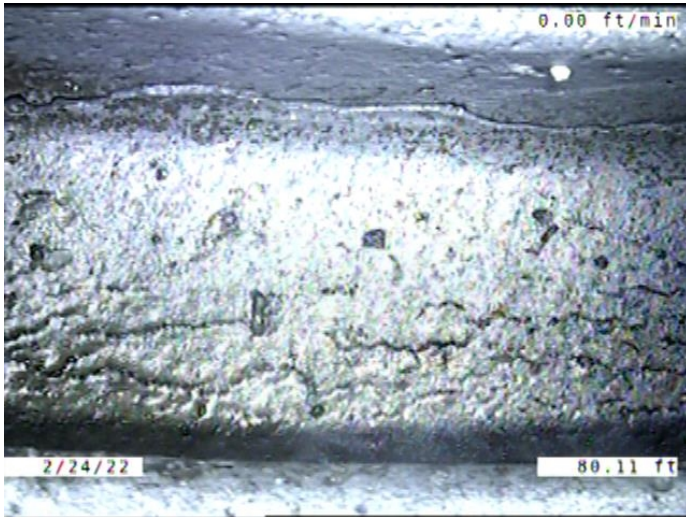
Code: **JAL**  
 Description: **Joint Angular Large**

Distance (ft): **80.1**  
 Structural Grade: **4**  
 O&M Grade: **0**  
 Clock Start/From:  
 Clock To:  
 1st Value:  
 2nd Value:  
 Value Percent:  
 Continuous Index:  
 Within 8" of Joint: **NO**  
 Remarks:

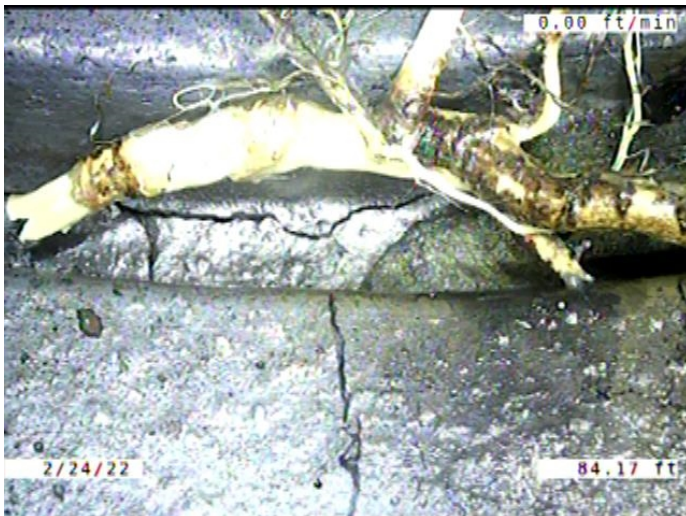
Code: **OBJ**  
 Description: **Obstruction Wedged In The Joint**

Distance (ft): **84.2**  
 Structural Grade: **0**  
 O&M Grade: **2**  
 Clock Start/From: **7**  
 Clock To: **9**  
 1st Value:  
 2nd Value:  
 Value Percent: **5.000**  
 Continuous Index:  
 Within 8" of Joint: **YES**  
 Remarks: **ROOT THAT HAS BEEN CUT**

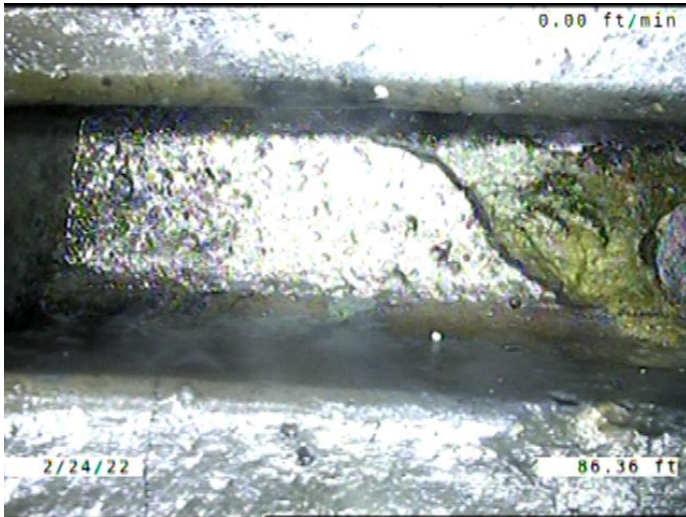
Code: **JAL**  
Description: **Joint Angular Large**

Distance (ft): **86.4**  
Structural Grade: **4**  
O&M Grade: **0**  
Clock Start/From:  
Clock To:  
1st Value:  
2nd Value:  
Value Percent:  
Continuous Index:  
Within 8" of Joint: **NO**  
Remarks:

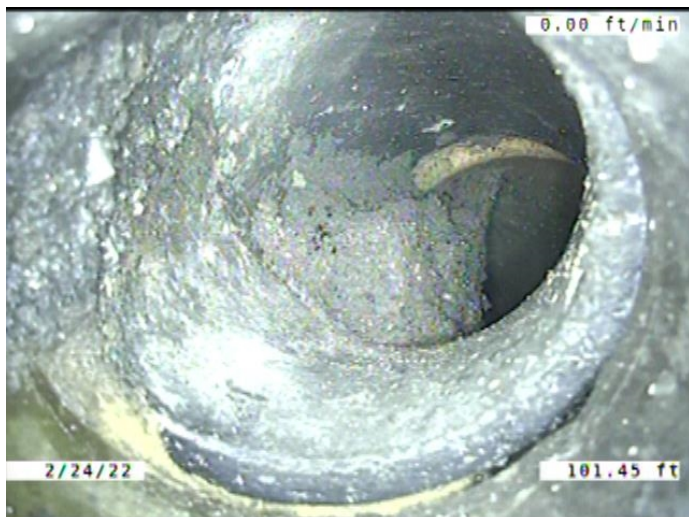
Code: **TF**  
 Description: **Tap Factory**

Distance (ft): **101.4**  
 Structural Grade: **0**  
 O&M Grade: **0**  
 Clock Start/From: **10**  
 Clock To:  
 1st Value: **6.000**  
 2nd Value:  
 Value Percent:  
 Continuous Index:  
 Within 8" of Joint: **YES**  
 Remarks:

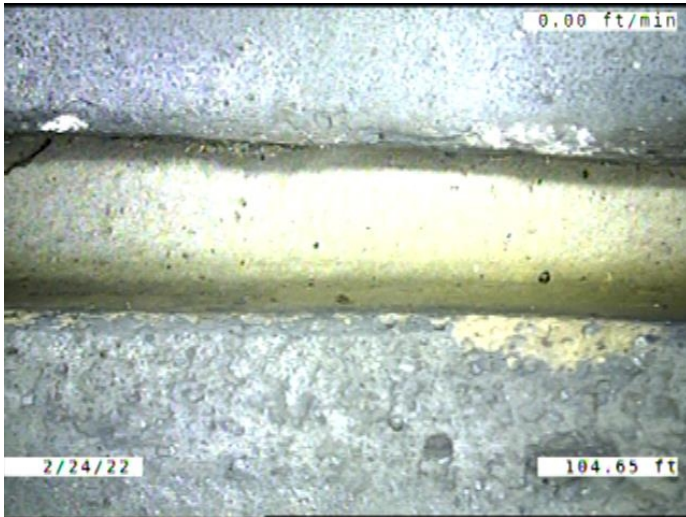
Code: **JAM**  
Description: **Joint Angular Medium**

Distance (ft): **104.6**  
Structural Grade: **3**  
O&M Grade: **0**  
Clock Start/From:  
Clock To:  
1st Value:  
2nd Value:  
Value Percent:  
Continuous Index:  
Within 8" of Joint: **NO**  
Remarks:

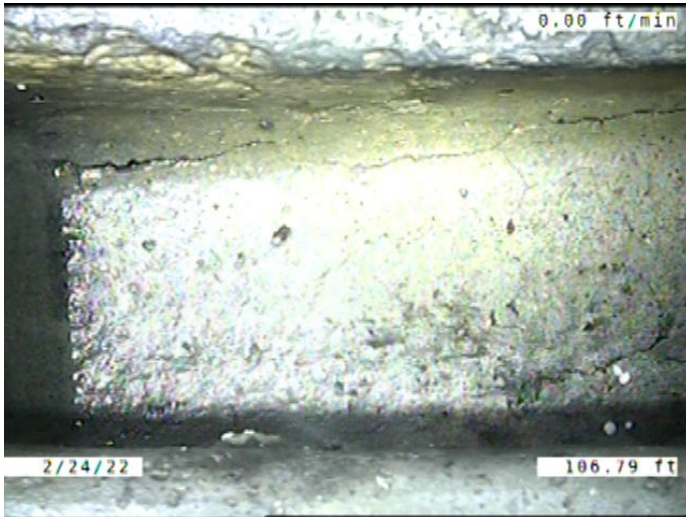
Code: **JAL**  
Description: **Joint Angular Large**

Distance (ft): **106.8**  
Structural Grade: **4**  
O&M Grade: **0**  
Clock Start/From:  
Clock To:  
1st Value:  
2nd Value:  
Value Percent:  
Continuous Index:  
Within 8" of Joint: **NO**  
Remarks:

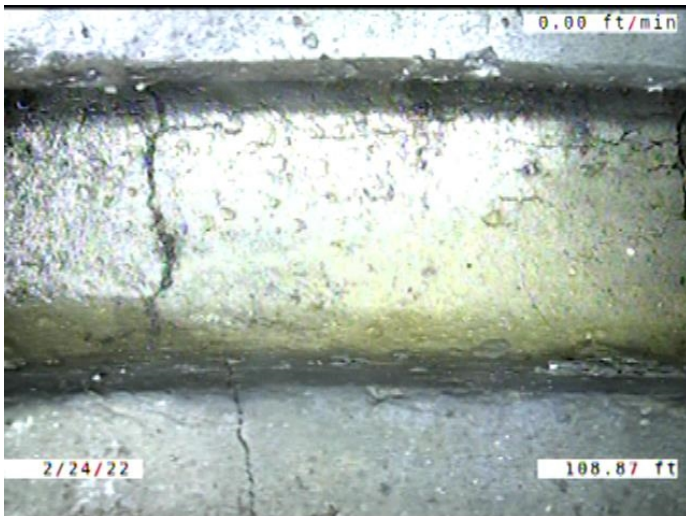
Code: **JAL**  
Description: **Joint Angular Large**

Distance (ft): **108.9**  
Structural Grade: **4**  
O&M Grade: **0**  
Clock Start/From:  
Clock To:  
1st Value:  
2nd Value:  
Value Percent:  
Continuous Index:  
Within 8" of Joint: **NO**  
Remarks:

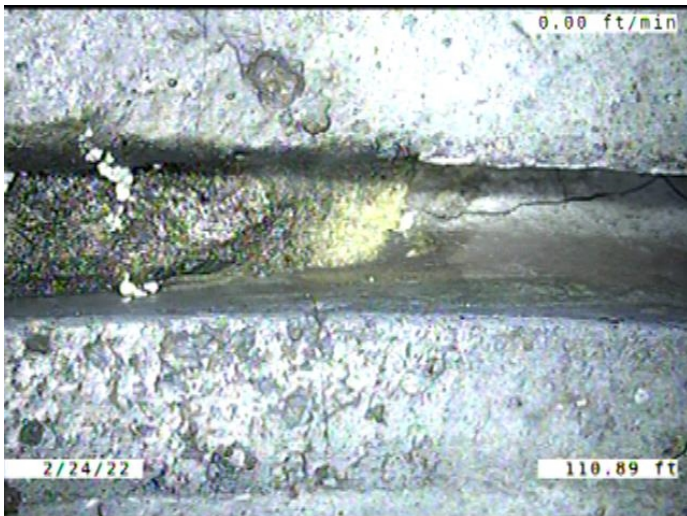
Code:	<b>JAM</b>
Description:	<b>Joint Angular Medium</b>
Distance (ft):	<b>110.9</b>
Structural Grade:	<b>3</b>
O&M Grade:	<b>0</b>
Clock Start/From:	
Clock To:	
1st Value:	
2nd Value:	
Value Percent:	
Continuous Index:	
Within 8" of Joint:	<b>NO</b>
Remarks:

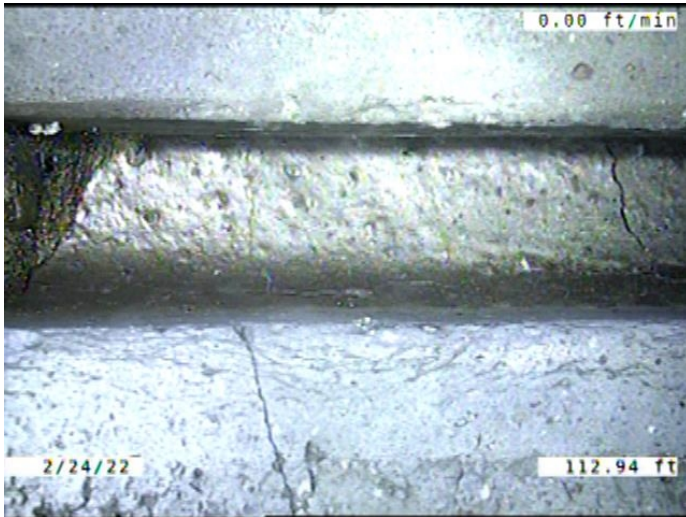
Code: **JAM**  
Description: **Joint Angular Medium**

Distance (ft): **112.9**  
Structural Grade: **3**  
O&M Grade: **0**  
Clock Start/From:  
Clock To:  
1st Value:  
2nd Value:  
Value Percent:  
Continuous Index:  
Within 8" of Joint: **NO**  
Remarks:

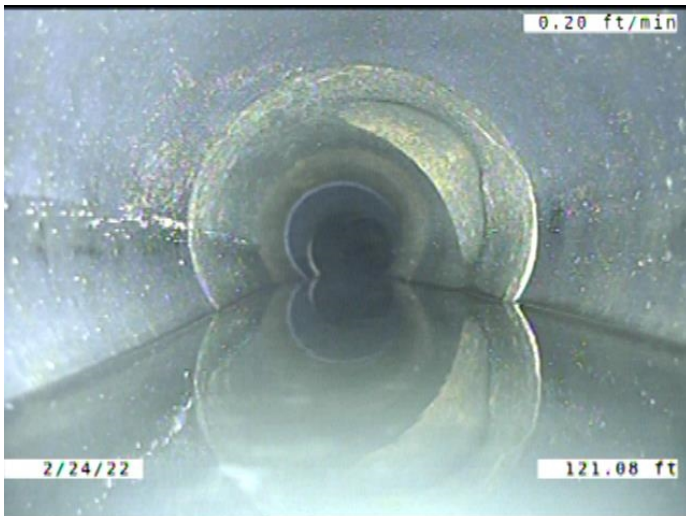
Code: **MWLS**  
Description: **Miscellaneous Water Level Sag**

Distance (ft): **121.1**  
Structural Grade: **2**  
O&M Grade: **0**  
Clock Start/From:  
Clock To:  
1st Value:  
2nd Value:  
Value Percent: **15.000**  
Continuous Index: **S04**  
Within 8" of Joint: **NO**  
Remarks:

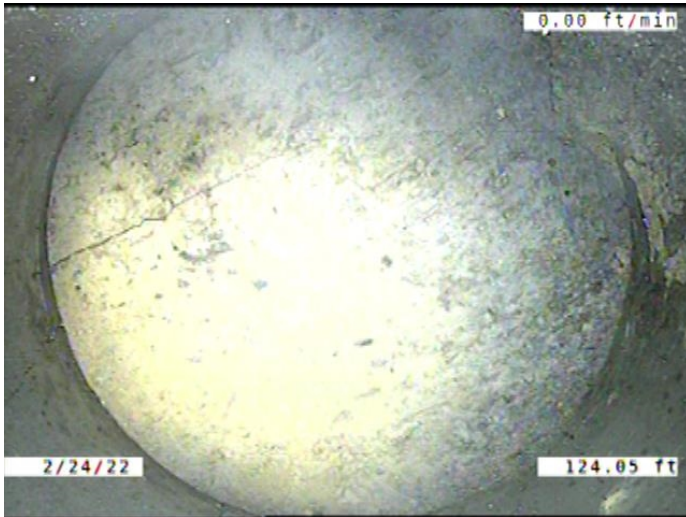
Code: **TFC**  
Description: **Tap Factory Capped**

Distance (ft): **124.0**  
Structural Grade: **0**  
O&M Grade: **0**  
Clock Start/From: **2**  
Clock To:  
1st Value: **6.000**  
2nd Value:  
Value Percent:  
Continuous Index:  
Within 8" of Joint: **YES**  
Remarks:

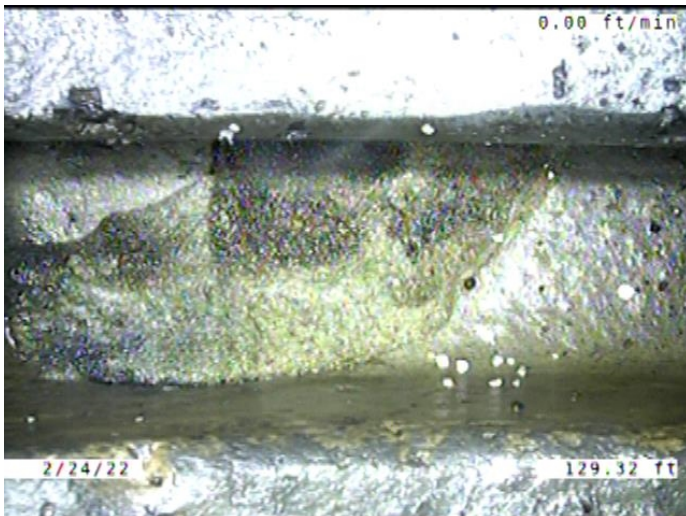
Code: **JAL**  
Description: **Joint Angular Large**

Distance (ft): **129.3**  
Structural Grade: **4**  
O&M Grade: **0**  
Clock Start/From:  
Clock To:  
1st Value:  
2nd Value:  
Value Percent:  
Continuous Index:  
Within 8" of Joint: **NO**  
Remarks:

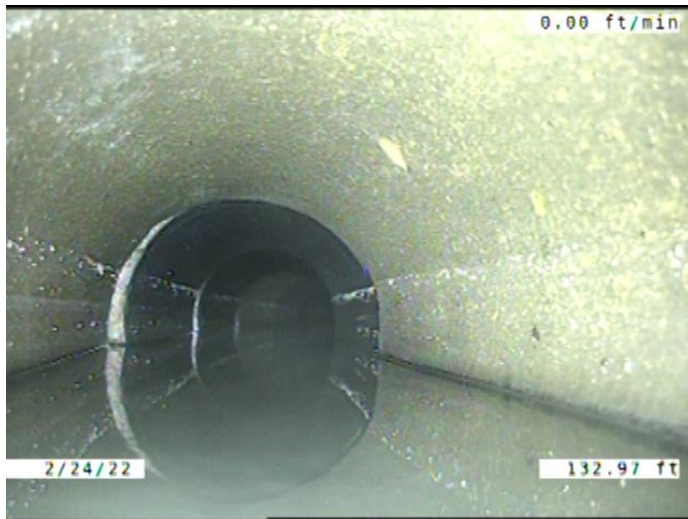
Code: **LL**  
Description: **Line Left**

Distance (ft): **133.0**  
Structural Grade: **0**  
O&M Grade: **1**  
Clock Start/From:  
Clock To:  
1st Value:  
2nd Value:  
Value Percent: **5.000**  
Continuous Index:  
Within 8" of Joint: **NO**  
Remarks:

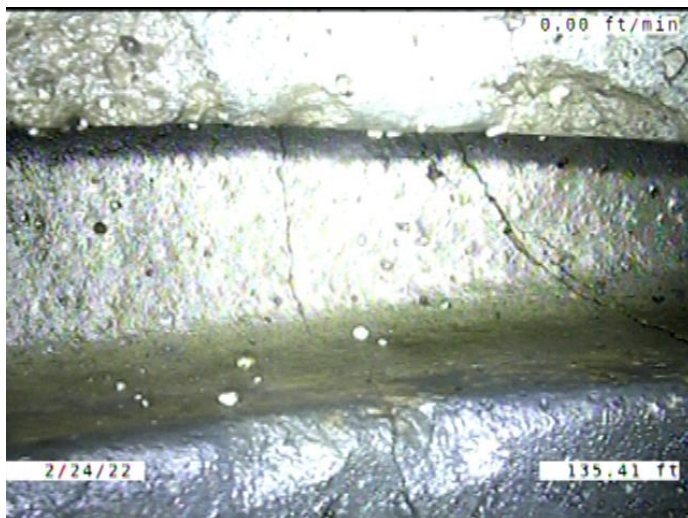
Code: **JAL**  
Description: **Joint Angular Large**

Distance (ft): **135.4**  
Structural Grade: **4**  
O&M Grade: **0**  
Clock Start/From:  
Clock To:  
1st Value:  
2nd Value:  
Value Percent:  
Continuous Index:  
Within 8" of Joint: **NO**  
Remarks:

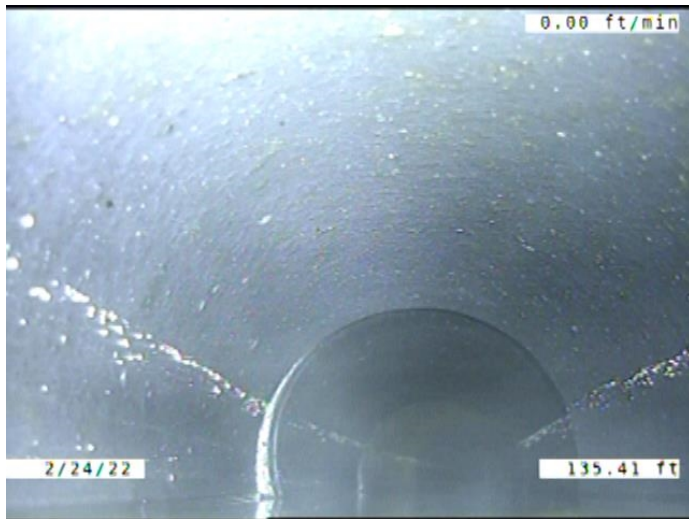
Code: **MWL**  
 Description: **Miscellaneous Water Level**

Distance (ft): **135.4**  
 Structural Grade: **0**  
 O&M Grade: **0**  
 Clock Start/From:  
 Clock To:  
 1st Value:  
 2nd Value:  
 Value Percent: **20.000**  
 Continuous Index:  
 Within 8" of Joint: **NO**  
 Remarks:

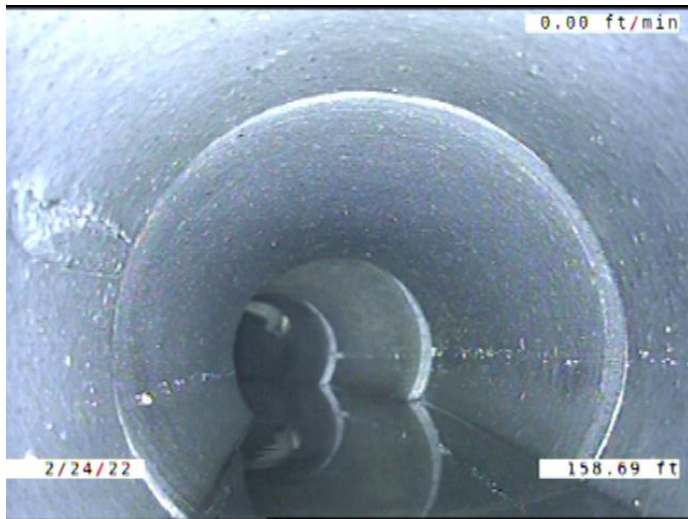
Code: **LR**  
Description: **Line Right**

Distance (ft): **158.7**  
Structural Grade: **0**  
O&M Grade: **4**  
Clock Start/From:  
Clock To:  
1st Value:  
2nd Value:  
Value Percent: **25.000**  
Continuous Index: **F05**  
Within 8" of Joint: **NO**  
Remarks:

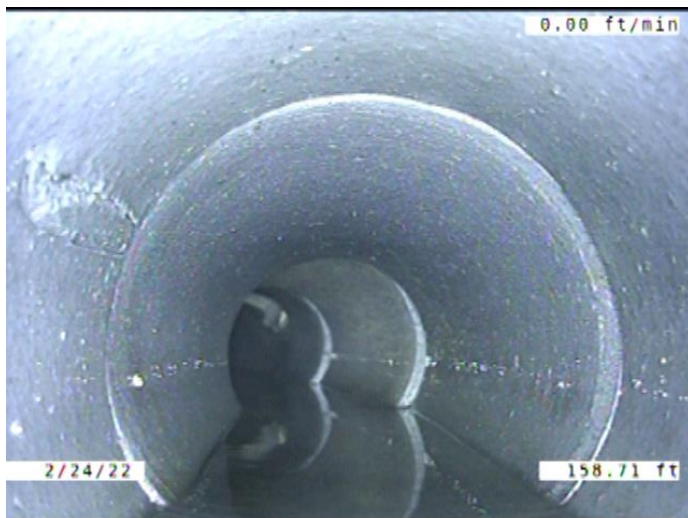
Code: **LL**  
Description: **Line Left**

Distance (ft): **158.7**  
Structural Grade: **0**  
O&M Grade: **4**  
Clock Start/From:  
Clock To:  
1st Value:  
2nd Value:  
Value Percent: **25.000**  
Continuous Index: **S07**  
Within 8" of Joint: **NO**  
Remarks:

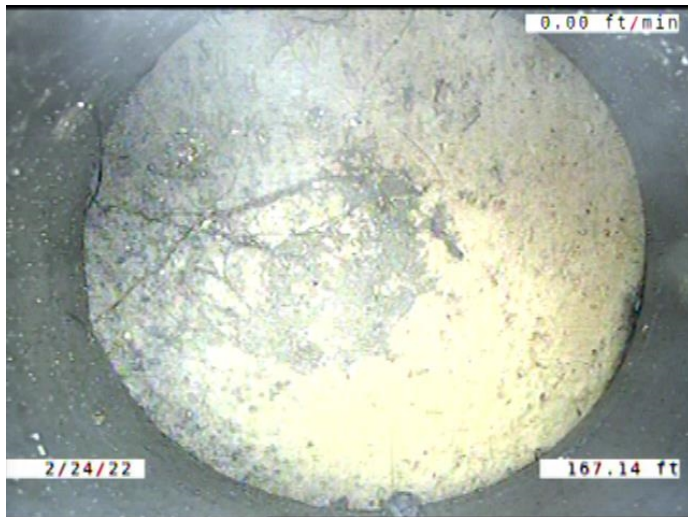
Code: **TFC**  
 Description: **Tap Factory Capped**

Distance (ft): **167.1**  
 Structural Grade: **0**  
 O&M Grade: **0**  
 Clock Start/From: **11**  
 Clock To:  
 1st Value: **6.000**  
 2nd Value:  
 Value Percent:  
 Continuous Index:  
 Within 8" of Joint: **YES**  
 Remarks:

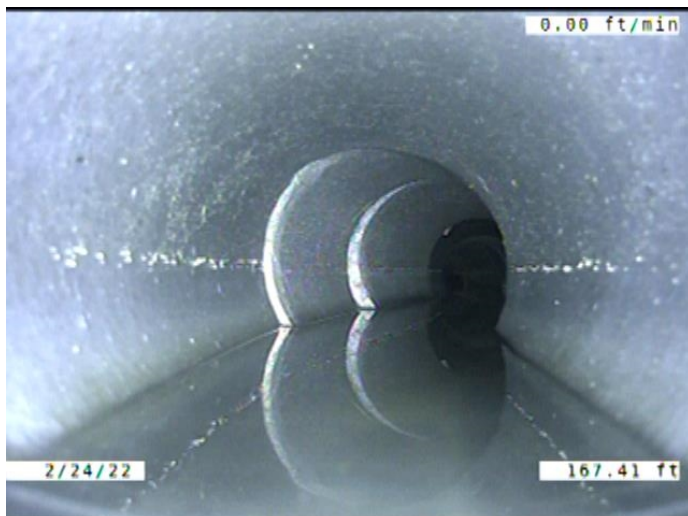
Code: **LL**  
 Description: **Line Left**

Distance (ft): **167.4**  
 Structural Grade: **0**  
 O&M Grade: **4**  
 Clock Start/From:  
 Clock To:  
 1st Value:  
 2nd Value:  
 Value Percent: **25.000**  
 Continuous Index: **F07**  
 Within 8" of Joint: **NO**  
 Remarks:

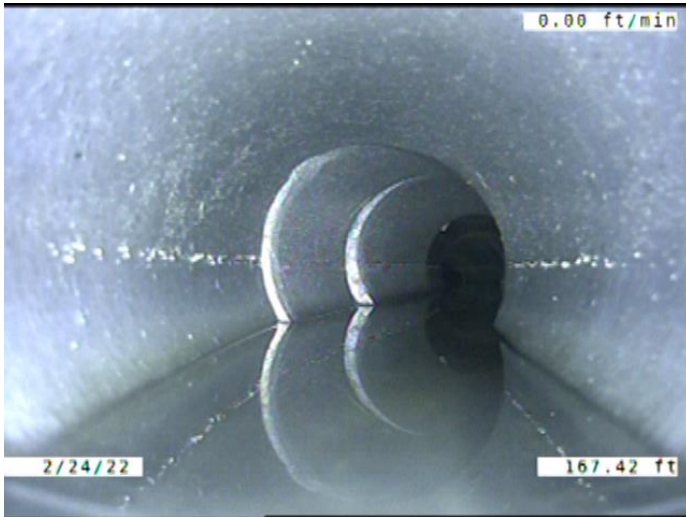
Code: **MWL**  
Description: **Miscellaneous Water Level**

Distance (ft): **167.4**  
Structural Grade: **0**  
O&M Grade: **0**  
Clock Start/From:  
Clock To:  
1st Value:  
2nd Value:  
Value Percent: **10.000**  
Continuous Index:  
Within 8" of Joint: **NO**  
Remarks:

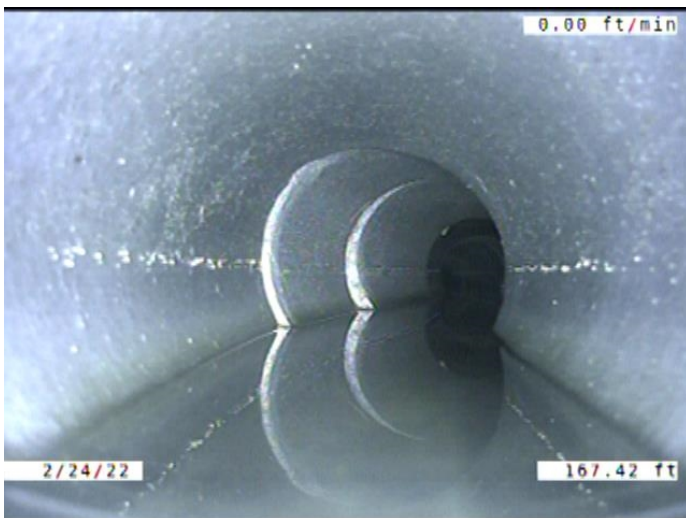
Code: **LL**  
Description: **Line Left**

Distance (ft): **167.4**  
Structural Grade: **0**  
O&M Grade: **2**  
Clock Start/From:  
Clock To:  
1st Value:  
2nd Value:  
Value Percent: **15.000**  
Continuous Index: **S08**  
Within 8" of Joint: **NO**  
Remarks:

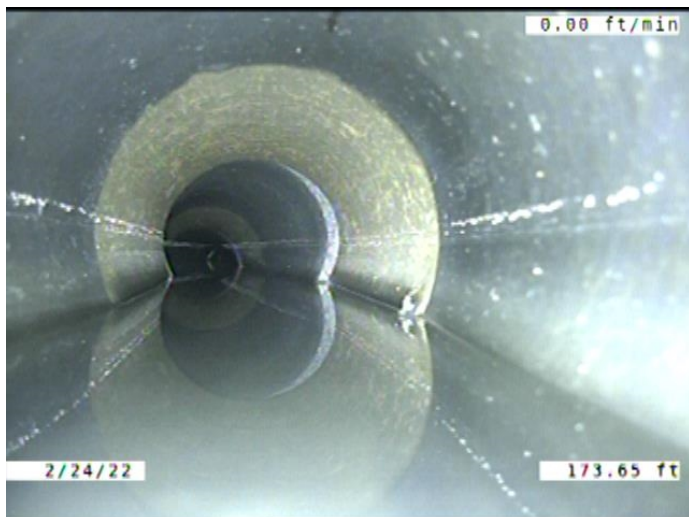
Code: **LL**  
Description: **Line Left**

Distance (ft): **173.6**  
Structural Grade: **0**  
O&M Grade: **2**  
Clock Start/From:  
Clock To:  
1st Value:  
2nd Value:  
Value Percent: **15.000**  
Continuous Index: **F08**  
Within 8" of Joint: **NO**  
Remarks:

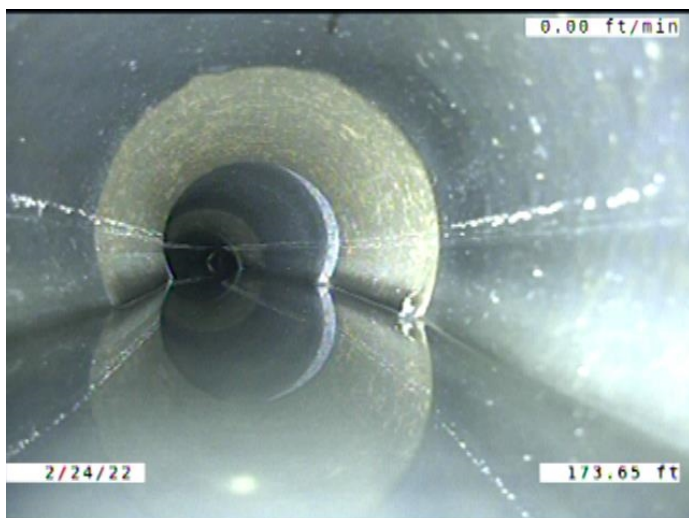
Code: **LL**  
Description: **Line Left**

Distance (ft): **173.6**  
Structural Grade: **0**  
O&M Grade: **2**  
Clock Start/From:  
Clock To:  
1st Value:  
2nd Value:  
Value Percent: **15.000**  
Continuous Index: **S09**  
Within 8" of Joint: **NO**  
Remarks:

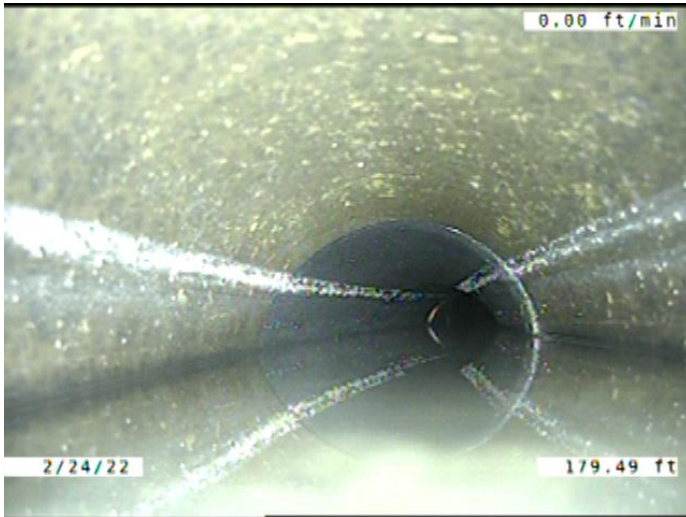
Code: **MWLS**  
Description: **Miscellaneous Water Level Sag**

Distance (ft): **179.5**  
Structural Grade: **3**  
O&M Grade: **0**  
Clock Start/From:  
Clock To:  
1st Value:  
2nd Value:  
Value Percent: **50.000**  
Continuous Index: **S10**  
Within 8" of Joint: **NO**  
Remarks:

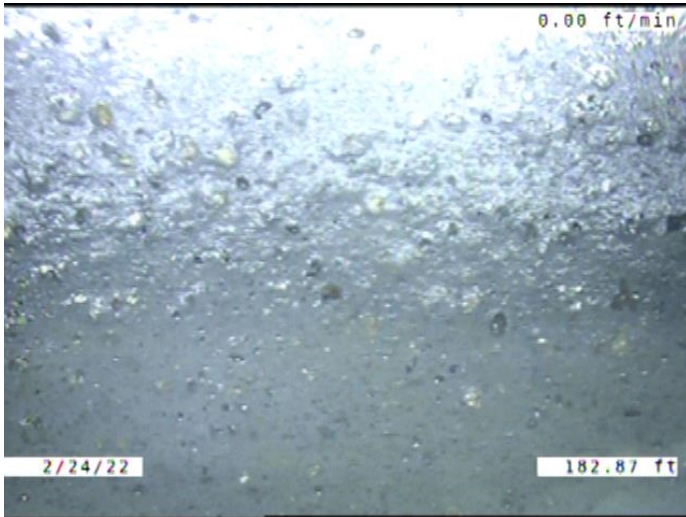
Code:	<b>MCU</b>
Description:	<b>Miscellaneous Camera Underwater</b>
Distance (ft):	<b>182.9</b>
Structural Grade:	<b>0</b>
O&M Grade:	<b>4</b>
Clock Start/From:	
Clock To:	
1st Value:	
2nd Value:	
Value Percent:	
Continuous Index:	<b>S11</b>
Within 8" of Joint:	<b>NO</b>
Remarks:

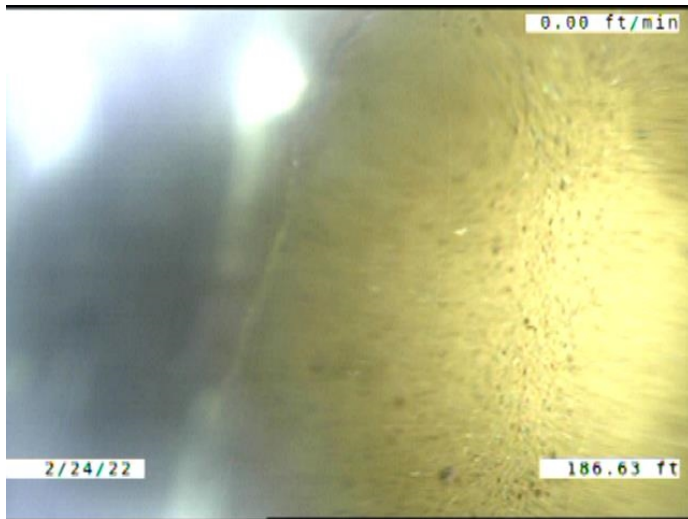
Code:	<b>FM</b>
Description:	<b>Fracture Multiple</b>
Distance (ft):	<b>186.3</b>
Structural Grade:	<b>4</b>
O&M Grade:	<b>0</b>
Clock Start/From:	<b>10</b>
Clock To:	<b>2</b>
1st Value:	
2nd Value:	
Value Percent:	
Continuous Index:	<b>S15</b>
Within 8" of Joint:	<b>NO</b>
Remarks:	<b>Visible through water. Wandering</b>

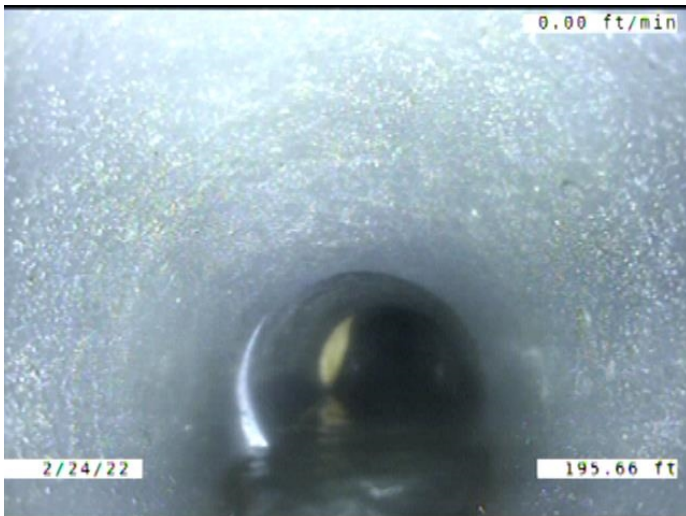
Code: **TFD**  
Description: **Tap Factory Defective**

Distance (ft): **195.1**  
Structural Grade: **0**  
O&M Grade: **3**  
Clock Start/From: **12**  
Clock To:  
1st Value: **6.000**  
2nd Value:  
Value Percent:  
Continuous Index:  
Within 8" of Joint: **YES**  
Remarks: **FL**

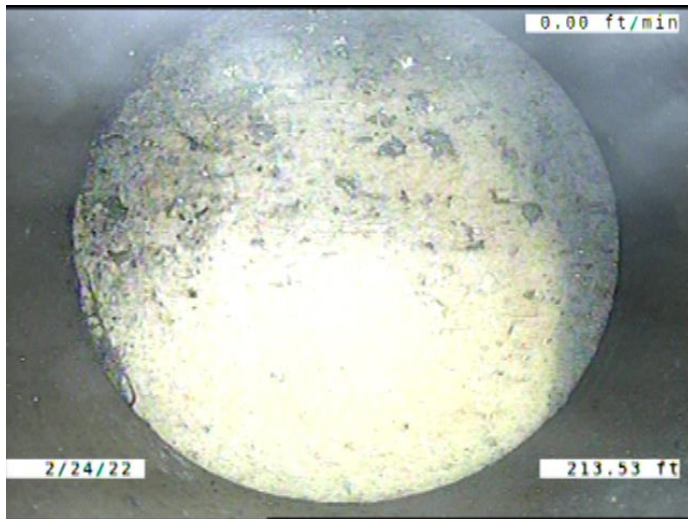
Code:	<b>TBI</b>
Description:	<b>Tap Break-in Intruding</b>
Distance (ft):	<b>200.8</b>
Structural Grade:	<b>0</b>
O&M Grade:	<b>2</b>
Clock Start/From:	<b>10</b>
Clock To:	
1st Value:	<b>6.000</b>
2nd Value:	<b>1.000</b>
Value Percent:	
Continuous Index:	
Within 8" of Joint:	<b>YES</b>
Remarks:

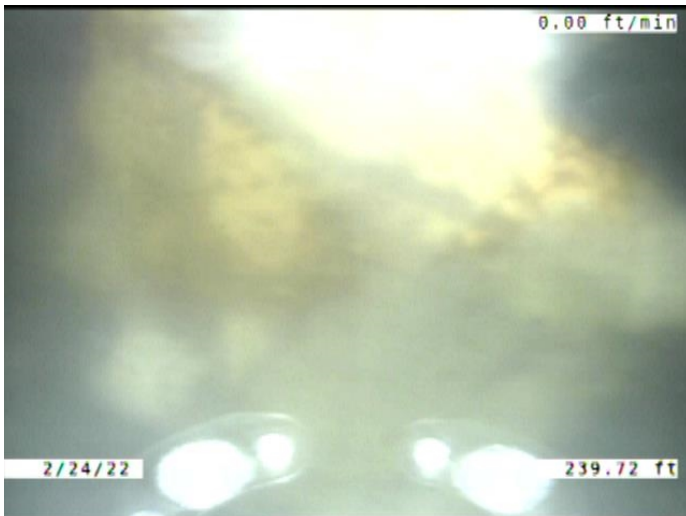
Code: **OBZ**  
 Description: **Obstruction Other**

Distance (ft): **235.6**  
 Structural Grade: **0**  
 O&M Grade: **2**  
 Clock Start/From: **4**  
 Clock To: **7**  
 1st Value:  
 2nd Value:  
 Value Percent: **5.000**  
 Continuous Index:  
 Within 8" of Joint: **NO**  
 Remarks: **ROOTS THAT HAVE BEEN CUT**

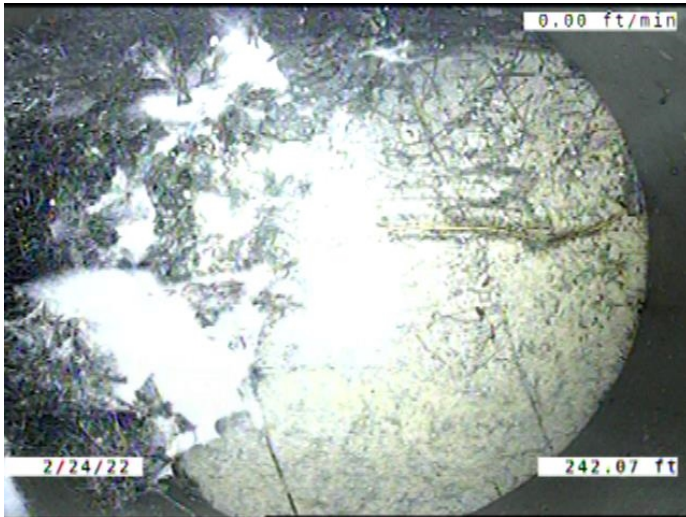
Code: **OBM**  
 Description: **Obstruction Pipe Material in Invert**

Distance (ft): **239.7**  
 Structural Grade: **0**  
 O&M Grade: **2**  
 Clock Start/From: **6**  
 Clock To:  
 1st Value:  
 2nd Value:  
 Value Percent: **5.000**  
 Continuous Index:  
 Within 8" of Joint: **YES**  
 Remarks:

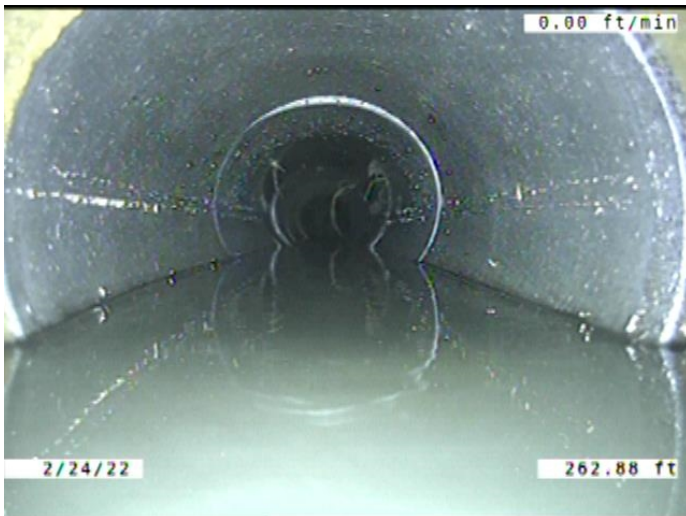
Code: **BVV**  
 Description: **Broken Void Visible**

Distance (ft): **257.6**  
 Structural Grade: **5**  
 O&M Grade: **0**  
 Clock Start/From: **7**  
 Clock To: **4**  
 1st Value:  
 2nd Value:  
 Value Percent:  
 Continuous Index:  
 Within 8" of Joint: **YES**  
 Remarks:

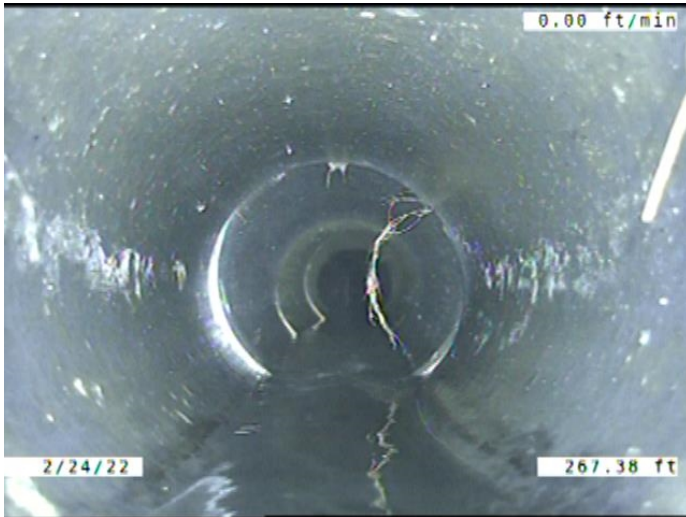
Code: **MWLS**  
 Description: **Miscellaneous Water Level Sag**

Distance (ft): **262.9**  
 Structural Grade: **2**  
 O&M Grade: **0**  
 Clock Start/From:  
 Clock To:  
 1st Value:  
 2nd Value:  
 Value Percent: **15.000**  
 Continuous Index: **S12**  
 Within 8" of Joint: **NO**  
 Remarks:

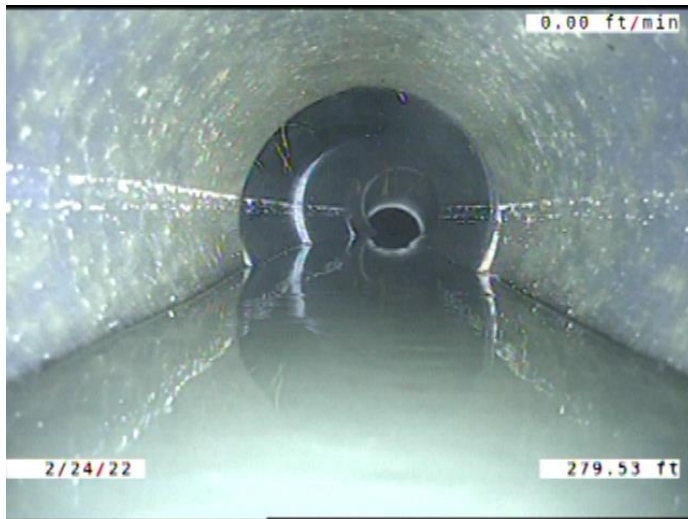
Code: **SSS**  
Description: **Surface Damage Surface Spalling**

Distance (ft): **272.8**  
Structural Grade: **2**  
O&M Grade: **0**  
Clock Start/From: **4**  
Clock To:  
1st Value:  
2nd Value:  
Value Percent:  
Continuous Index:  
Within 8" of Joint: **NO**  
Remarks:

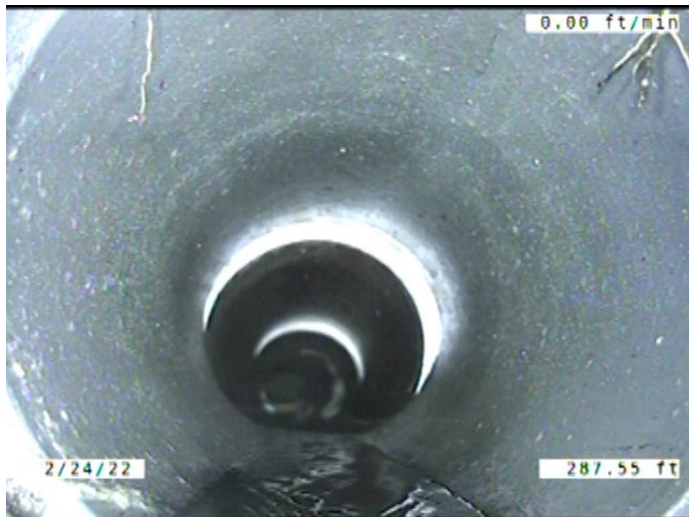
Code: **JAL**  
 Description: **Joint Angular Large**

Distance (ft): **284.2**  
 Structural Grade: **4**  
 O&M Grade: **0**  
 Clock Start/From:  
 Clock To:  
 1st Value:  
 2nd Value:  
 Value Percent:  
 Continuous Index:  
 Within 8" of Joint: **NO**  
 Remarks:

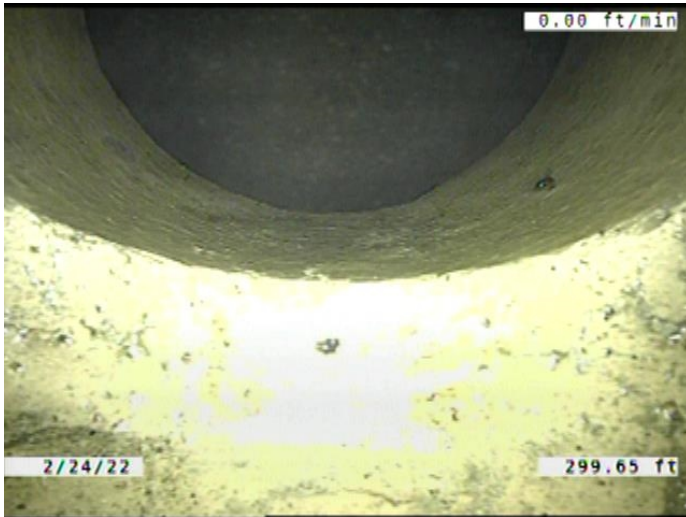
Code: **DSF**  
 Description: **Deposits Settled Fine**

Distance (ft): **299.6**  
 Structural Grade: **0**  
 O&M Grade: **2**  
 Clock Start/From: **5**  
 Clock To: **7**  
 1st Value:  
 2nd Value:  
 Value Percent: **5.000**  
 Continuous Index: **F03**  
 Within 8" of Joint: **YES**  
 Remarks:

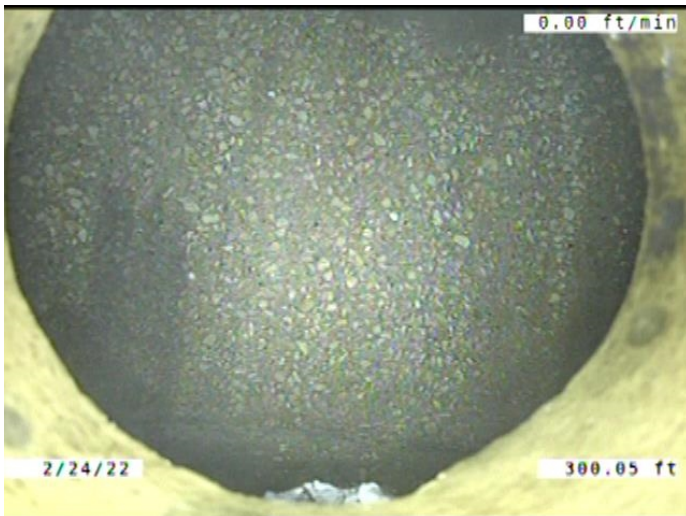
Code: **RFJ**  
 Description: **Roots Fine Joint**

Distance (ft): **299.6**  
 Structural Grade: **0**  
 O&M Grade: **1**  
 Clock Start/From: **8**  
 Clock To: **4**  
 1st Value:  
 2nd Value:  
 Value Percent:  
 Continuous Index: **F02**  
 Within 8" of Joint: **YES**  
 Remarks:
