Profile/Photo Observation Report

Date:	04/14/2018	Weather:		Coding:	PACP 6.0
Pipe Length (ft):	222.5	Owner:	NA	Pre Clean:	Not Known
P.O.#:		Surveyor:	Jen Costello	PSR:	P-706-008.6-008.3
Customer:		Clean Date:	01/01/1900	Shape:	C

Street:	GARFIELD ST	Flow Control:	Not Controlled
City:	Hobart, IN	Year Renewed:	
Location:	Light Highway	Tape/Media #:	
Purpose:	Maintenance Related	Dia/Height:	8"
Use:	Sanitary	Material:	VCP
Drain Area:	NA	Lining:	Cured in Place
Category:	NA		
Comment:	reverse setup.flow incorrect. roots at 41'.		
Location Details:		Direction of Survey:	Downstream
US MH:	M-706-008.3	DS MH:	M-706-008.6
		Total Length Surveyed (ft):	42.4

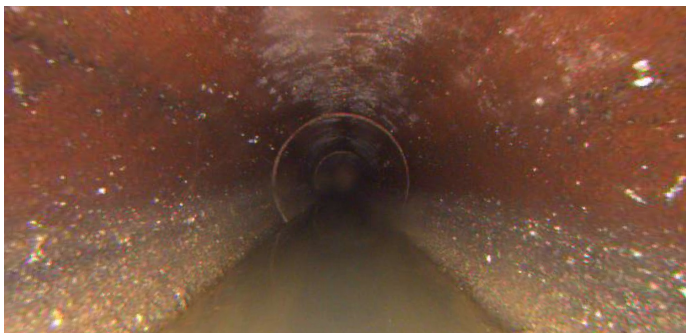
Code: **AMH**
Description: **Manhole**

Distance (ft): **.0**
Structural Grade: **0**
O&M Grade: **0**
Clock Start/From:
Clock To:
1st Value:
2nd Value:
Value Percent:
Continuous Index:
Within 8" of Joint: **NO**
Remarks: **M-706-008.3**

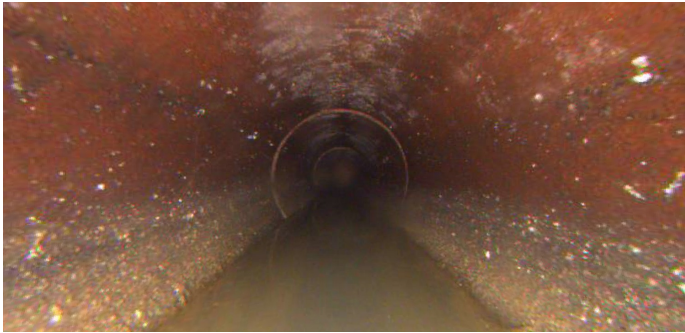
Code:	MWL
Description:	Water Level

Distance (ft):	.0
Structural Grade:	0
O&M Grade:	0
Clock Start/From:	
Clock To:	
1st Value:	
2nd Value:	
Value Percent:	5.000
Continuous Index:	
Within 8" of Joint:	NO
Remarks:
