Profile/Photo Observation Report

Date:	04/14/2018	Weather:		Coding:	PACP 6.0
Pipe Length (ft):	222.5	Owner:	NA	Pre Clean:	Not Known
P.O.#:		Surveyor:	Jen Costello	PSR:	P-706-008.6-008.3
Customer:		Clean Date:	01/01/1900	Shape:	C

Street:	Capitol	Flow Control:	Not Controlled
City:	Hobart, IN	Year Renewed:	
Location:	Light Highway	Tape/Media #:	
Purpose:	Maintenance Related	Dia/Height:	8"
Use:	Sanitary	Material:	VCP
Drain Area:	NA	Lining:	Cured in Place
Category:	NA		
Comment:	reverse setup.flow incorrect. roots at 41'.		
Location Details:		Direction of Survey:	Downstream
US MH:	M-706-008.3	DS MH:	M-706-008.6
		Total Length Surveyed (ft):	42.4

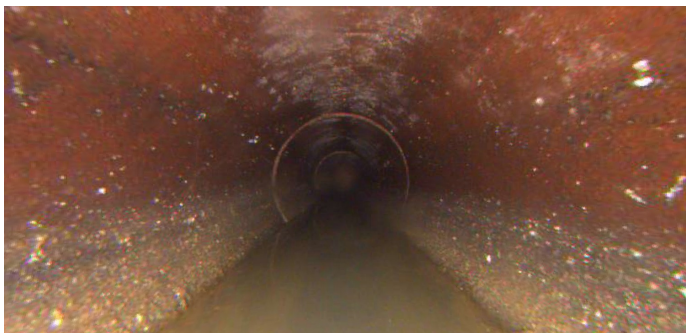
Code: **AMH**
Description: **Manhole**

Distance (ft): **.0**
Structural Grade: **0**
O&M Grade: **0**
Clock Start/From:
Clock To:
1st Value:
2nd Value:
Value Percent:
Continuous Index:
Within 8" of Joint: **NO**
Remarks: **M-706-008.3**

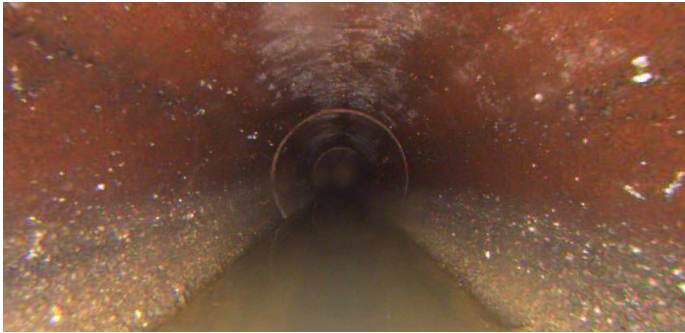
Code:	MWL
Description:	Water Level

Distance (ft):	.0
Structural Grade:	0
O&M Grade:	0
Clock Start/From:	
Clock To:	
1st Value:	
2nd Value:	
Value Percent:	5.000
Continuous Index:	
Within 8" of Joint:	NO
Remarks:
