Profile/Photo Observation Report

Date:	04/14/2018	Weather:		Coding:	PACP 6.0
Pipe Length (ft):	218.3	Owner:	NA	Pre Clean:	Not Known
P.O.#:		Surveyor:	Jen Costello	PSR:	P-706-008.7-008.6
Customer:		Clean Date:	01/01/1900	Shape:	C

Street:	Capitol	Flow Control:	Not Controlled
City:	Hobart, IN	Year Renewed:	
Location:	Light Highway	Tape/Media #:	
Purpose:	Maintenance Related	Dia/Height:	8"
Use:	Sanitary	Material:	VCP
Drain Area:	NA	Lining:	Cured in Place
Category:	NA		
Comment:	roots at 29'.

Location Details:		Direction of Survey:	Downstream
US MH:	M-706-008.6	DS MH:	M-706-008.7
		Total Length Surveyed (ft):	30.4

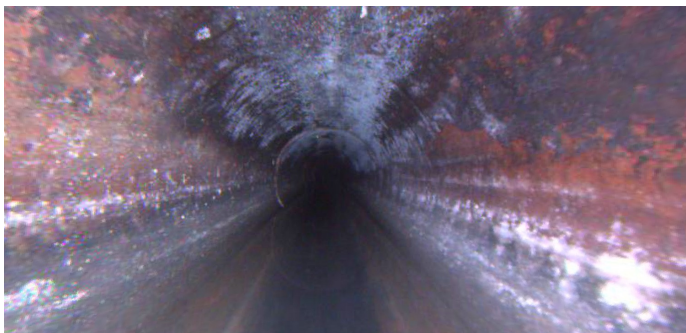
Code: **AMH**
Description: **Manhole**

Distance (ft): **.0**
Structural Grade: **0**
O&M Grade: **0**
Clock Start/From:
Clock To:
1st Value:
2nd Value:
Value Percent:
Continuous Index:
Within 8" of Joint: **NO**
Remarks: **M-706-008.6**

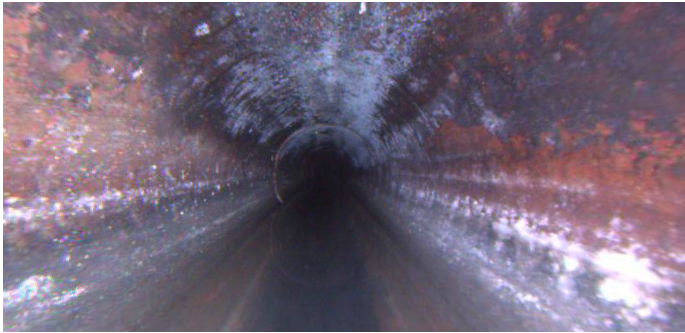
Code:	MWL
Description:	Water Level

Distance (ft):	.0
Structural Grade:	0
O&M Grade:	0
Clock Start/From:	
Clock To:	
1st Value:	
2nd Value:	
Value Percent:	10.000
Continuous Index:	
Within 8" of Joint:	NO
Remarks:

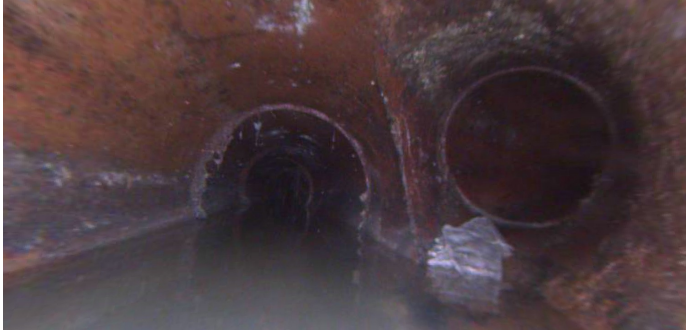
Code: **TF**
Description: **Tap Factory**

Distance (ft): **13.2**
Structural Grade: **0**
O&M Grade: **0**
Clock Start/From: **3**
Clock To:
1st Value: **4.000**
2nd Value:
Value Percent:
Continuous Index:
Within 8" of Joint:
Remarks:

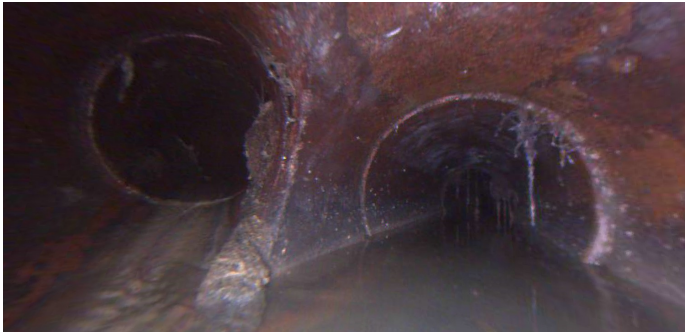
Code: **TFA**
Description: **Tap Factory Active**

Distance (ft): **15.5**
Structural Grade: **0**
O&M Grade: **0**
Clock Start/From: **9**
Clock To:
1st Value: **4.000**
2nd Value:
Value Percent:
Continuous Index:
Within 8" of Joint:
Remarks:
