Profile/Photo Observation Report

Date:	04/14/2018	Weather:		Coding:	PACP 6.0
Pipe Length (ft):	218.3	Owner:	NA	Pre Clean:	Not Known
P.O.#:		Surveyor:	Jen Costello	PSR:	P-706-008.7-008.6
Customer:		Clean Date:	01/01/1900	Shape:	C

Street:	GARFIELD ST	Flow Control:	Not Controlled
City:	Hobart, IN	Year Renewed:	
Location:	Light Highway	Tape/Media #:	
Purpose:	Maintenance Related	Dia/Height:	8"
Use:	Sanitary	Material:	VCP
Drain Area:	NA	Lining:	Cured in Place
Category:	NA		
Comment:	Reverse setup. heavy debris at 37'.flow incorrect		
Location Details:		Direction of Survey:	Upstream
US MH:	M-706-008.6	DS MH:	M-706-008.7
		Total Length Surveyed (ft):	38.3

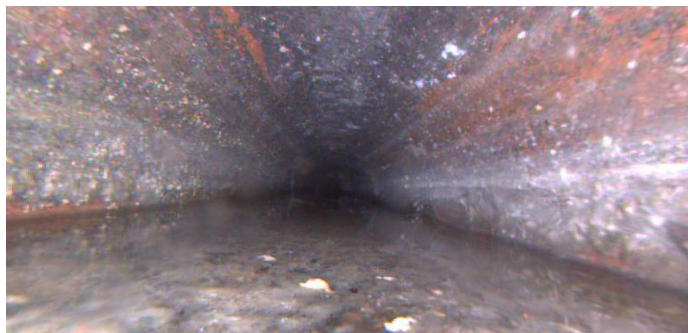
Code: **AMH**
Description: **Manhole**

Distance (ft): **.0**
Structural Grade: **0**
O&M Grade: **0**
Clock Start/From:
Clock To:
1st Value:
2nd Value:
Value Percent:
Continuous Index:
Within 8" of Joint: **NO**
Remarks: **M-706-008.7**

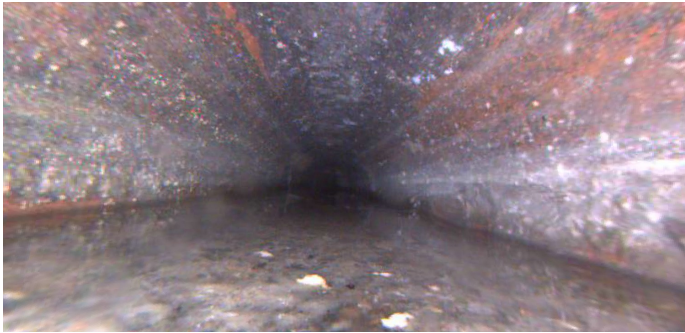
Code:	MWL
Description:	Water Level

Distance (ft):	.0
Structural Grade:	0
O&M Grade:	0
Clock Start/From:	
Clock To:	
1st Value:	
2nd Value:	
Value Percent:	40.000
Continuous Index:	
Within 8" of Joint:	NO
Remarks:

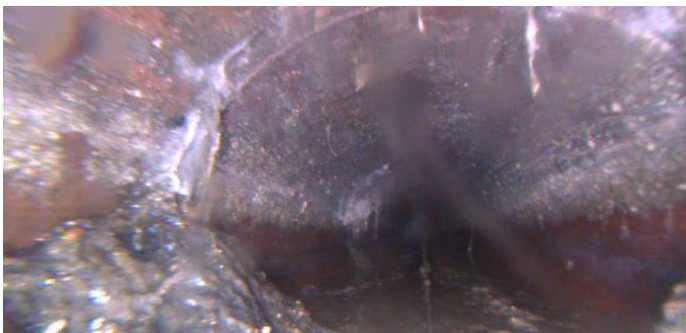
Code: **MGO**
Description: **General Observation**

Distance (ft): **7.1**
Structural Grade: **0**
O&M Grade: **0**
Clock Start/From:
Clock To:
1st Value:
2nd Value:
Value Percent:
Continuous Index:
Within 8" of Joint: **NO**
Remarks: **REAR CAMERA**

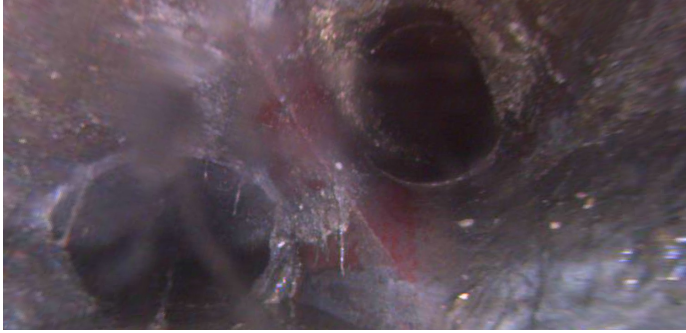
Code: **TF**
Description: **Tap Factory**

Distance (ft): **7.9**
Structural Grade: **0**
O&M Grade: **0**
Clock Start/From: **10**
Clock To:
1st Value: **4.000**
2nd Value:
Value Percent:
Continuous Index:
Within 8" of Joint:
Remarks:
