Profile/Photo Observation Report

Date:	02/23/2022	Weather:		Coding:	PACP 7.0
Pipe Length (ft):	218.0	Owner:	City of Hobart	Pre Clean:	Heavy Cleaning
P.O.#:	YES502259	Surveyor:	S. Bucklin	PSR:	P-706-008.7-008.6
Customer:	City of Hobart, IN (Red	Clean Date:	02/18/2022	Shape:	C

Street:	South Garfield Street	Flow Control:	Not Controlled
City:	Hobart, IN	Year Renewed:	
Location:	Local rural streets with light traffic, t	Tape/Media #:	
Purpose:	Routine Assessment	Dia/Height:	8"
Use:	Sanitary Sewage Pipe	Material:	VCP
Drain Area:		Lining:	None
Category:	NA		
Comment:			
Location Details:		Direction of Survey:	Downstream
US MH:	M-706-008.6	DS MH:	M-706-008.7
		Total Length Surveyed (ft):	217.6

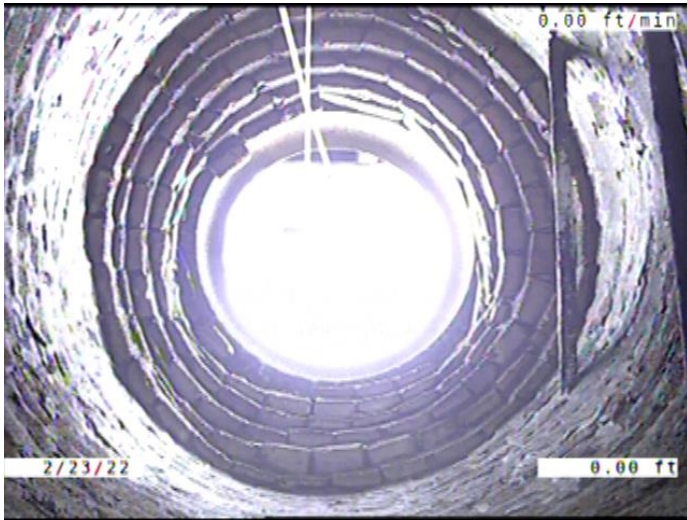
Code: **AMH**
Description: **Manhole**

Distance (ft): **.0**
Structural Grade: **0**
O&M Grade: **0**
Clock Start/From:
Clock To:
1st Value:
2nd Value:
Value Percent:
Continuous Index:
Within 8" of Joint: **NO**
Remarks: **M-706-008.6**

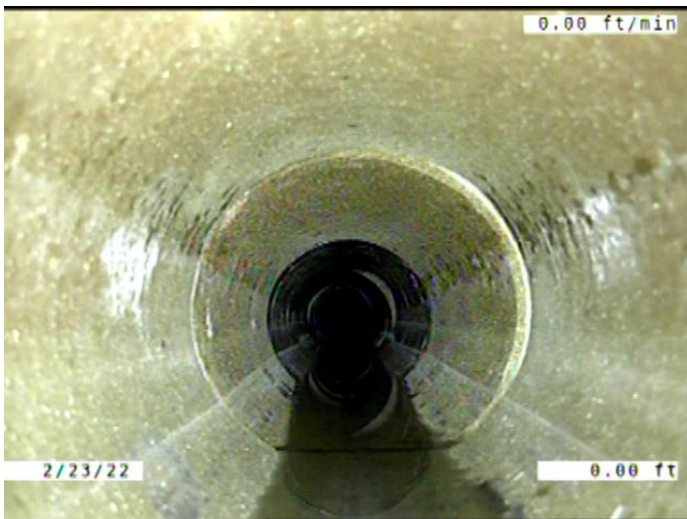
Code: **MWL**
Description: **Miscellaneous Water Level**

Distance (ft): **.0**
Structural Grade: **0**
O&M Grade: **0**
Clock Start/From:
Clock To:
1st Value:
2nd Value:
Value Percent: **5.000**
Continuous Index:
Within 8" of Joint: **NO**
Remarks:

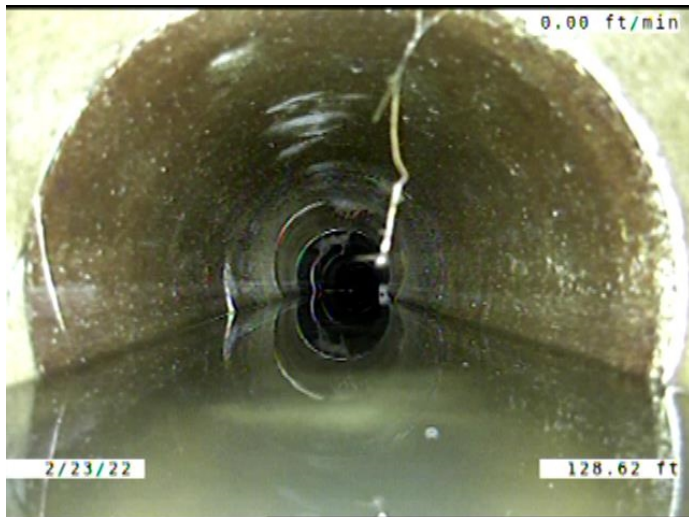
Code: **MWL**
 Description: **Miscellaneous Water Level**

Distance (ft): **128.6**
 Structural Grade: **0**
 O&M Grade: **0**
 Clock Start/From:
 Clock To:
 1st Value:
 2nd Value:
 Value Percent: **15.000**
 Continuous Index:
 Within 8" of Joint: **NO**
 Remarks:

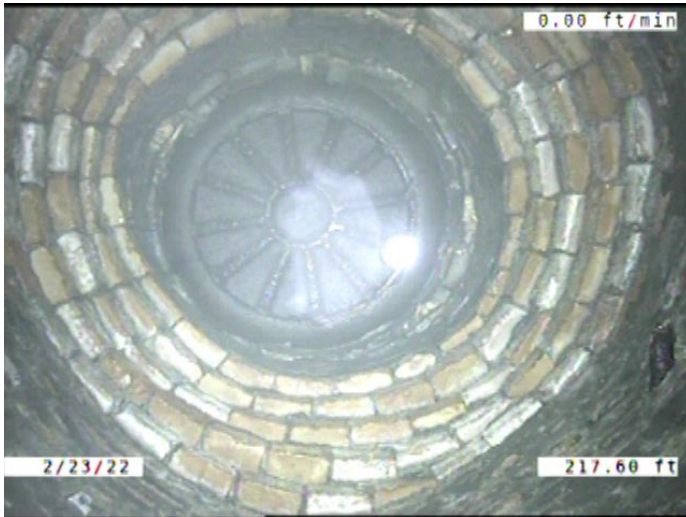
Code:	AMH
Description:	Manhole
Distance (ft):	217.6
Structural Grade:	0
O&M Grade:	0
Clock Start/From:	
Clock To:	
1st Value:	
2nd Value:	
Value Percent:	
Continuous Index:	
Within 8" of Joint:	NO
Remarks:	M-706-008.7
