Profile/Photo Observation Report

Date:	04/20/2018	Weather:		Coding:	PACP 6.0
Pipe Length (ft):	194.5	Owner:	NA	Pre Clean:	Not Known
P.O.#:		Surveyor:	Byrd Fitzgerald	PSR:	P-706-011.2-011.1
Customer:		Clean Date:	01/01/1900	Shape:	C

Street:	Capitol	Flow Control:	Not Controlled
City:	Hobart, IN	Year Renewed:	
Location:	Light Highway	Tape/Media #:	
Purpose:	Maintenance Related	Dia/Height:	12"
Use:	Sanitary	Material:	PVC
Drain Area:	NA	Lining:	Cured in Place
Category:	NA		
Comment:	unknown rollover at 120'. flow incorrect.

Location Details:		Direction of Survey:	Downstream
US MH:	M-706-011.1	DS MH:	M-706-011.2
		Total Length Surveyed (ft):	121.1

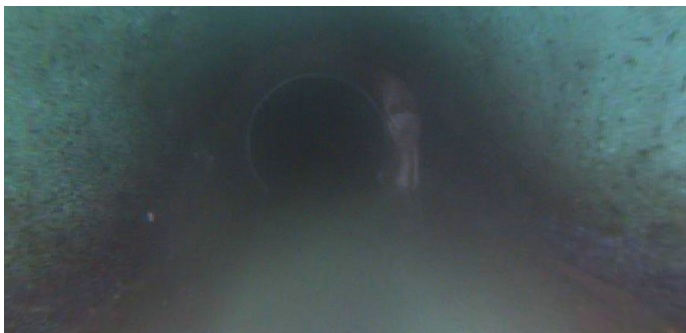
Code: **AMH**
Description: **Manhole**

Distance (ft): **.0**
Structural Grade: **0**
O&M Grade: **0**
Clock Start/From:
Clock To:
1st Value:
2nd Value:
Value Percent:
Continuous Index:
Within 8" of Joint: **NO**
Remarks: **M-706-011.1**

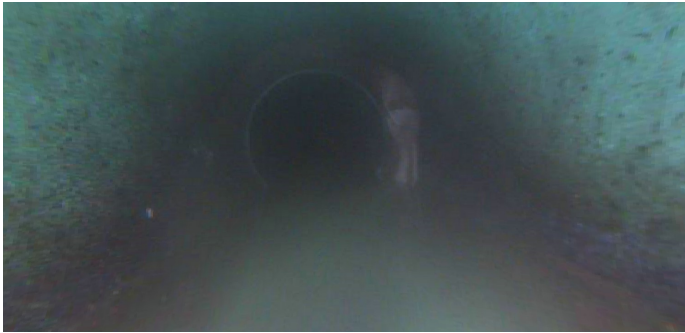
Code:	MWL
Description:	Water Level

Distance (ft):	.0
Structural Grade:	0
O&M Grade:	0
Clock Start/From:	
Clock To:	
1st Value:	
2nd Value:	
Value Percent:	5.000
Continuous Index:	
Within 8" of Joint:	NO
Remarks:

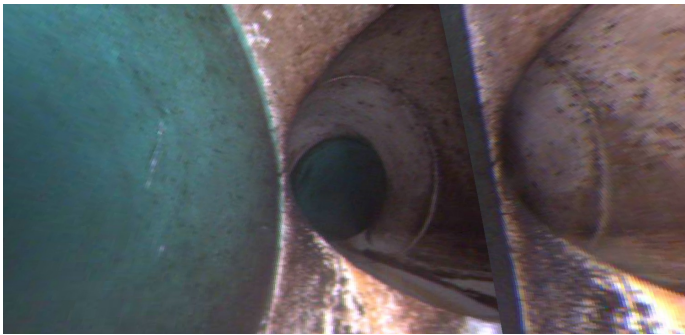
Code:	TF
Description:	Tap Factory

Distance (ft):	3.0
Structural Grade:	0
O&M Grade:	0
Clock Start/From:	2
Clock To:	
1st Value:	4.000
2nd Value:	
Value Percent:	
Continuous Index:	
Within 8" of Joint:	YES
Remarks:

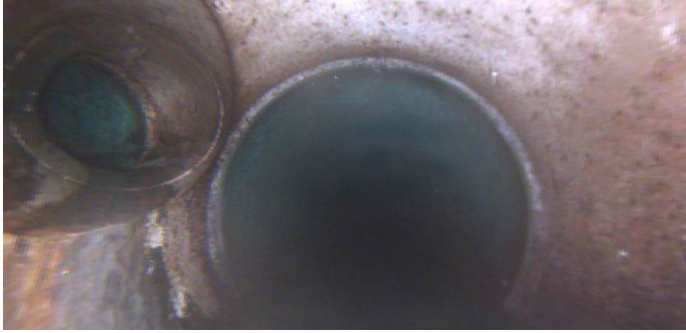
Code: **TF**
Description: **Tap Factory**

Distance (ft): **9.6**
Structural Grade: **0**
O&M Grade: **0**
Clock Start/From: **10**
Clock To:
1st Value: **4.000**
2nd Value:
Value Percent:
Continuous Index:
Within 8" of Joint: **YES**
Remarks:

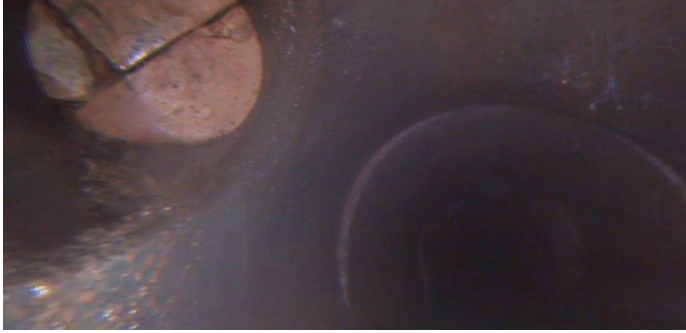
Code: **TFC**
Description: **Tap Factory Capped**

Distance (ft): **38.3**
Structural Grade: **0**
O&M Grade: **0**
Clock Start/From: **11**
Clock To:
1st Value: **4.000**
2nd Value:
Value Percent:
Continuous Index:
Within 8" of Joint: **YES**
Remarks:

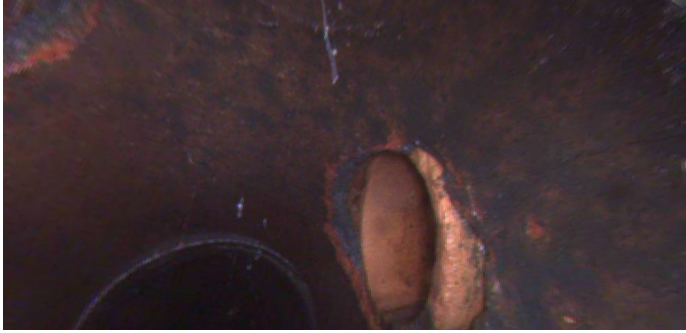
Code: **TB**
Description: **Tap Break-in**

Distance (ft): **59.4**
Structural Grade: **0**
O&M Grade: **0**
Clock Start/From: **10**
Clock To:
1st Value: **4.000**
2nd Value:
Value Percent:
Continuous Index:
Within 8" of Joint: **YES**
Remarks:

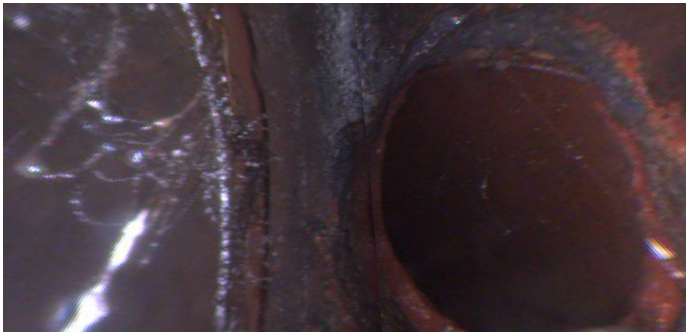
Code: **TB**
Description: **Tap Break-in**

Distance (ft): **59.4**
Structural Grade: **0**
O&M Grade: **0**
Clock Start/From: **2**
Clock To:
1st Value: **4.000**
2nd Value:
Value Percent:
Continuous Index:
Within 8" of Joint: **YES**
Remarks:

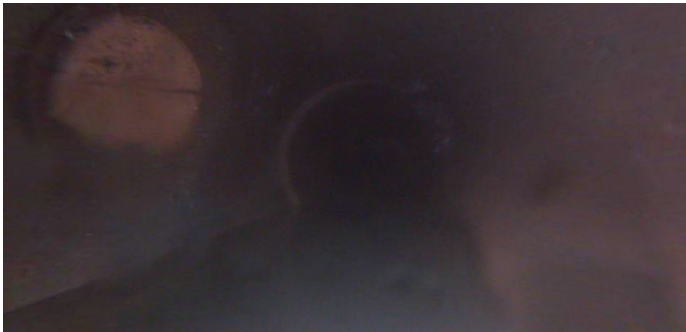
Code: **TF**
Description: **Tap Factory**

Distance (ft): **83.4**
Structural Grade: **0**
O&M Grade: **0**
Clock Start/From: **10**
Clock To:
1st Value: **4.000**
2nd Value:
Value Percent:
Continuous Index:
Within 8" of Joint: **YES**
Remarks:

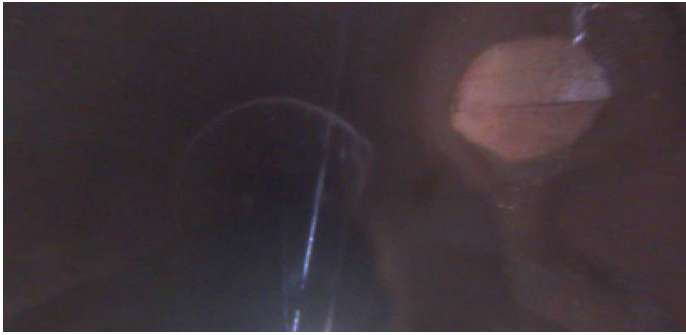
Code: **TFC**
Description: **Tap Factory Capped**

Distance (ft): **86.6**
Structural Grade: **0**
O&M Grade: **0**
Clock Start/From: **2**
Clock To:
1st Value: **4.000**
2nd Value:
Value Percent:
Continuous Index:
Within 8" of Joint: **YES**
Remarks:

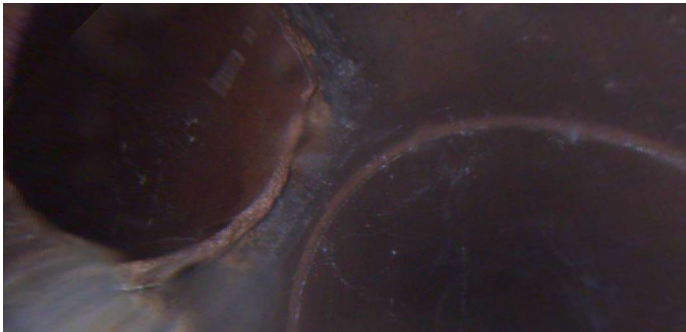
Code: **TB**
Description: **Tap Break-in**

Distance (ft): **92.6**
Structural Grade: **0**
O&M Grade: **0**
Clock Start/From: **11**
Clock To:
1st Value: **6.000**
2nd Value:
Value Percent:
Continuous Index:
Within 8" of Joint: **YES**
Remarks:

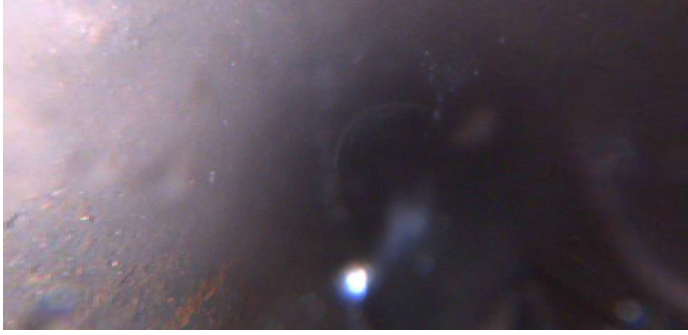
Code:	MSA
Description:	Abandoned Survey
Distance (ft):	121.1
Structural Grade:	0
O&M Grade:	0
Clock Start/From:	
Clock To:	
1st Value:	
2nd Value:	
Value Percent:	
Continuous Index:	
Within 8" of Joint:	NO
Remarks:	no blockage
