Profile/Photo Observation Report

Date:	02/26/2022	Weather:		Coding:	PACP 7.0
Pipe Length (ft):	373.0	Owner:	City of Hobart	Pre Clean:	Heavy Cleaning
P.O.#:	YES502259	Surveyor:	S. Bucklin	PSR:	P-806-024-018
Customer:	City of Hobart, IN (Red	Clean Date:	02/22/2022	Shape:	C

Street:	South Main Street	Flow Control:	Not Controlled
City:	Hobart, IN	Year Renewed:	
Location:	Local rural streets with light traffic, t	Tape/Media #:	
Purpose:	Routine Assessment	Dia/Height:	12"
Use:	Sanitary Sewage Pipe	Material:	VCP
Drain Area:		Lining:	None
Category:	NA		
Comment:			
Location Details:		Direction of Survey:	Downstream
US MH:	M-706-018	DS MH:	M-806-024
		Total Length Surveyed (ft):	368.5

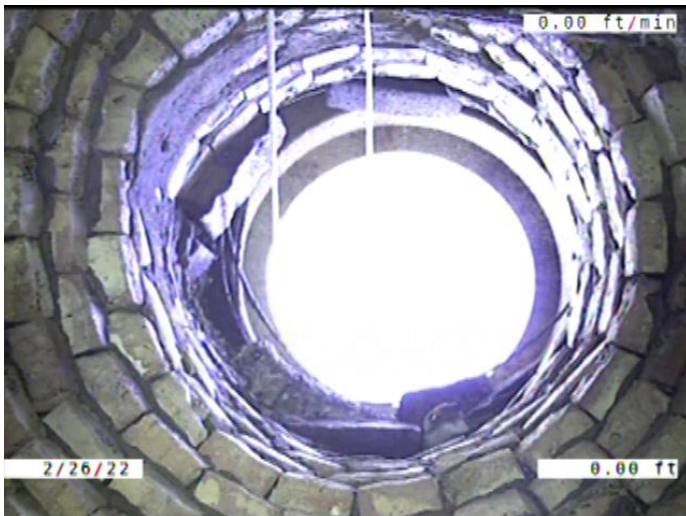
Code: **AMH**
Description: **Manhole**

Distance (ft): **.0**
Structural Grade: **0**
O&M Grade: **0**
Clock Start/From:
Clock To:
1st Value:
2nd Value:
Value Percent:
Continuous Index:
Within 8" of Joint: **NO**
Remarks: **M-706-018**

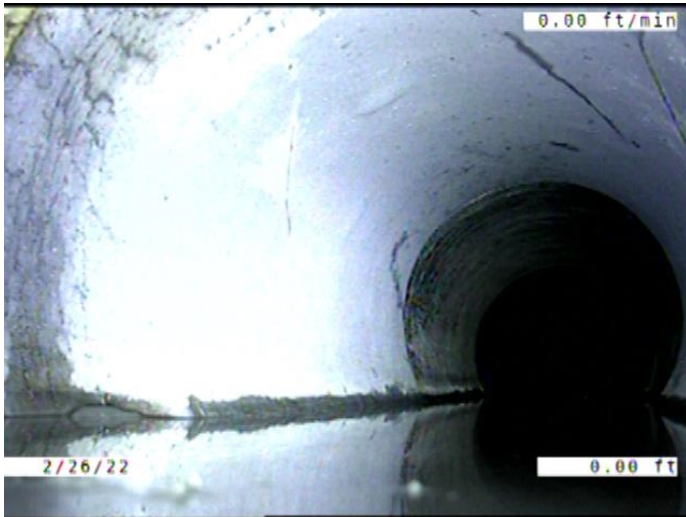
Code: **MWL**
Description: **Miscellaneous Water Level**

Distance (ft): **.0**
Structural Grade: **0**
O&M Grade: **0**
Clock Start/From:
Clock To:
1st Value:
2nd Value:
Value Percent: **10.000**
Continuous Index:
Within 8" of Joint: **NO**
Remarks:

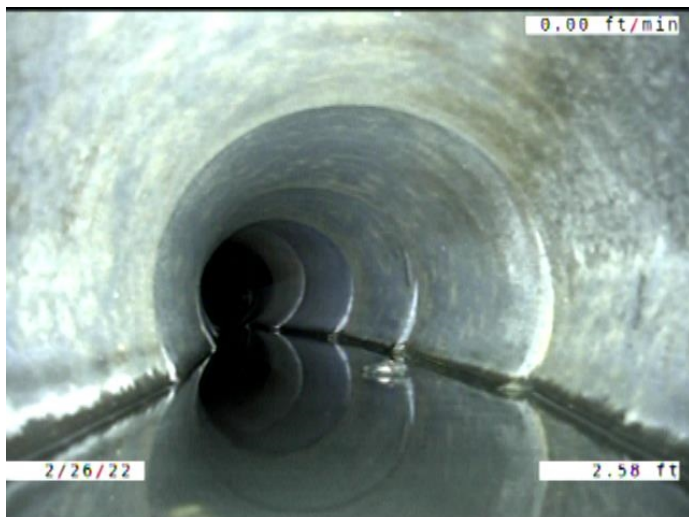
Code: **LL**
Description: **Line Left**

Distance (ft): **2.6**
Structural Grade: **0**
O&M Grade: **2**
Clock Start/From:
Clock To:
1st Value:
2nd Value:
Value Percent: **15.000**
Continuous Index: **S02**
Within 8" of Joint: **NO**
Remarks:

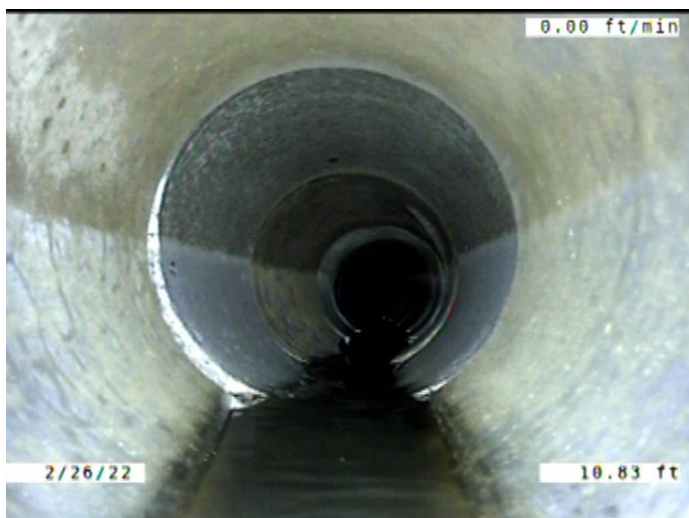
Code: **LL**
Description: **Line Left**

Distance (ft): **10.8**
Structural Grade: **0**
O&M Grade: **2**
Clock Start/From:
Clock To:
1st Value:
2nd Value:
Value Percent: **15.000**
Continuous Index: **F02**
Within 8" of Joint: **NO**
Remarks:

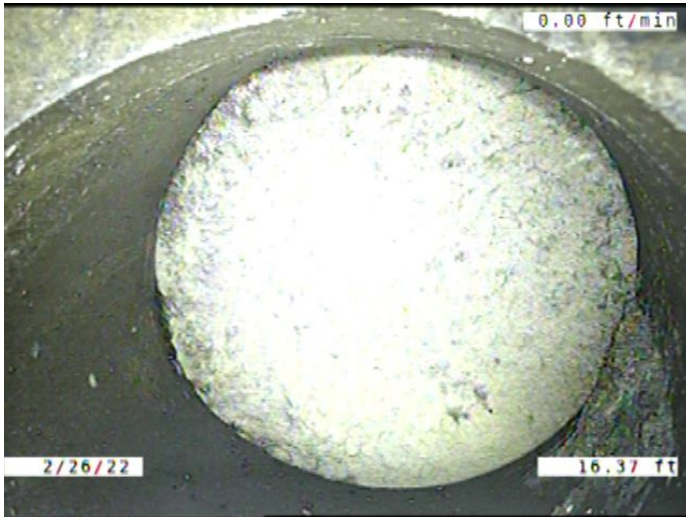
Code: **TFC**
 Description: **Tap Factory Capped**

Distance (ft): **16.4**
 Structural Grade: **0**
 O&M Grade: **0**
 Clock Start/From: **2**
 Clock To:
 1st Value: **6.000**
 2nd Value:
 Value Percent:
 Continuous Index:
 Within 8" of Joint: **YES**
 Remarks:

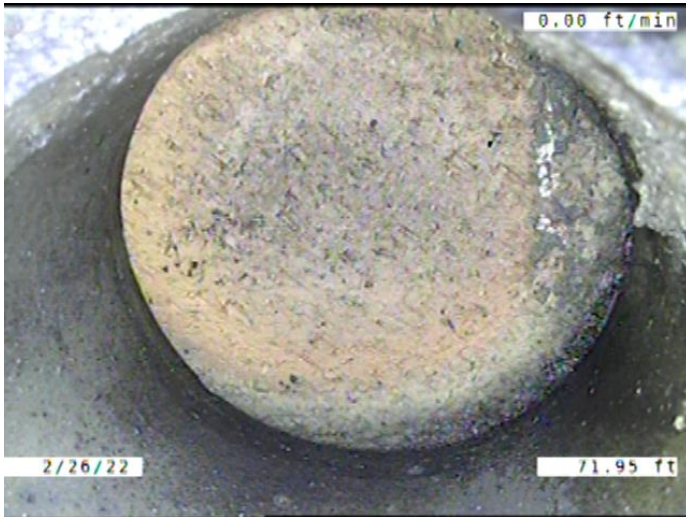
Code: **TFC**
 Description: **Tap Factory Capped**

Distance (ft): **71.9**
 Structural Grade: **0**
 O&M Grade: **0**
 Clock Start/From: **3**
 Clock To:
 1st Value: **6.000**
 2nd Value:
 Value Percent:
 Continuous Index:
 Within 8" of Joint: **YES**
 Remarks:

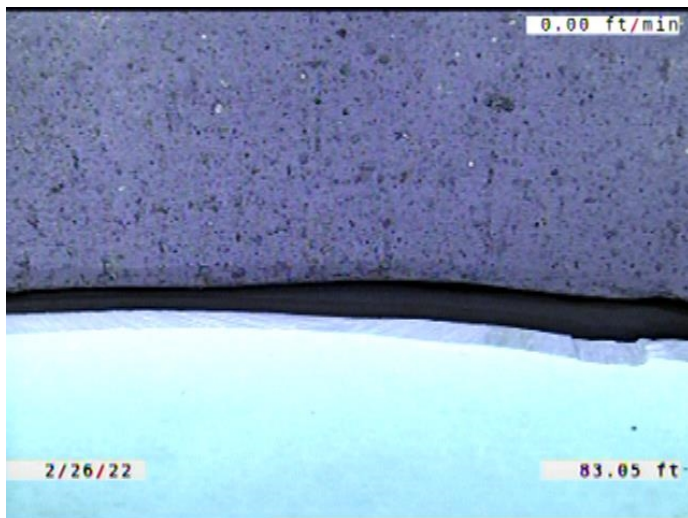
Code: **MMC**
Description: **Miscellaneous Material Change**

Distance (ft): **83.1**
Structural Grade: **0**
O&M Grade: **0**
Clock Start/From:
Clock To:
1st Value:
2nd Value:
Value Percent:
Continuous Index:
Within 8" of Joint: **NO**
Remarks: **VCP TO PVC**

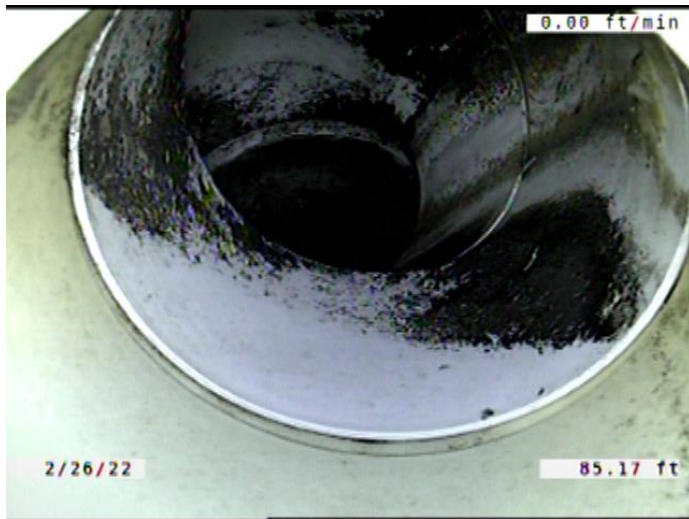
Code: **TF**
Description: **Tap Factory**

Distance (ft): **85.2**
Structural Grade: **0**
O&M Grade: **0**
Clock Start/From: **3**
Clock To:
1st Value: **6.000**
2nd Value:
Value Percent:
Continuous Index:
Within 8" of Joint: **YES**
Remarks:

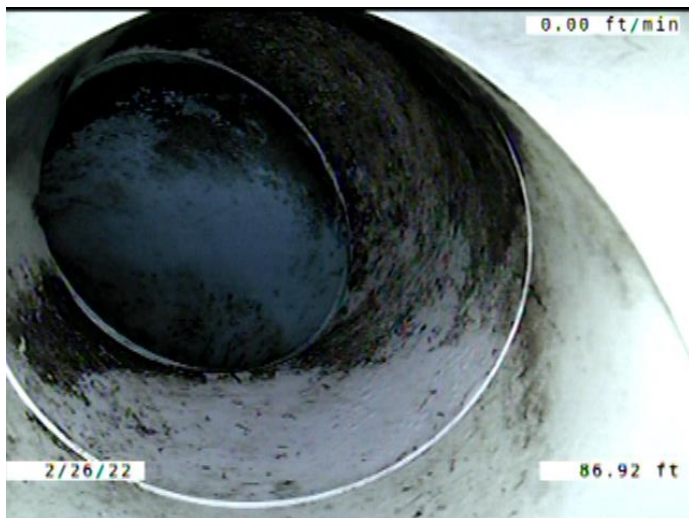
Code: **TF**
Description: **Tap Factory**

Distance (ft): **86.9**
Structural Grade: **0**
O&M Grade: **0**
Clock Start/From: **11**
Clock To:
1st Value: **6.000**
2nd Value:
Value Percent:
Continuous Index:
Within 8" of Joint: **YES**
Remarks:

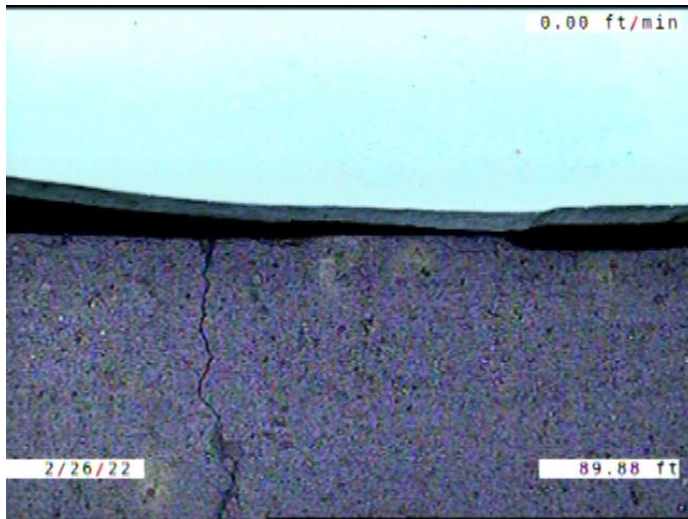
Code: **MMC**
 Description: **Miscellaneous Material Change**

Distance (ft): **89.9**
 Structural Grade: **0**
 O&M Grade: **0**
 Clock Start/From:
 Clock To:
 1st Value:
 2nd Value:
 Value Percent:
 Continuous Index:
 Within 8" of Joint: **NO**
 Remarks: **PVC TO VCP**

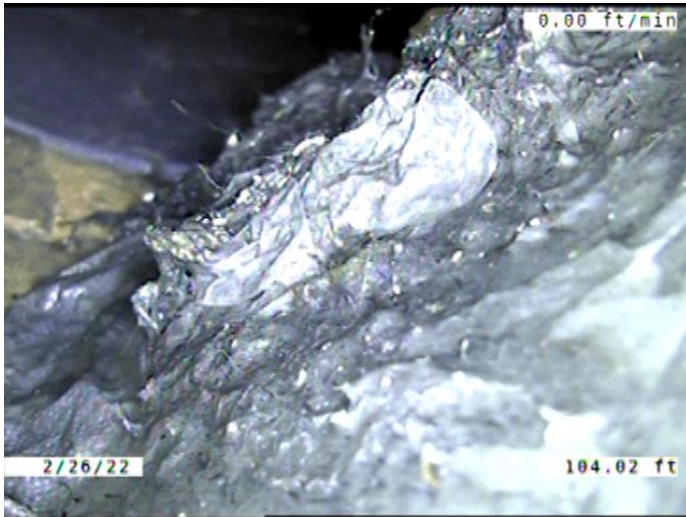
Code: **OBZ**
 Description: **Obstruction Other**

Distance (ft): **104.0**
 Structural Grade: **0**
 O&M Grade: **2**
 Clock Start/From: **4**
 Clock To: **8**
 1st Value:
 2nd Value:
 Value Percent: **5.000**
 Continuous Index:
 Within 8" of Joint: **YES**
 Remarks: **ROOTS THAT HAVE BEEN CUT. RAGS AND TP**

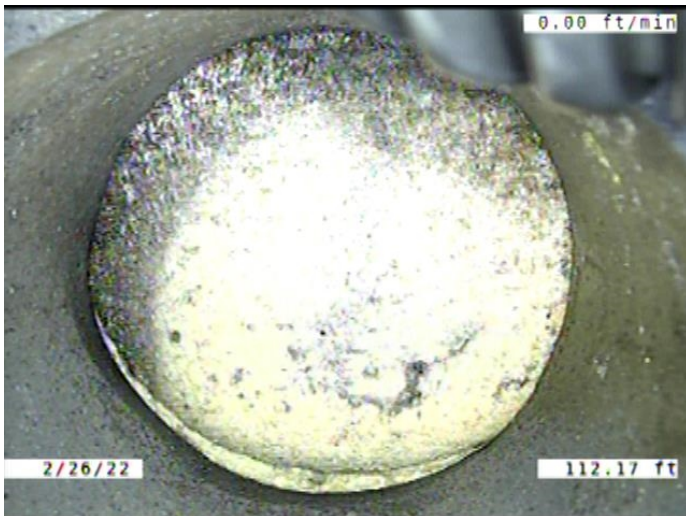
Code: **TFC**
 Description: **Tap Factory Capped**

Distance (ft): **112.2**
 Structural Grade: **0**
 O&M Grade: **0**
 Clock Start/From: **2**
 Clock To:
 1st Value: **6.000**
 2nd Value:
 Value Percent:
 Continuous Index:
 Within 8" of Joint: **YES**
 Remarks:

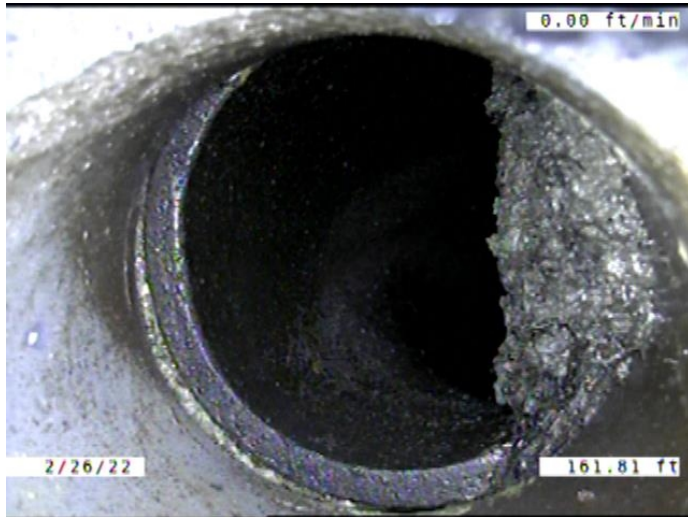
Code: **TF**
 Description: **Tap Factory**

Distance (ft): **161.8**
 Structural Grade: **0**
 O&M Grade: **0**
 Clock Start/From: **2**
 Clock To:
 1st Value: **6.000**
 2nd Value:
 Value Percent:
 Continuous Index:
 Within 8" of Joint: **YES**
 Remarks:

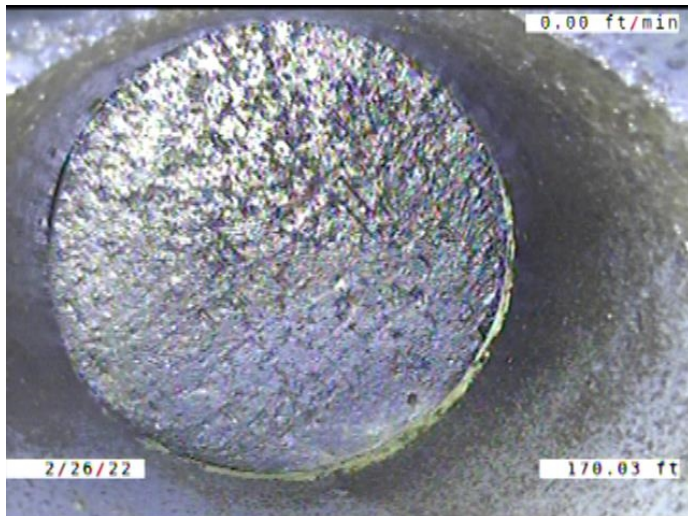
Code: **TFC**
 Description: **Tap Factory Capped**

Distance (ft): **170.0**
 Structural Grade: **0**
 O&M Grade: **0**
 Clock Start/From: **10**
 Clock To:
 1st Value: **6.000**
 2nd Value:
 Value Percent:
 Continuous Index:
 Within 8" of Joint: **YES**
 Remarks:

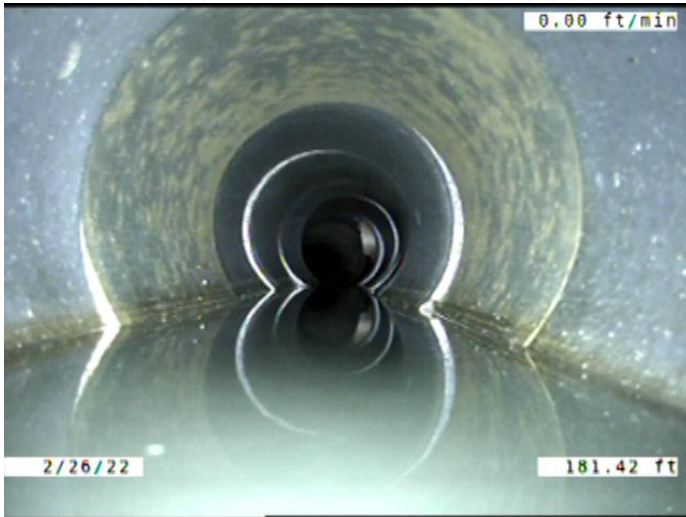
Code: **MWLS**
 Description: **Miscellaneous Water Level Sag**

Distance (ft): **181.4**
 Structural Grade: **2**
 O&M Grade: **0**
 Clock Start/From:
 Clock To:
 1st Value:
 2nd Value:
 Value Percent: **15.000**
 Continuous Index:
 Within 8" of Joint: **NO**
 Remarks:

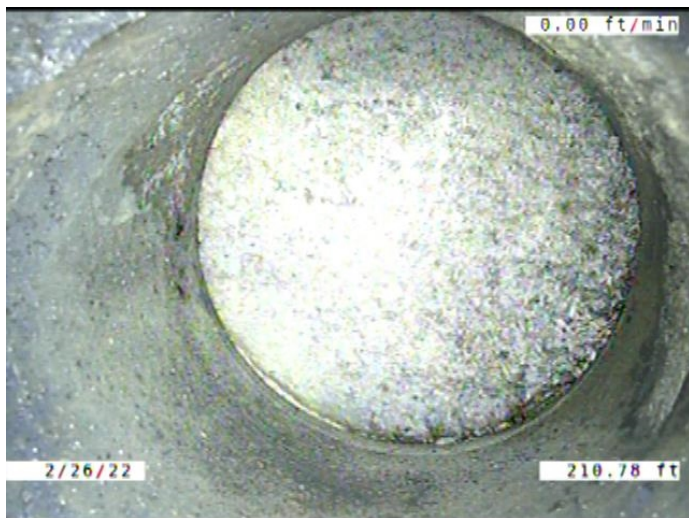
Code: **TFC**
Description: **Tap Factory Capped**

Distance (ft): **210.8**
Structural Grade: **0**
O&M Grade: **0**
Clock Start/From: **2**
Clock To:
1st Value: **6.000**
2nd Value:
Value Percent:
Continuous Index:
Within 8" of Joint: **YES**
Remarks:

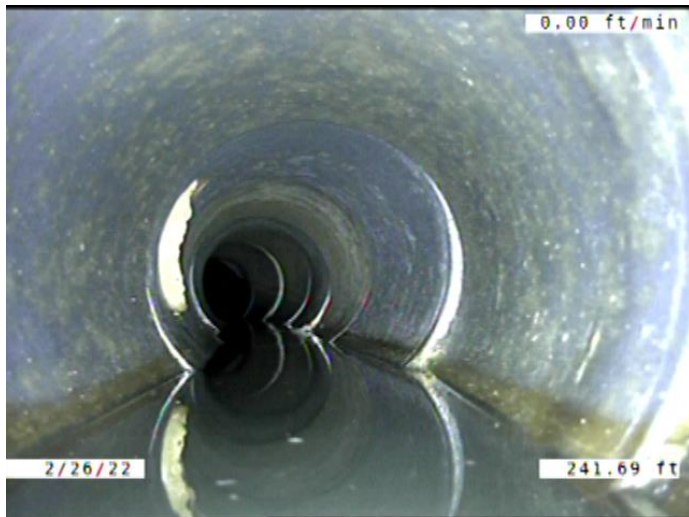
Code: **LL**
 Description: **Line Left**

Distance (ft): **241.7**
 Structural Grade: **0**
 O&M Grade: **2**
 Clock Start/From:
 Clock To:
 1st Value:
 2nd Value:
 Value Percent: **15.000**
 Continuous Index:
 Within 8" of Joint: **NO**
 Remarks:

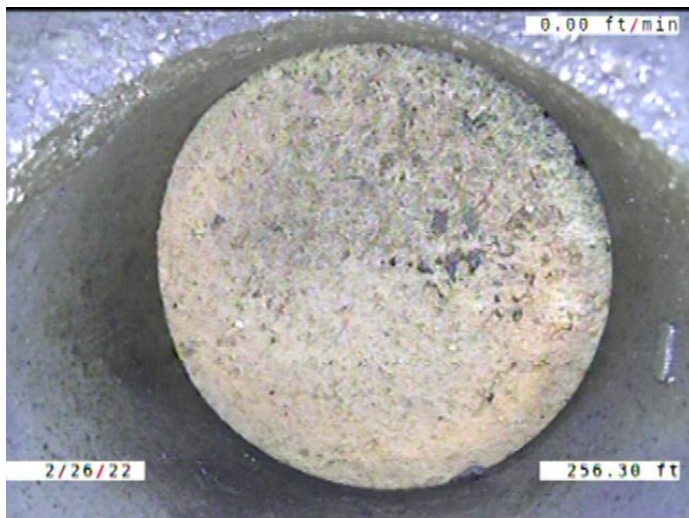
Code: **TBC**
 Description: **Tap Break-in Capped**

Distance (ft): **256.3**
 Structural Grade: **0**
 O&M Grade: **0**
 Clock Start/From: **2**
 Clock To:
 1st Value: **6.000**
 2nd Value:
 Value Percent:
 Continuous Index:
 Within 8" of Joint: **YES**
 Remarks:

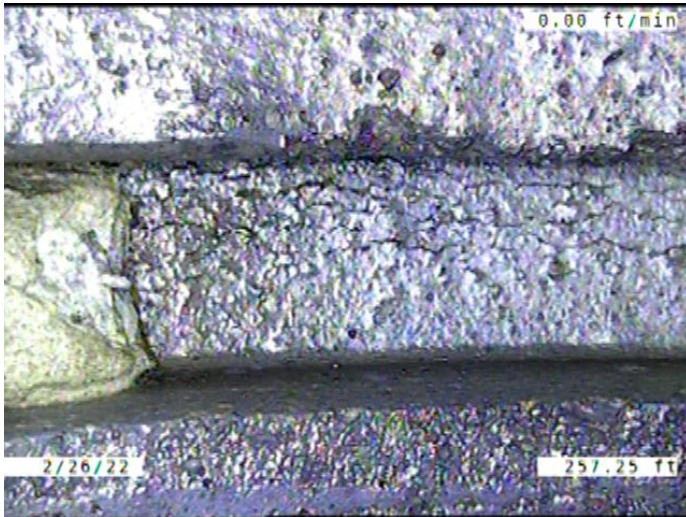
Code: **JAM**
 Description: **Joint Angular Medium**

Distance (ft): **257.3**
 Structural Grade: **3**
 O&M Grade: **0**
 Clock Start/From:
 Clock To:
 1st Value:
 2nd Value:
 Value Percent:
 Continuous Index:
 Within 8" of Joint: **NO**
 Remarks:

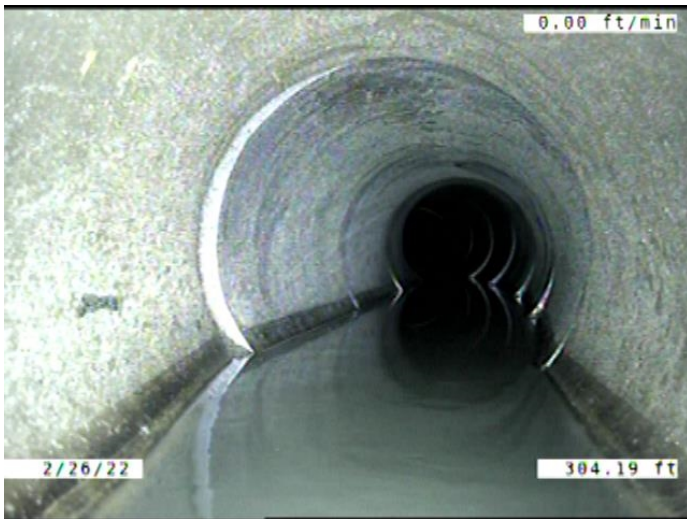
Code: **LR**
 Description: **Line Right**

Distance (ft): **304.2**
 Structural Grade: **0**
 O&M Grade: **1**
 Clock Start/From:
 Clock To:
 1st Value:
 2nd Value:
 Value Percent: **10.000**
 Continuous Index:
 Within 8" of Joint: **NO**
 Remarks:

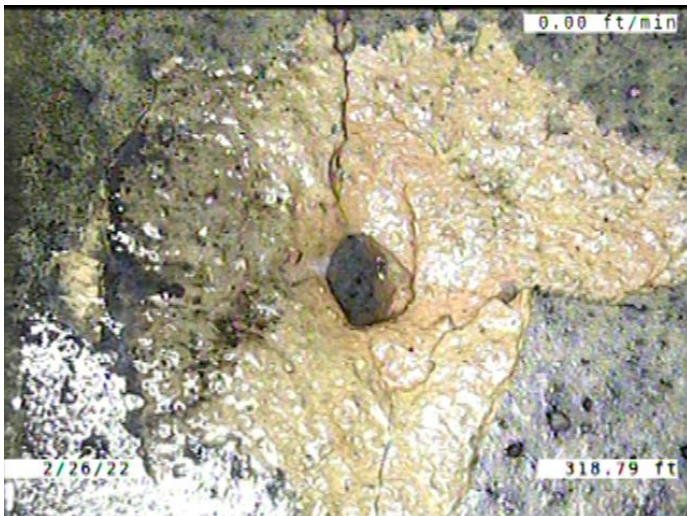
Code: **H**
 Description: **Hole**

Distance (ft): **318.8**
 Structural Grade: **5**
 O&M Grade: **0**
 Clock Start/From: **4**
 Clock To: **5**

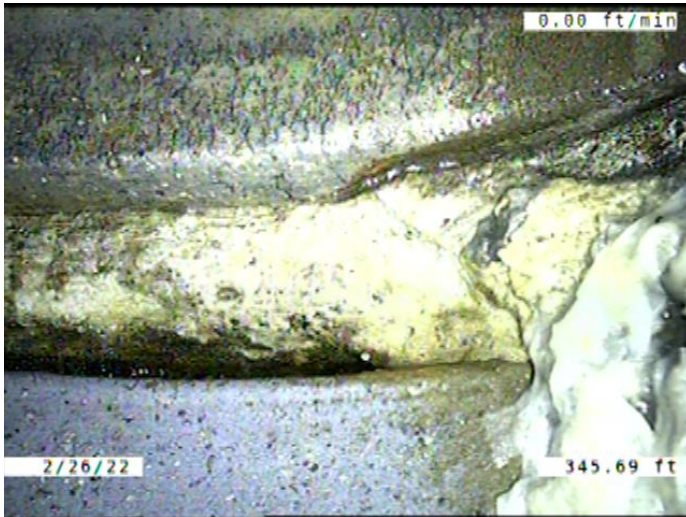
Code: **ISGT**
 Description: **Intruding Sealing Material Grout**

Distance (ft): **345.7**
 Structural Grade: **0**
 O&M Grade: **2**
 Clock Start/From: **8**
 Clock To: **9**
 1st Value:
 2nd Value:
 Value Percent: **5.000**
 Continuous Index:
 Within 8" of Joint: **NO**
 Remarks:

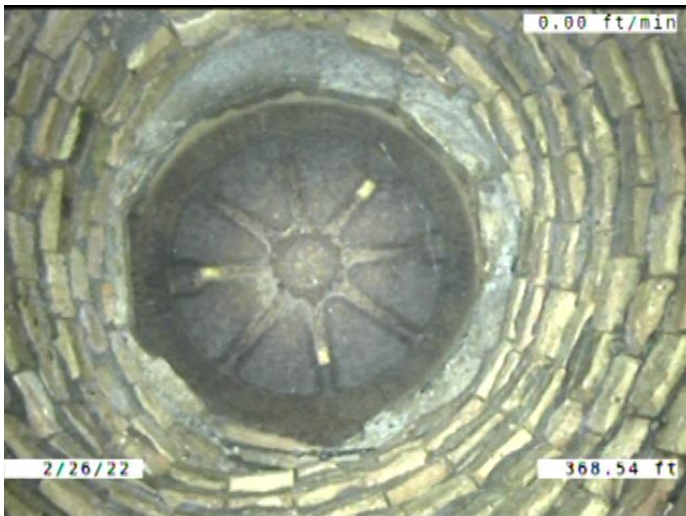
Code: **AMH**
 Description: **Manhole**

Distance (ft): **368.5**
 Structural Grade: **0**
 O&M Grade: **0**
 Clock Start/From:
 Clock To:
 1st Value:
 2nd Value:
 Value Percent:
 Continuous Index:
 Within 8" of Joint: **NO**
 Remarks: **M-806-024**
