Profile/Photo Observation Report

Date:	02/26/2022	Weather:		Coding:	PACP 7.0
Pipe Length (ft):	258.0	Owner:	City of Hobart	Pre Clean:	Heavy Cleaning
P.O.#:	YES502259	Surveyor:	S. Bucklin	PSR:	P-706-018-019
Customer:	City of Hobart, IN (Red	Clean Date:	02/24/2022	Shape:	C

Street:	South Main Street	Flow Control:	Not Controlled
City:	Hobart, IN	Year Renewed:	
Location:	Local rural streets with light traffic, t	Tape/Media #:	
Purpose:	Routine Assessment	Dia/Height:	12"
Use:	Sanitary Sewage Pipe	Material:	VCP
Drain Area:		Lining:	None
Category:	NA		
Comment:			
Location Details:		Direction of Survey:	Downstream
US MH:	M-706-019	DS MH:	M-706-018
		Total Length Surveyed (ft):	259.0

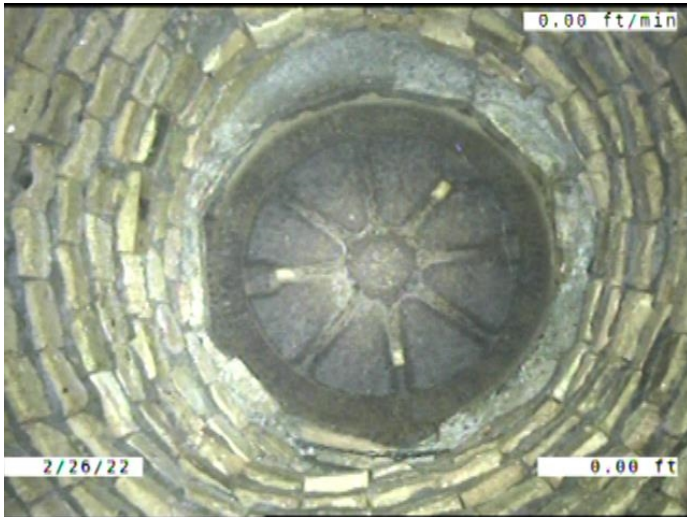
Code: **AMH**
 Description: **Manhole**

Distance (ft): **.0**
 Structural Grade: **0**
 O&M Grade: **0**
 Clock Start/From:
 Clock To:
 1st Value:
 2nd Value:
 Value Percent:
 Continuous Index:
 Within 8" of Joint: **NO**
 Remarks: **M-706-019**

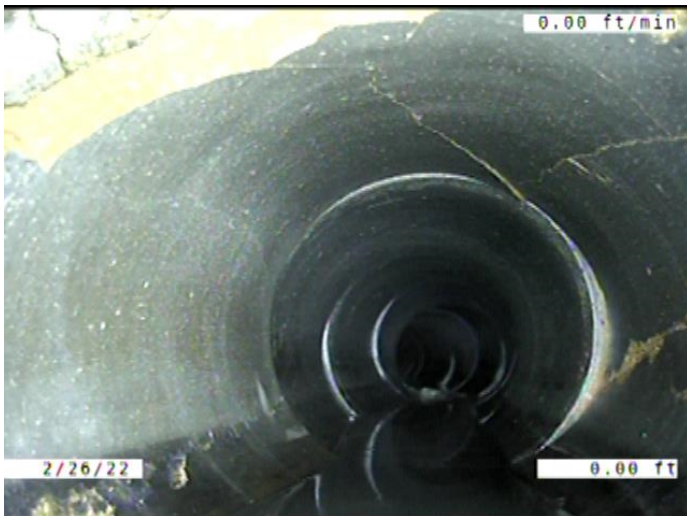
Code: **MWL**
 Description: **Miscellaneous Water Level**

Distance (ft): **.0**
 Structural Grade: **0**
 O&M Grade: **0**
 Clock Start/From:
 Clock To:
 1st Value:
 2nd Value:
 Value Percent: **5.000**
 Continuous Index:
 Within 8" of Joint: **NO**
 Remarks:

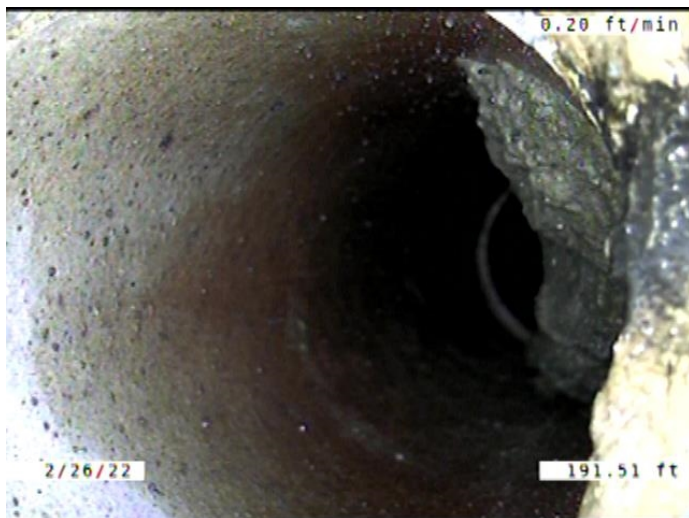
Code:	SSS
Description:	Surface Damage Surface Spalling
Distance (ft):	191.2
Structural Grade:	2
O&M Grade:	0
Clock Start/From:	1
Clock To:	3
1st Value:	
2nd Value:	
Value Percent:	
Continuous Index:	
Within 8" of Joint:	YES
Remarks:

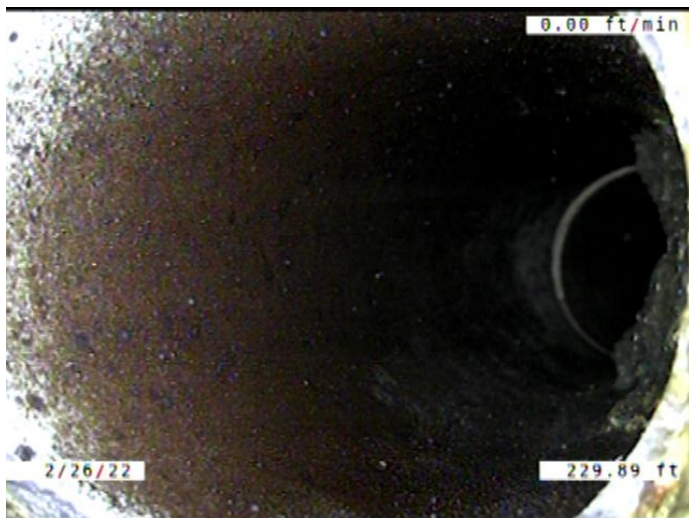
Code: **SSS**
 Description: **Surface Damage Surface Spalling**

Distance (ft): **229.7**
 Structural Grade: **2**
 O&M Grade: **0**
 Clock Start/From: **1**
 Clock To: **3**
 1st Value:
 2nd Value:
 Value Percent:
 Continuous Index:
 Within 8" of Joint: **NO**
 Remarks:
