# Profile/Photo Observation Report

Date:	<b>03/09/2022</b>	Weather:		Coding:	<b>PACP 7.0</b>
Pipe Length (ft):	<b>177.0</b>	Owner:	<b>City of Hobart</b>	Pre Clean:	<b>Heavy Cleaning</b>
P.O.#:	<b>YES502259</b>	Surveyor:	<b>S. Bucklin</b>	PSR:	<b>P-706-033-032</b>
Customer:	<b>City of Hobart, IN (Red</b>	Clean Date:	<b>03/04/2022</b>	Shape:	<b>C</b>

Street:	<b>South Lake Street</b>	Flow Control:	<b>Not Controlled</b>
City:	<b>Hobart, IN</b>	Year Renewed:	
Location:	<b>Local rural streets with light traffic, t</b>	Tape/Media #:	
Purpose:	<b>Routine Assessment</b>	Dia/Height:	<b>10"</b>
Use:	<b>Sanitary Sewage Pipe</b>	Material:	<b>VCP</b>
Drain Area:		Lining:	<b>None</b>
Category:	<b>NA</b>		
Comment:			
Location Details:		Direction of Survey:	<b>Downstream</b>
US MH:	<b>M-706-032</b>	DS MH:	<b>M-706-033</b>
		Total Length Surveyed (ft):	<b>175.4</b>

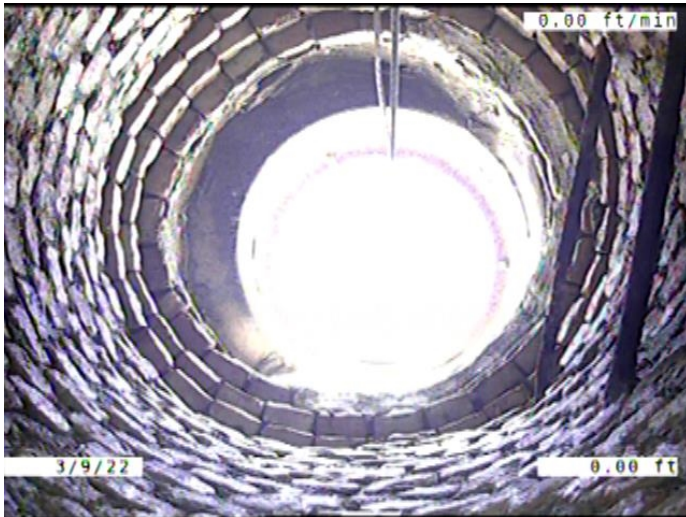
Code: **AMH**  
Description: **Manhole**

Distance (ft): **.0**  
Structural Grade: **0**  
O&M Grade: **0**  
Clock Start/From:  
Clock To:  
1st Value:  
2nd Value:  
Value Percent:  
Continuous Index:  
Within 8" of Joint: **NO**  
Remarks: **M-706-032**

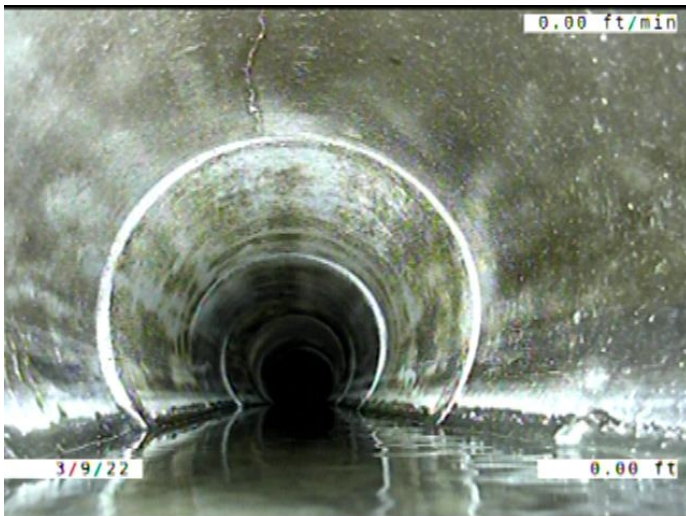
Code: **MWL**  
Description: **Miscellaneous Water Level**

Distance (ft): **.0**  
Structural Grade: **0**  
O&M Grade: **0**  
Clock Start/From:  
Clock To:  
1st Value:  
2nd Value:  
Value Percent: **5.000**  
Continuous Index:  
Within 8" of Joint: **NO**  
Remarks:

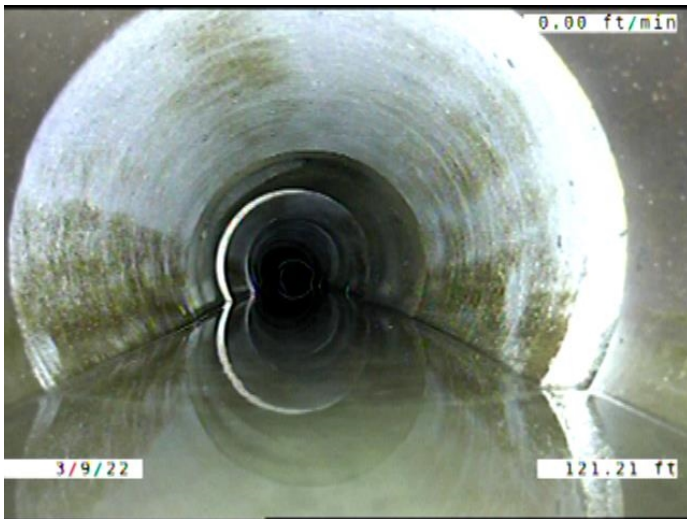
Code: **MWL**  
 Description: **Miscellaneous Water Level**

Distance (ft): **121.2**  
 Structural Grade: **0**  
 O&M Grade: **0**  
 Clock Start/From:  
 Clock To:  
 1st Value:  
 2nd Value:  
 Value Percent: **15.000**  
 Continuous Index:  
 Within 8" of Joint: **NO**  
 Remarks:

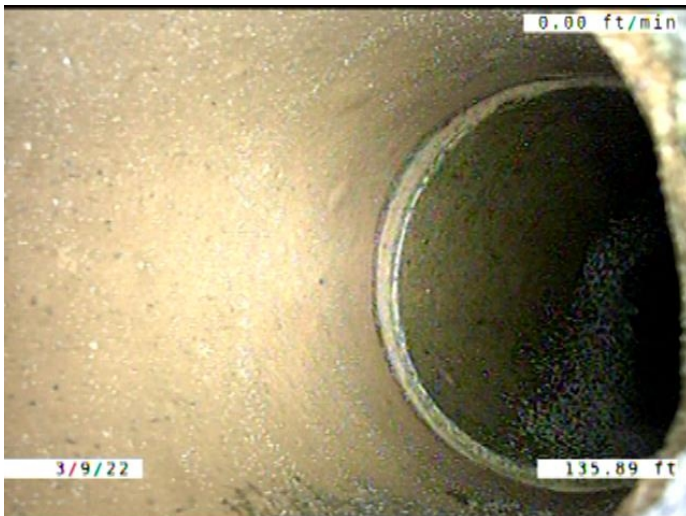
Code: **TB**  
 Description: **Tap Break-in/Hammer**

Distance (ft): **135.9**  
 Structural Grade: **0**  
 O&M Grade: **0**  
 Clock Start/From: **1**  
 Clock To:  
 1st Value: **6.000**  
 2nd Value:  
 Value Percent:  
 Continuous Index:  
 Within 8" of Joint: **YES**  
 Remarks:

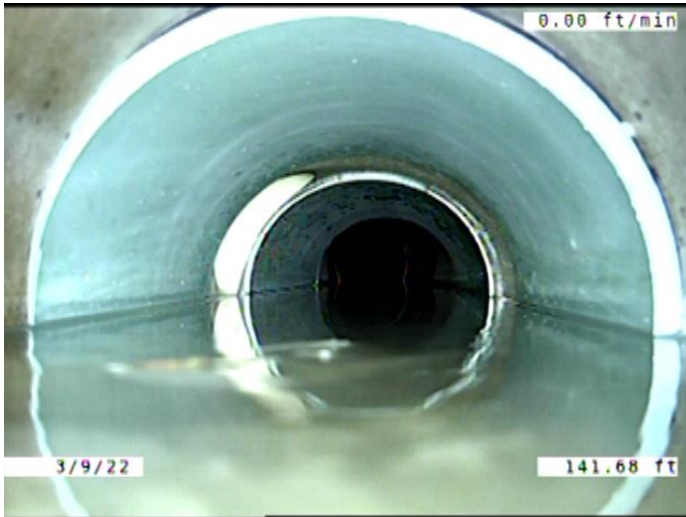
Code: **MWL**  
Description: **Miscellaneous Water Level**

Distance (ft): **141.7**  
Structural Grade: **0**  
O&M Grade: **0**  
Clock Start/From:  
Clock To:  
1st Value:  
2nd Value:  
Value Percent: **35.000**  
Continuous Index:  
Within 8" of Joint: **NO**  
Remarks:

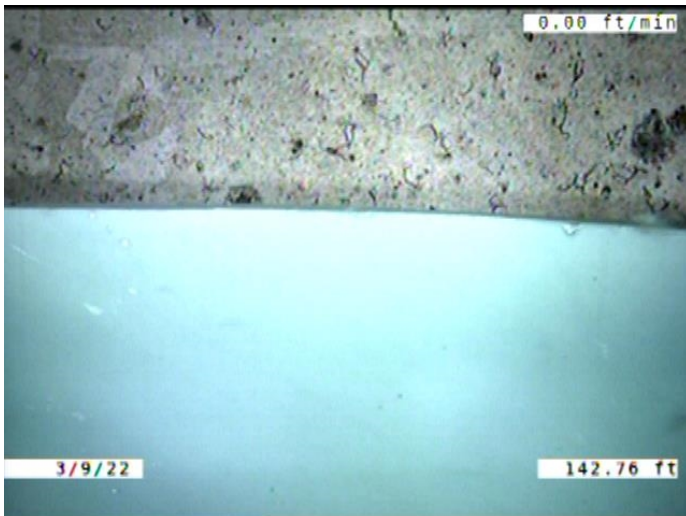
Code: **MMC**  
Description: **Miscellaneous Material Change**

Distance (ft): **142.8**  
Structural Grade: **0**  
O&M Grade: **0**  
Clock Start/From:  
Clock To:  
1st Value:  
2nd Value:  
Value Percent:  
Continuous Index:  
Within 8" of Joint: **NO**  
Remarks: **VCP TO PVC**

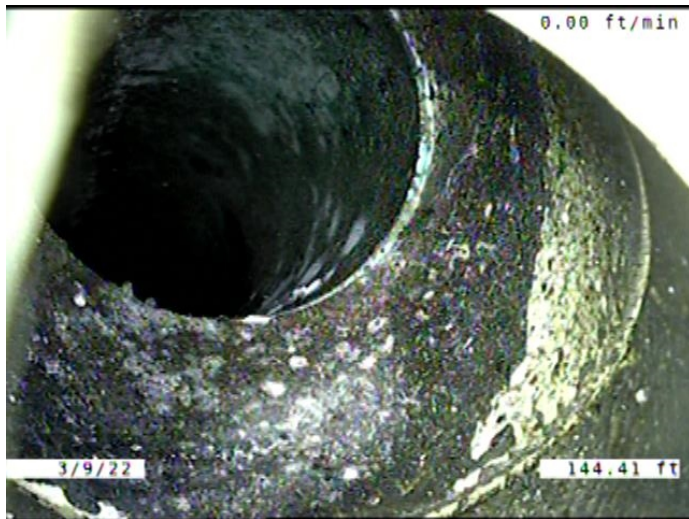
Code: **TF**  
Description: **Tap Factory**

Distance (ft): **144.4**  
Structural Grade: **0**  
O&M Grade: **0**  
Clock Start/From: **10**  
Clock To:  
1st Value: **6.000**  
2nd Value:  
Value Percent:  
Continuous Index:  
Within 8" of Joint: **YES**  
Remarks:

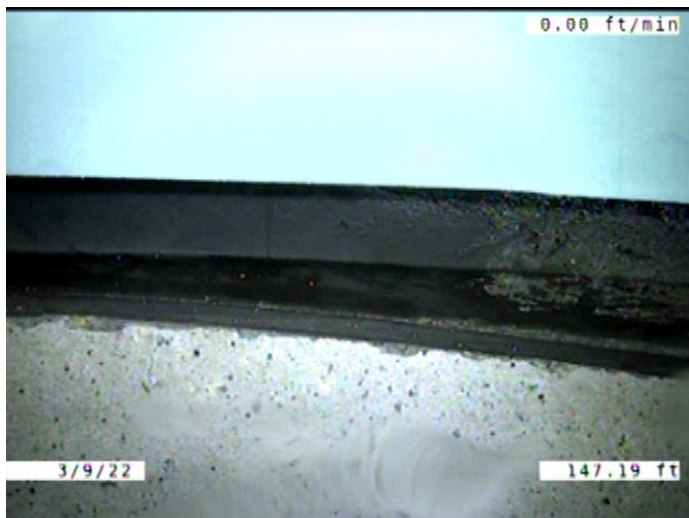
Code: **MMC**  
Description: **Miscellaneous Material Change**

Distance (ft): **147.2**  
Structural Grade: **0**  
O&M Grade: **0**  
Clock Start/From:  
Clock To:  
1st Value:  
2nd Value:  
Value Percent:  
Continuous Index:  
Within 8" of Joint: **NO**  
Remarks: **PVC TO VCP**

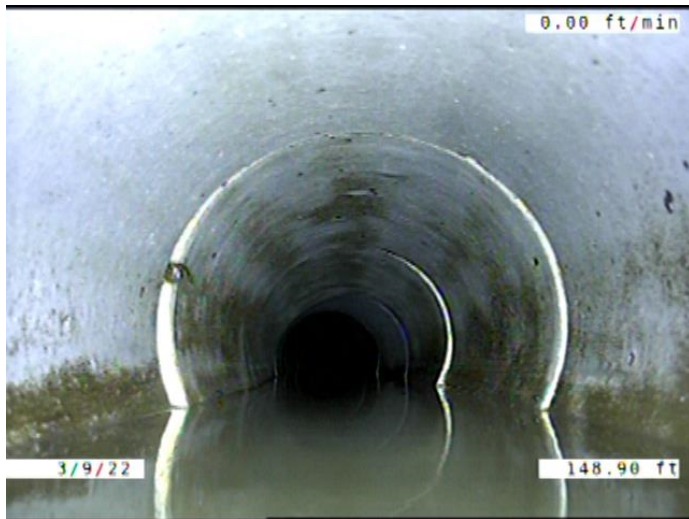
Code: **MWL**  
 Description: **Miscellaneous Water Level**

Distance (ft): **148.9**  
 Structural Grade: **0**  
 O&M Grade: **0**  
 Clock Start/From:  
 Clock To:  
 1st Value:  
 2nd Value:  
 Value Percent: **15.000**  
 Continuous Index:  
 Within 8" of Joint: **NO**  
 Remarks:

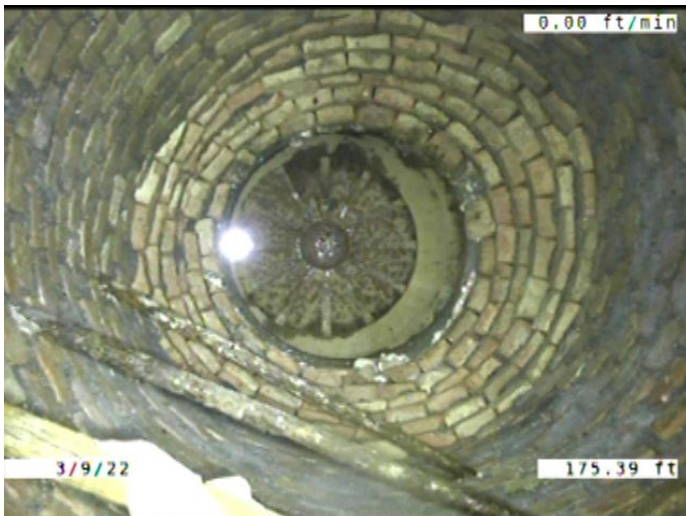
Code: **AMH**  
 Description: **Manhole**

Distance (ft): **175.4**  
 Structural Grade: **0**  
 O&M Grade: **0**  
 Clock Start/From:  
 Clock To:  
 1st Value:  
 2nd Value:  
 Value Percent:  
 Continuous Index:  
 Within 8" of Joint: **NO**  
 Remarks: **M-706-033**
