Profile/Photo Observation Report

Date:	03/08/2022	Weather:		Coding:	PACP 7.0
Pipe Length (ft):	168.0	Owner:	City of Hobart	Pre Clean:	Heavy Cleaning
P.O.#:	YES502259	Surveyor:	S. Bucklin	PSR:	P-706-034-033
Customer:	City of Hobart, IN (Red	Clean Date:	03/04/2022	Shape:	C

Street:	South Lake Street	Flow Control:	Not Controlled
City:	Hobart, IN	Year Renewed:	
Location:	Local rural streets with light traffic, t	Tape/Media #:	
Purpose:	Routine Assessment	Dia/Height:	10"
Use:	Sanitary Sewage Pipe	Material:	VCP
Drain Area:		Lining:	None
Category:	NA		
Comment:			
Location Details:		Direction of Survey:	Downstream
US MH:	M-706-033	DS MH:	M-706-034
		Total Length Surveyed (ft):	157.1

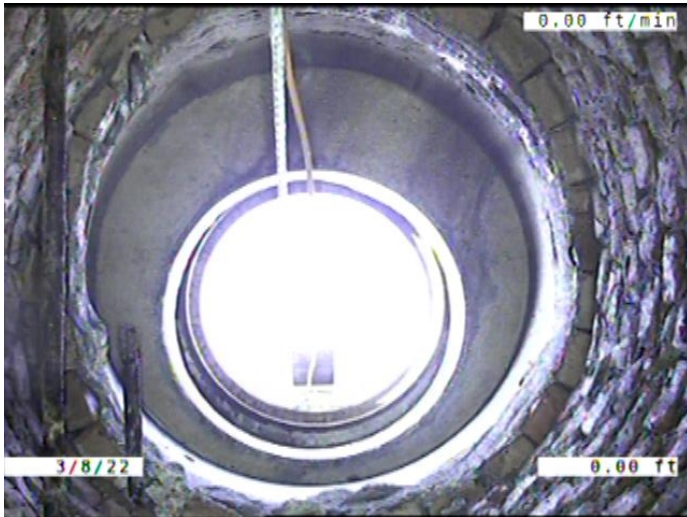
Code: **AMH**
 Description: **Manhole**

Distance (ft): **.0**
 Structural Grade: **0**
 O&M Grade: **0**
 Clock Start/From:
 Clock To:
 1st Value:
 2nd Value:
 Value Percent:
 Continuous Index:
 Within 8" of Joint: **NO**
 Remarks: **M-706-033**

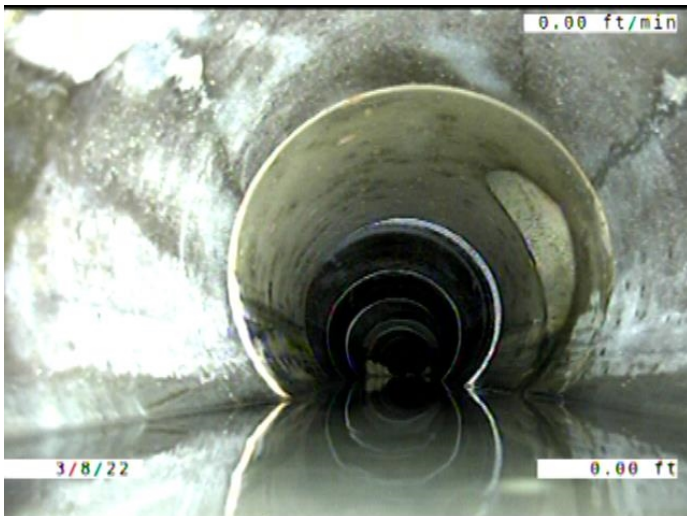
Code: **MWL**
 Description: **Miscellaneous Water Level**

Distance (ft): **.0**
 Structural Grade: **0**
 O&M Grade: **0**
 Clock Start/From:
 Clock To:
 1st Value:
 2nd Value:
 Value Percent: **10.000**
 Continuous Index:
 Within 8" of Joint: **NO**
 Remarks:

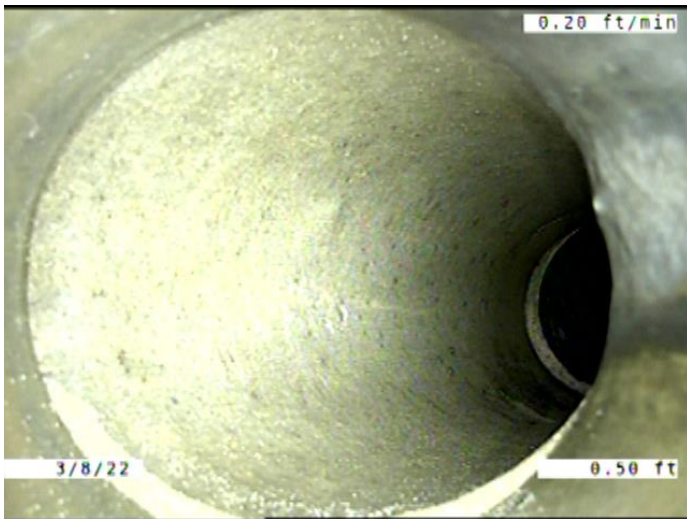
Code: **TF**
Description: **Tap Factory**

Distance (ft): **.5**
Structural Grade: **0**
O&M Grade: **0**
Clock Start/From: **2**
Clock To:
1st Value: **6.000**
2nd Value:
Value Percent:
Continuous Index:
Within 8" of Joint: **YES**
Remarks:

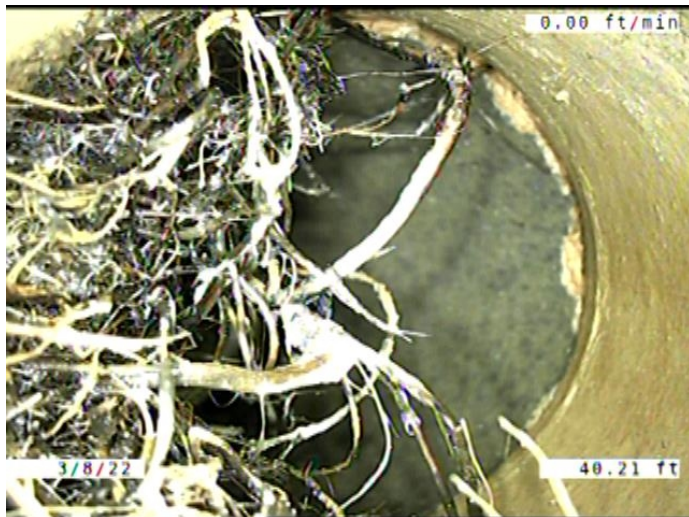
Code: **TF**
 Description: **Tap Factory**

Distance (ft): **40.2**
 Structural Grade: **0**
 O&M Grade: **0**
 Clock Start/From: **11**
 Clock To:
 1st Value: **6.000**
 2nd Value:
 Value Percent:
 Continuous Index:
 Within 8" of Joint: **YES**
 Remarks:

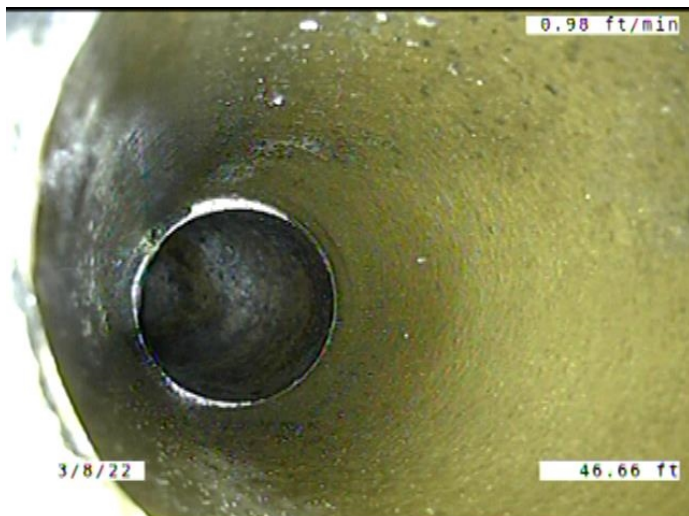
Code: **TB**
 Description: **Tap Break-in/Hammer**

Distance (ft): **46.6**
 Structural Grade: **0**
 O&M Grade: **0**
 Clock Start/From: **11**
 Clock To:
 1st Value: **6.000**
 2nd Value:
 Value Percent:
 Continuous Index:
 Within 8" of Joint: **YES**
 Remarks:

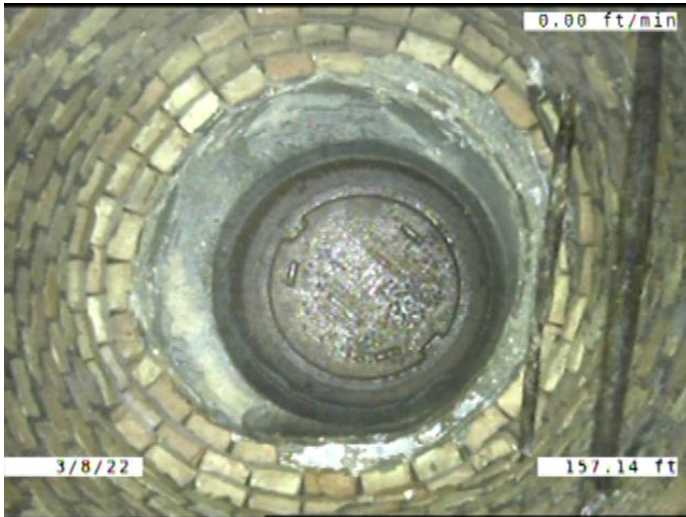
Code:	AMH
Description:	Manhole
Distance (ft):	157.1
Structural Grade:	0
O&M Grade:	0
Clock Start/From:	
Clock To:	
1st Value:	
2nd Value:	
Value Percent:	
Continuous Index:	
Within 8" of Joint:	NO
Remarks:	M-706-034
