## Profile/Photo Observation Report

Date:	03/03/2022	Weather:		Coding:	PACP 7.0
Pipe Length (ft):	235.0	Owner:	City of Hobart	Pre Clean:	Heavy Cleaning
P.O.#:	YES502259	Surveyor:	S. Bucklin	PSR:	P-706-049-018
Customer:	City of Hobart, IN (Red	Clean Date:	02/23/2022	Shape:	C

Street:	South Garfield Street	Flow Control:	Not Controlled
City:	Hobart, IN	Year Renewed:	
Location:	Local rural streets with light traffic, t	Tape/Media #:	
Purpose:	Routine Assessment	Dia/Height:	8"
Use:	Sanitary Sewage Pipe	Material:	VCP
Drain Area:		Lining:	None
Category:	NA		
Comment:			
Location Details:		Direction of Survey:	Downstream
US MH:	M-706-049	DS MH:	M-706-018
		Total Length Surveyed (ft):	233.5

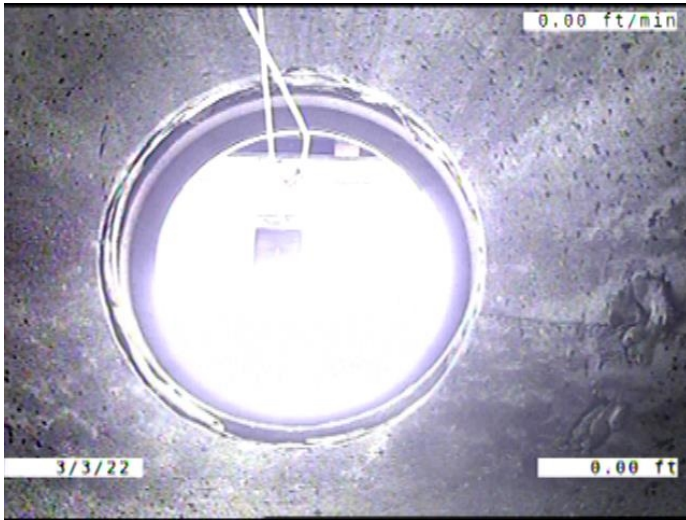
Code: **AMH**  
Description: **Manhole**

Distance (ft): **.0**  
Structural Grade: **0**  
O&M Grade: **0**  
Clock Start/From:  
Clock To:  
1st Value:  
2nd Value:  
Value Percent:  
Continuous Index:  
Within 8" of Joint: **NO**  
Remarks: **M-706-049**

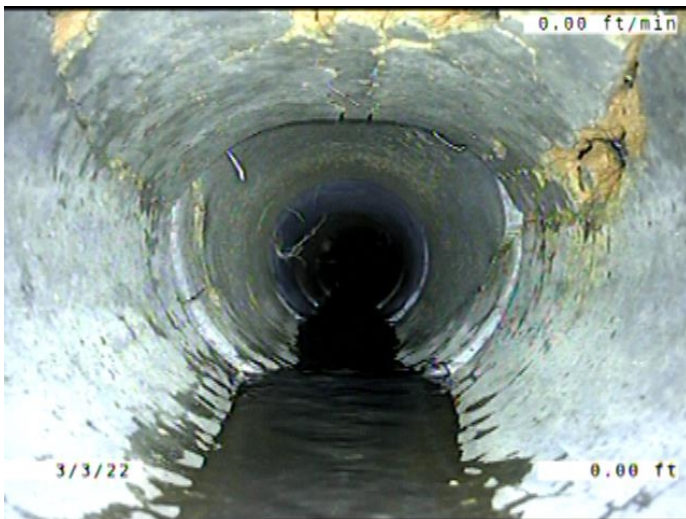
Code: **MWL**  
Description: **Miscellaneous Water Level**

Distance (ft): **.0**  
Structural Grade: **0**  
O&M Grade: **0**  
Clock Start/From:  
Clock To:  
1st Value:  
2nd Value:  
Value Percent: **5.000**  
Continuous Index:  
Within 8" of Joint: **NO**  
Remarks:

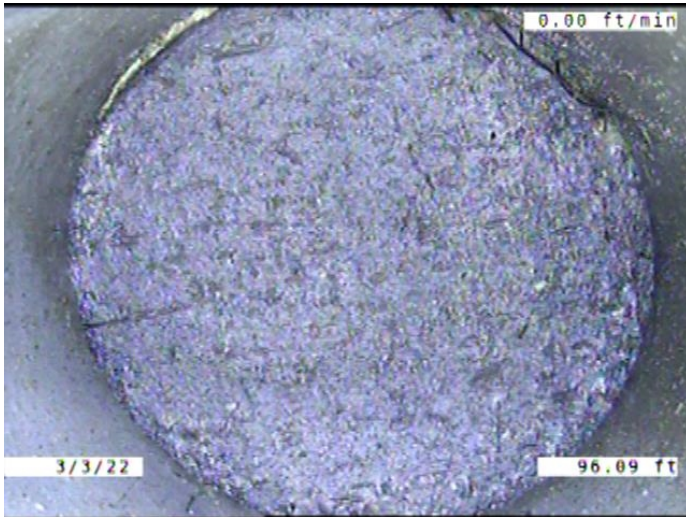
Code: **TFC**  
Description: **Tap Factory Capped**

Distance (ft): **96.1**  
Structural Grade: **0**  
O&M Grade: **0**  
Clock Start/From: **2**  
Clock To:  
1st Value: **4.000**  
2nd Value:  
Value Percent:  
Continuous Index:  
Within 8" of Joint: **YES**  
Remarks:

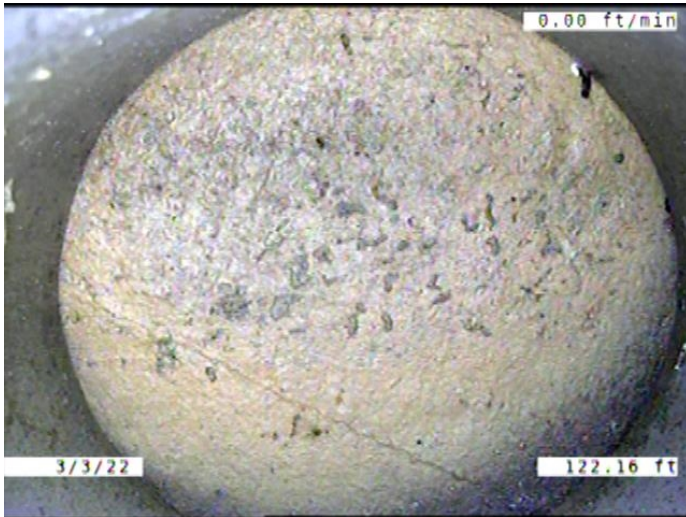
Code: **TFC**  
Description: **Tap Factory Capped**

Distance (ft): **122.2**  
Structural Grade: **0**  
O&M Grade: **0**  
Clock Start/From: **10**  
Clock To:  
1st Value: **4.000**  
2nd Value:  
Value Percent:  
Continuous Index:  
Within 8" of Joint: **YES**  
Remarks:

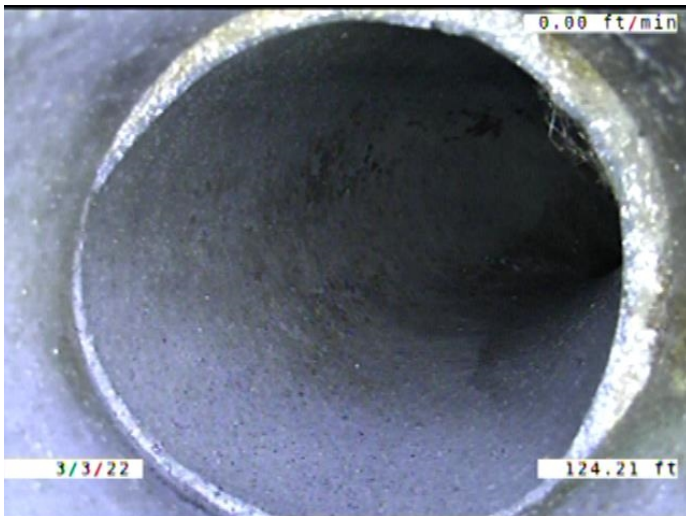
Code: **TF**  
Description: **Tap Factory**

Distance (ft): **124.2**  
Structural Grade: **0**  
O&M Grade: **0**  
Clock Start/From: **2**  
Clock To:  
1st Value: **4.000**  
2nd Value:  
Value Percent:  
Continuous Index:  
Within 8" of Joint: **YES**  
Remarks:

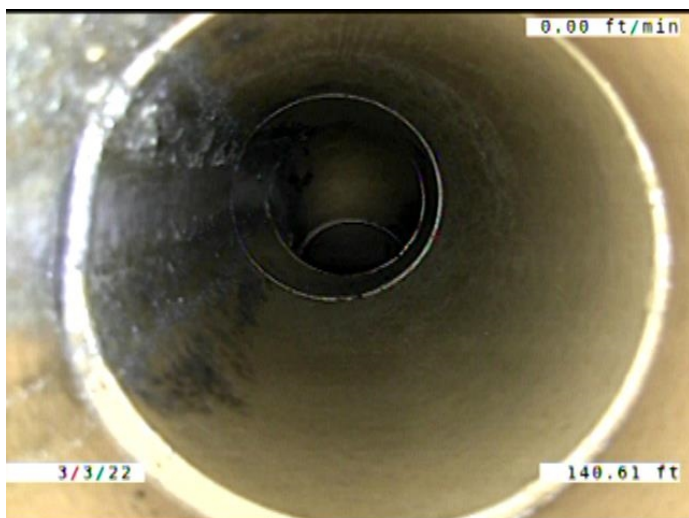
Code: **TF**  
 Description: **Tap Factory**

Distance (ft): **140.6**  
 Structural Grade: **0**  
 O&M Grade: **0**  
 Clock Start/From: **9**  
 Clock To:  
 1st Value: **6.000**  
 2nd Value:  
 Value Percent:  
 Continuous Index:  
 Within 8" of Joint: **YES**  
 Remarks:

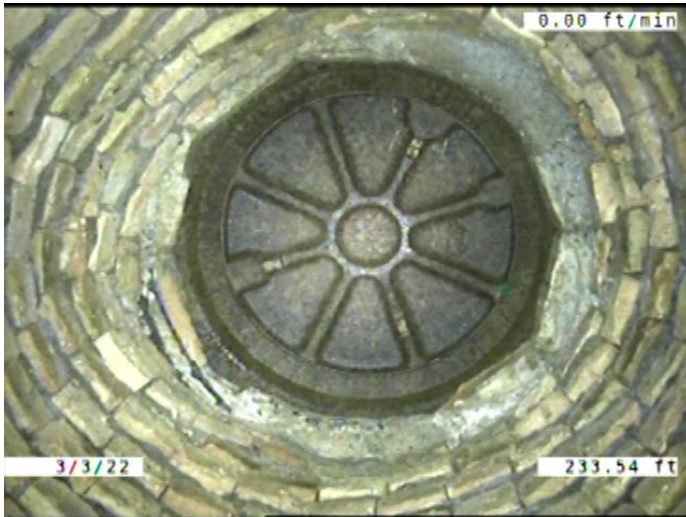
Code:	<b>AMH</b>
Description:	<b>Manhole</b>
Distance (ft):	<b>233.5</b>
Structural Grade:	<b>0</b>
O&M Grade:	<b>0</b>
Clock Start/From:	
Clock To:	
1st Value:	
2nd Value:	
Value Percent:	
Continuous Index:	
Within 8" of Joint:	<b>NO</b>
Remarks:	<b>M-706-018</b>
