Profile/Photo Observation Report

Street:	Middle School Lot	Flow Control:	
City:	Hobart, IN	Year Renewed:	
Location:	Parking Lot	Tape/Media #:	929
Purpose:	Routine Assessment	Dia/Height:	10"
Use:	Sanitary	Material:	VCP
Drain Area:		Lining:	
Category:	NA		
Comment:

Location Details:		Direction of Survey:	Downstream
US MH:	M-706-65	DS MH:	M-706-17
		Total Length Surveyed (ft):	93.2

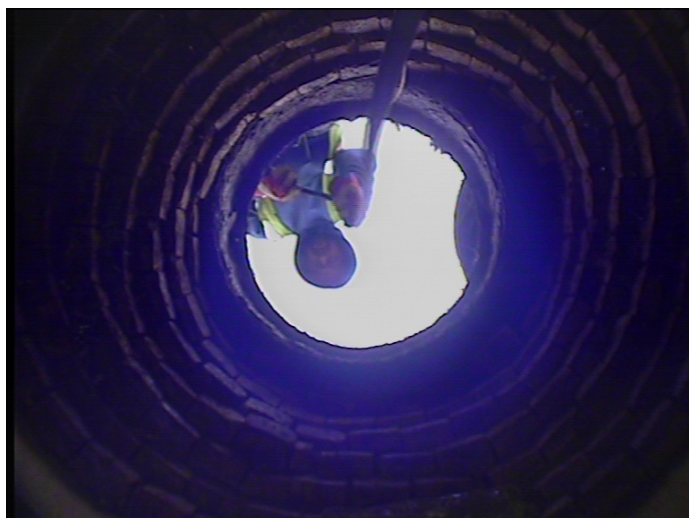
Code: **AMH**
 Description: **Manhole**

Distance (ft): **.0**
 Structural Grade: **0**
 O&M Grade: **0**
 Clock Start/From:
 Clock To:
 1st Value:
 2nd Value:
 Value Percent:
 Continuous Index:
 Within 8" of Joint: **NO**
 Remarks: **M-706-65**

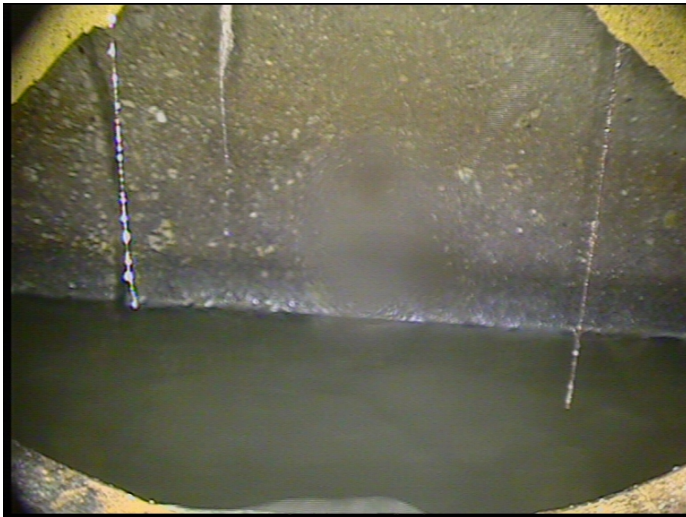
Code: **ATC**
Description: **Tee Connection**

Distance (ft): **93.1**
Structural Grade: **0**
O&M Grade: **0**
Clock Start/From: **2**
Clock To:
1st Value: **24.000**
2nd Value:
Value Percent:
Continuous Index:
Within 8" of Joint: **NO**
Remarks: **M-706-17**
