Profile/Photo Observation Report

Date:	02/09/2022	Weather:		Coding:	PACP 7.0
Pipe Length (ft):	226.8	Owner:	City of Hobart	Pre Clean:	Heavy Cleaning
P.O.#:	YES502259	Surveyor:	S. Bucklin	PSR:	P-707-019-020
Customer:	City of Hobart	Clean Date:	02/09/2022	Shape:	C

Street:	South Lincoln Street	Flow Control:	Not Controlled
City:	Hobart, IN	Year Renewed:	
Location:	Local rural streets with light traffic, t	Tape/Media #:	
Purpose:	Routine Assessment	Dia/Height:	8"
Use:	Sanitary Sewage Pipe	Material:	VCP
Drain Area:		Lining:	None
Category:	NA		
Comment:			
Location Details:		Direction of Survey:	Downstream
US MH:	M-707-020	DS MH:	M-707-019
		Total Length Surveyed (ft):	226.8

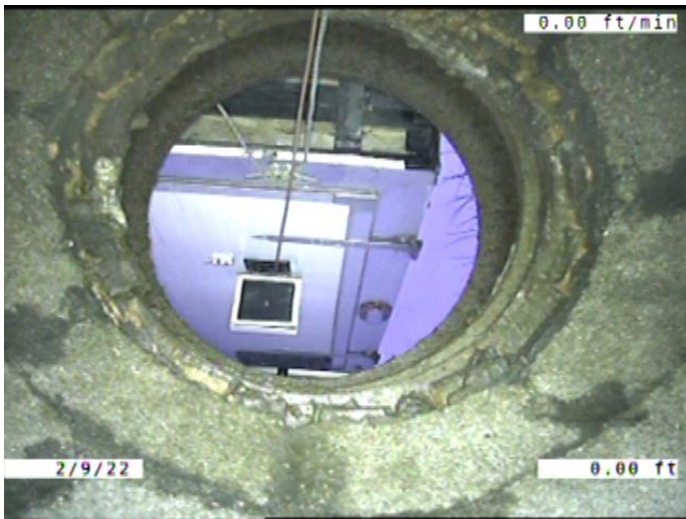
Code: **AMH**
Description: **Manhole**

Distance (ft): **.0**
Structural Grade: **0**
O&M Grade: **0**
Clock Start/From:
Clock To:
1st Value:
2nd Value:
Value Percent:
Continuous Index:
Within 8" of Joint: **NO**
Remarks: **M-707-020**

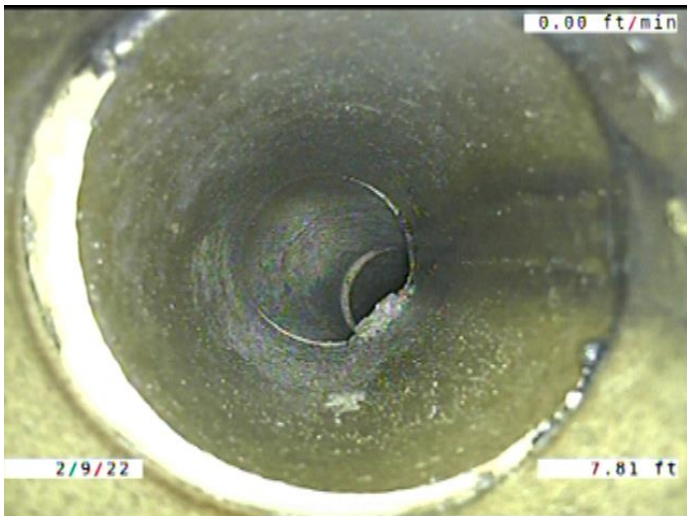
Code: **TF**
 Description: **Tap Factory**

Distance (ft): **7.8**
 Structural Grade: **0**
 O&M Grade: **0**
 Clock Start/From: **2**
 Clock To:
 1st Value: **4.000**
 2nd Value:
 Value Percent:
 Continuous Index:
 Within 8" of Joint: **YES**
 Remarks:

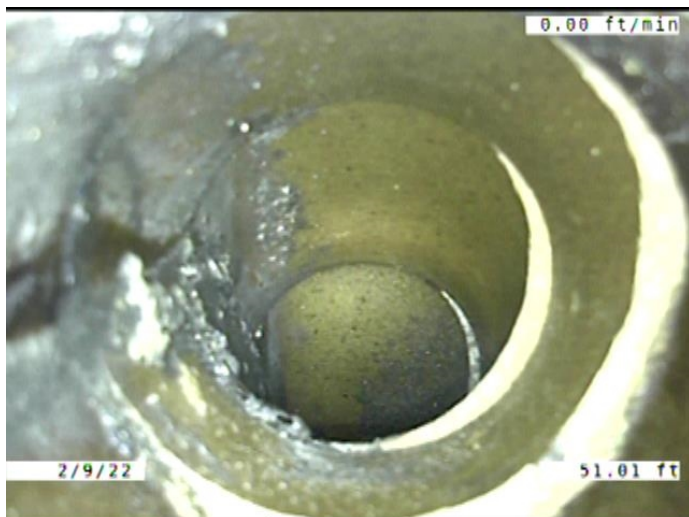
Code: **TF**
 Description: **Tap Factory**

Distance (ft): **51.0**
 Structural Grade: **0**
 O&M Grade: **0**
 Clock Start/From: **9**
 Clock To:
 1st Value: **4.000**
 2nd Value:
 Value Percent:
 Continuous Index:
 Within 8" of Joint: **YES**
 Remarks:

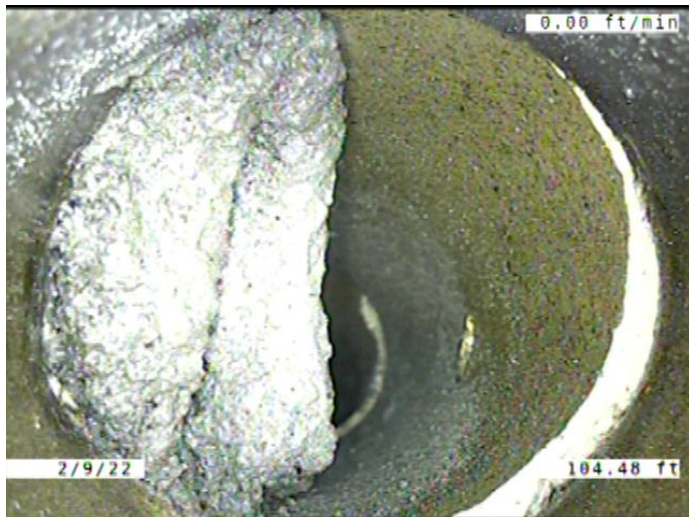
Code: **TF**
 Description: **Tap Factory**

Distance (ft): **104.5**
 Structural Grade: **0**
 O&M Grade: **0**
 Clock Start/From: **9**
 Clock To:
 1st Value: **4.000**
 2nd Value:
 Value Percent:
 Continuous Index:
 Within 8" of Joint: **YES**
 Remarks:

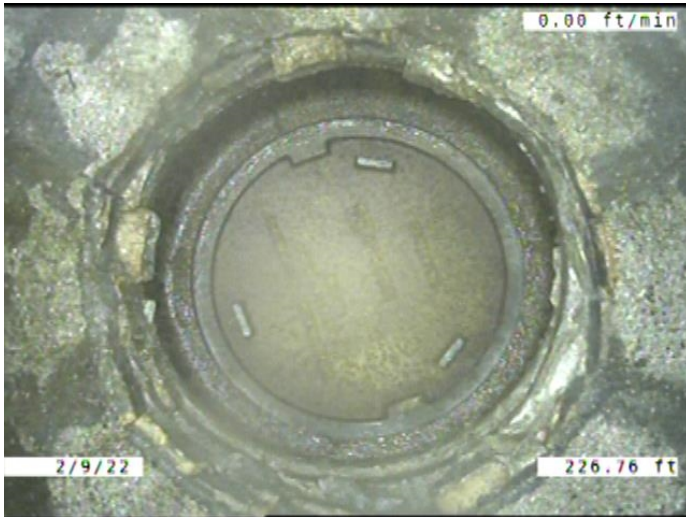
Code:	AMH
Description:	Manhole
Distance (ft):	226.8
Structural Grade:	0
O&M Grade:	0
Clock Start/From:	
Clock To:	
1st Value:	
2nd Value:	
Value Percent:	
Continuous Index:	
Within 8" of Joint:	NO
Remarks:	M-707-019
