## Profile/Photo Observation Report

Date:	<b>04/10/2018</b>	Weather:		Coding:	<b>PACP 6.0</b>
Pipe Length (ft):	<b>283.8</b>	Owner:	<b>NA</b>	Pre Clean:	<b>Not Known</b>
P.O.#:		Surveyor:	<b>Byrd Fitzgerald</b>	PSR:	<b>P-707-078-036</b>
Customer:		Clean Date:	<b>01/01/1900</b>	Shape:	<b>C</b>

Street:	<b>Capitol</b>	Flow Control:	<b>Not Controlled</b>
City:	<b>Hobart, IN</b>	Year Renewed:	
Location:	<b>Light Highway</b>	Tape/Media #:	
Purpose:	<b>Maintenance Related</b>	Dia/Height:	<b>12"</b>
Use:	<b>Sanitary</b>	Material:	<b>CP</b>
Drain Area:	<b>NA</b>	Lining:	<b>Cured in Place</b>
Category:	<b>NA</b>		
Comment:	<b>Heavy mud at 57'.</b>

Location Details:		Direction of Survey:	<b>Upstream</b>
US MH:	<b>M-707-036</b>	DS MH:	<b>M-707-078</b>
		Total Length Surveyed (ft):	<b>58.7</b>

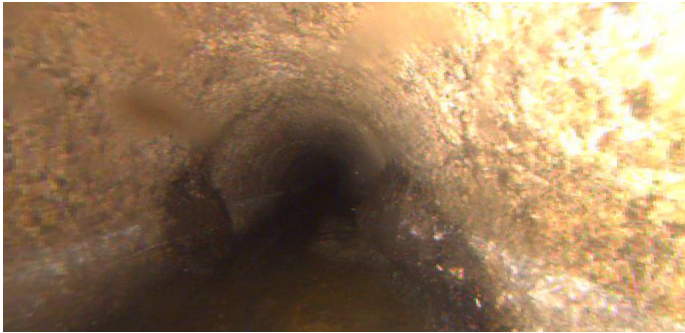
Code:	<b>MWL</b>
Description:	<b>Water Level</b>

Distance (ft):	<b>.0</b>
Structural Grade:	<b>0</b>
O&M Grade:	<b>0</b>
Clock Start/From:	
Clock To:	
1st Value:	
2nd Value:	
Value Percent:	<b>5.000</b>
Continuous Index:	
Within 8" of Joint:	<b>NO</b>
Remarks:
