Profile/Photo Observation Report

Date:	02/12/2022	Weather:		Coding:	PACP 7.0
Pipe Length (ft):	249.1	Owner:	City of Hobart	Pre Clean:	Heavy Cleaning
P.O.#:	YES502259	Surveyor:	S. Bucklin	PSR:	P-707-079-037
Customer:	City of Hobart	Clean Date:	02/10/2022	Shape:	C

Street:	South State Street	Flow Control:	Not Controlled
City:	Hobart, IN	Year Renewed:	
Location:	Local rural streets with light traffic, t	Tape/Media #:	
Purpose:	Routine Assessment	Dia/Height:	12"
Use:	Sanitary Sewage Pipe	Material:	VCP
Drain Area:		Lining:	None
Category:	NA		
Comment:			
Location Details:		Direction of Survey:	Downstream
US MH:	M-707-079	DS MH:	M-707-037
		Total Length Surveyed (ft):	249.0

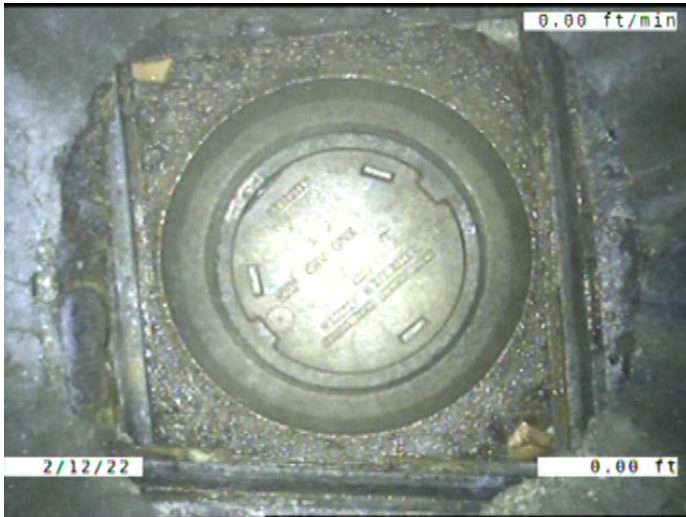
Code: **AMH**
Description: **Manhole**

Distance (ft): **.0**
Structural Grade: **0**
O&M Grade: **0**
Clock Start/From:
Clock To:
1st Value:
2nd Value:
Value Percent:
Continuous Index:
Within 8" of Joint: **NO**
Remarks: **M-707-079**

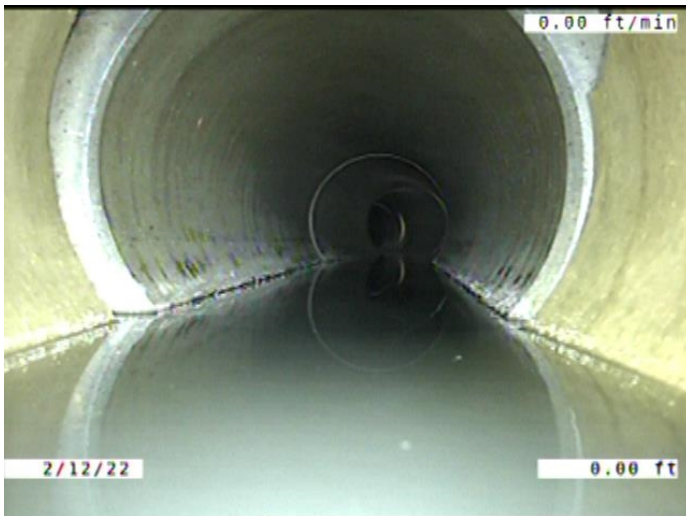
Code: **MWL**
Description: **Miscellaneous Water Level**

Distance (ft): **.0**
Structural Grade: **0**
O&M Grade: **0**
Clock Start/From:
Clock To:
1st Value:
2nd Value:
Value Percent: **10.000**
Continuous Index:
Within 8" of Joint: **NO**
Remarks:

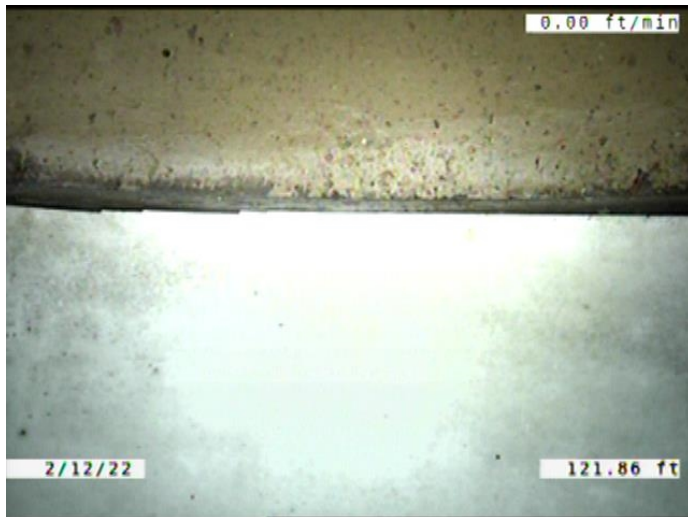
Code: **MMC**
Description: **Miscellaneous Material Change**

Distance (ft): **121.9**
Structural Grade: **0**
O&M Grade: **0**
Clock Start/From:
Clock To:
1st Value:
2nd Value:
Value Percent:
Continuous Index:
Within 8" of Joint: **NO**
Remarks: **VCP TO PVC**

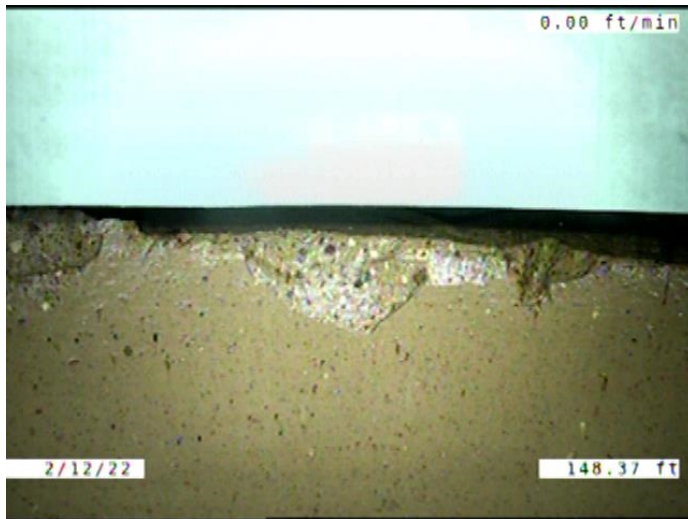
Code: **MMC**
Description: **Miscellaneous Material Change**

Distance (ft): **148.4**
Structural Grade: **0**
O&M Grade: **0**
Clock Start/From:
Clock To:
1st Value:
2nd Value:
Value Percent:
Continuous Index:
Within 8" of Joint: **NO**
Remarks: **PVC TO VCP**

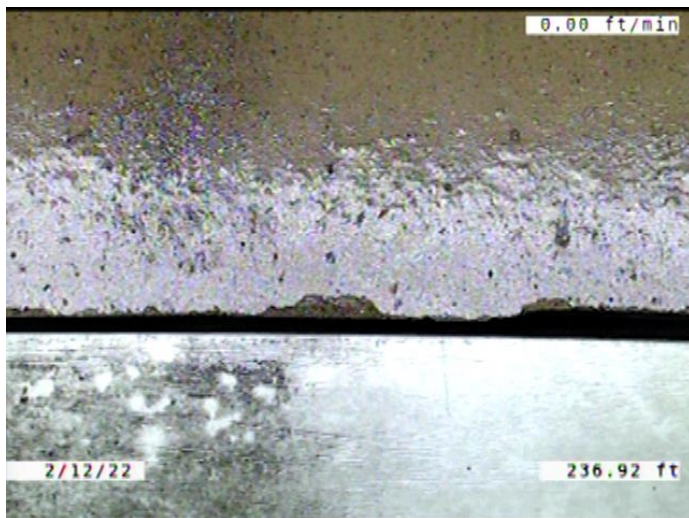
Code: **MMC**
Description: **Miscellaneous Material Change**

Distance (ft): **236.9**
Structural Grade: **0**
O&M Grade: **0**
Clock Start/From:
Clock To:
1st Value:
2nd Value:
Value Percent:
Continuous Index:
Within 8" of Joint: **NO**
Remarks: **VCP TO PVC**

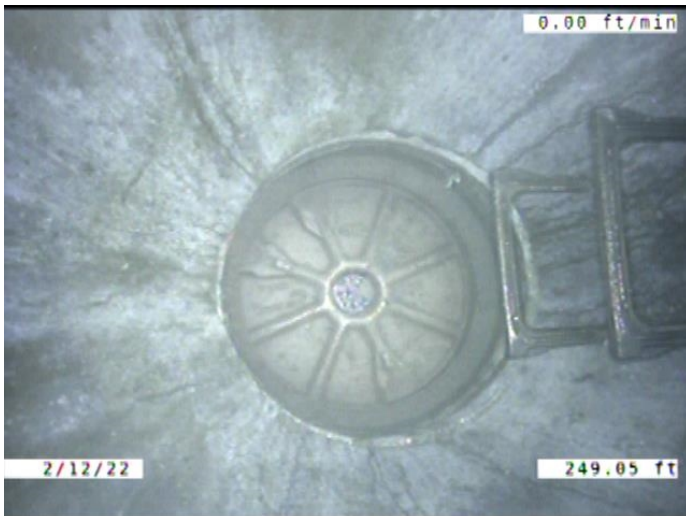
Code: **AMH**
 Description: **Manhole**

Distance (ft): **249.0**
 Structural Grade: **0**
 O&M Grade: **0**
 Clock Start/From:
 Clock To:
 1st Value:
 2nd Value:
 Value Percent:
 Continuous Index:
 Within 8" of Joint: **NO**
 Remarks: **M-707-037**
