Profile/Photo Observation Report

Date:	04/11/2018	Weather:		Coding:	PACP 6.0
Pipe Length (ft):	364.1	Owner:	NA	Pre Clean:	Not Known
P.O.#:		Surveyor:	Jen Costello	PSR:	P-707-037-038
Customer:		Clean Date:	01/01/1900	Shape:	C

Street:	Capitol	Flow Control:	Not Controlled
City:	Hobart, IN	Year Renewed:	
Location:	Light Highway	Tape/Media #:	
Purpose:	Maintenance Related	Dia/Height:	12"
Use:	Sanitary	Material:	VCP
Drain Area:	NA	Lining:	Cured in Place
Category:	NA		
Comment:	flow incorrect.

Location Details:		Direction of Survey:	Upstream
US MH:	M-707-038	DS MH:	M-707-037
		Total Length Surveyed (ft):	360.9

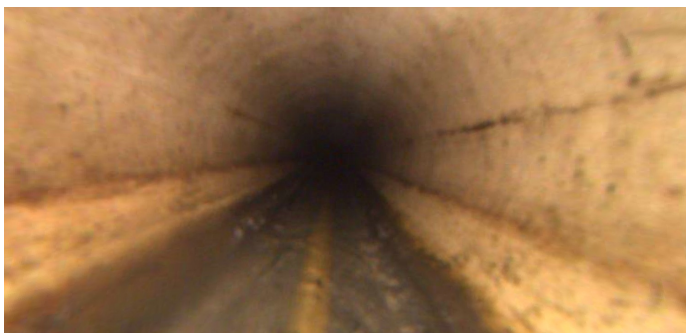
Code: **AMH**
Description: **Manhole**

Distance (ft): **.0**
Structural Grade: **0**
O&M Grade: **0**
Clock Start/From:
Clock To:
1st Value:
2nd Value:
Value Percent:
Continuous Index:
Within 8" of Joint: **NO**
Remarks: **M-707-037**

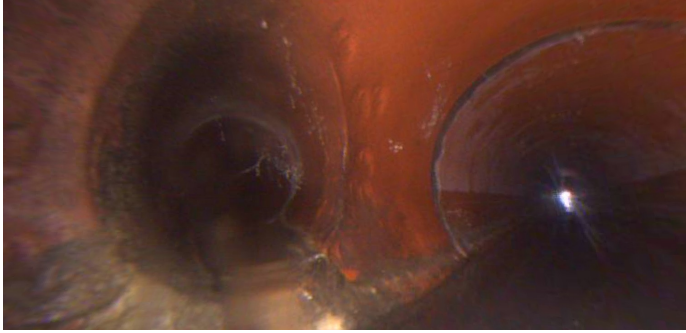
Code: **TFA**
Description: **Tap Factory Active**

Distance (ft): **64.4**
Structural Grade: **0**
O&M Grade: **0**
Clock Start/From: **3**
Clock To:
1st Value: **4.000**
2nd Value:
Value Percent:
Continuous Index:
Within 8" of Joint:
Remarks:

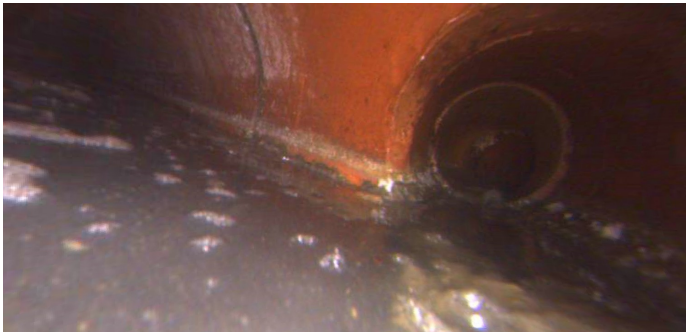
Code: **TFA**
Description: **Tap Factory Active**

Distance (ft): **138.9**
Structural Grade: **0**
O&M Grade: **0**
Clock Start/From: **9**
Clock To:
1st Value: **4.000**
2nd Value:
Value Percent:
Continuous Index:
Within 8" of Joint:
Remarks:

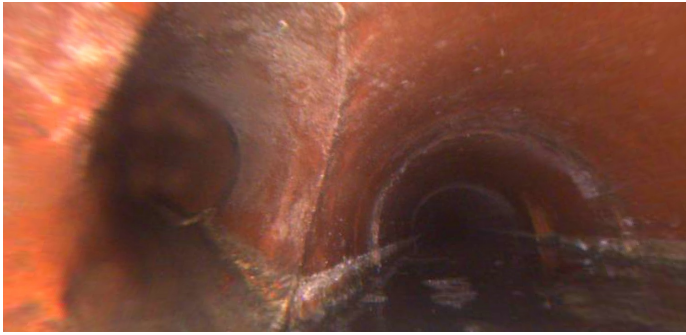
Code: **TFA**
Description: **Tap Factory Active**

Distance (ft): **141.3**
Structural Grade: **0**
O&M Grade: **0**
Clock Start/From: **3**
Clock To:
1st Value: **4.000**
2nd Value:
Value Percent:
Continuous Index:
Within 8" of Joint:
Remarks:

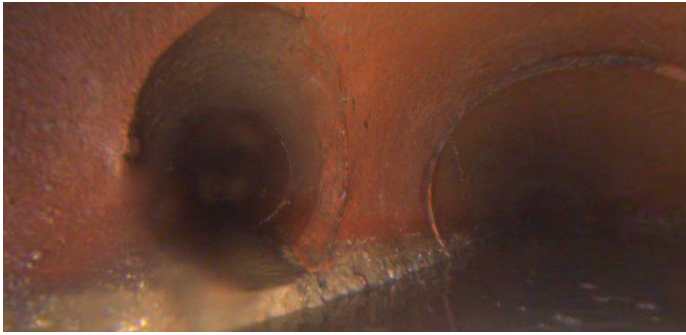
Code: **TFA**
Description: **Tap Factory Active**

Distance (ft): **217.5**
Structural Grade: **0**
O&M Grade: **0**
Clock Start/From: **3**
Clock To:
1st Value: **4.000**
2nd Value:
Value Percent:
Continuous Index:
Within 8" of Joint:
Remarks:

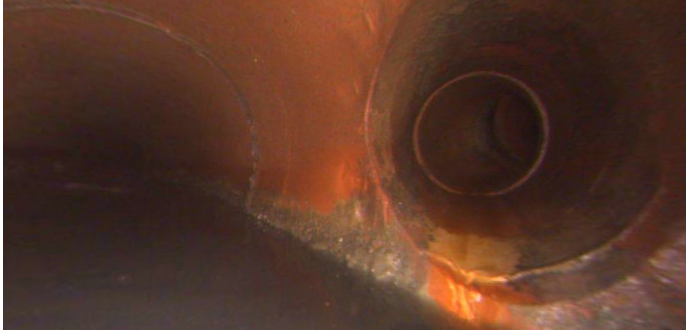
Code: **TFA**
Description: **Tap Factory Active**

Distance (ft): **243.6**
Structural Grade: **0**
O&M Grade: **0**
Clock Start/From: **9**
Clock To:
1st Value: **4.000**
2nd Value:
Value Percent:
Continuous Index:
Within 8" of Joint:
Remarks:

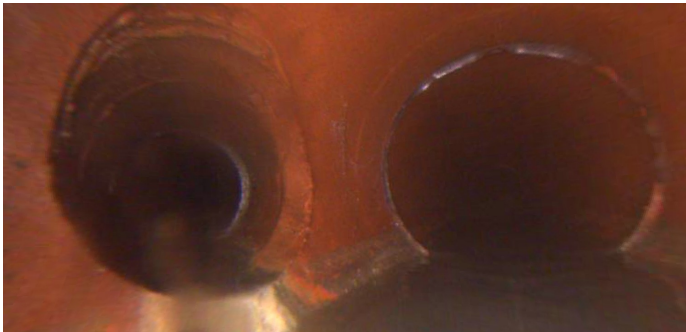
Code: **TFA**
Description: **Tap Factory Active**

Distance (ft): **335.7**
Structural Grade: **0**
O&M Grade: **0**
Clock Start/From: **3**
Clock To:
1st Value: **4.000**
2nd Value:
Value Percent:
Continuous Index:
Within 8" of Joint:
Remarks:

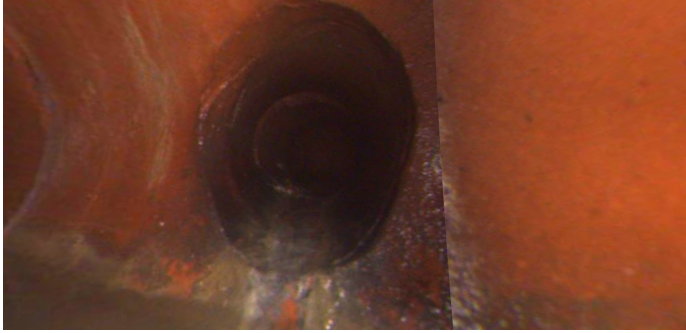
Code: **TFA**
Description: **Tap Factory Active**

Distance (ft): **337.8**
Structural Grade: **0**
O&M Grade: **0**
Clock Start/From: **9**
Clock To:
1st Value: **4.000**
2nd Value:
Value Percent:
Continuous Index:
Within 8" of Joint:
Remarks:

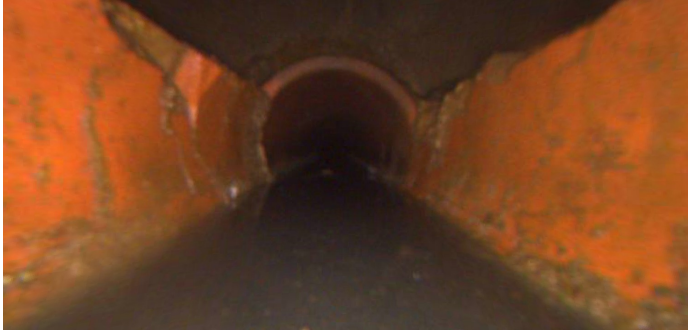
Code:	AMH
Description:	Manhole
Distance (ft):	360.9
Structural Grade:	0
O&M Grade:	0
Clock Start/From:	
Clock To:	
1st Value:	
2nd Value:	
Value Percent:	
Continuous Index:	
Within 8" of Joint:	NO
Remarks:	M-707-038
