Profile/Photo Observation Report

Date:	02/17/2022	Weather:		Coding:	PACP 7.0
Pipe Length (ft):	214.9	Owner:	City of Hobart	Pre Clean:	Heavy Cleaning
P.O.#:	YES502259	Surveyor:	S. Bucklin	PSR:	P-707-064-071
Customer:	City of Hobart	Clean Date:	02/15/2022	Shape:	C

Street:	East 11th Place	Flow Control:	Not Controlled
City:	Hobart, IN	Year Renewed:	
Location:	Local rural streets with light traffic, t	Tape/Media #:	
Purpose:	Routine Assessment	Dia/Height:	12"
Use:	Sanitary Sewage Pipe	Material:	VCP
Drain Area:		Lining:	None
Category:	NA		
Comment:			
Location Details:		Direction of Survey:	Upstream
US MH:	M-707-071	DS MH:	M-707-064
		Total Length Surveyed (ft):	214.9

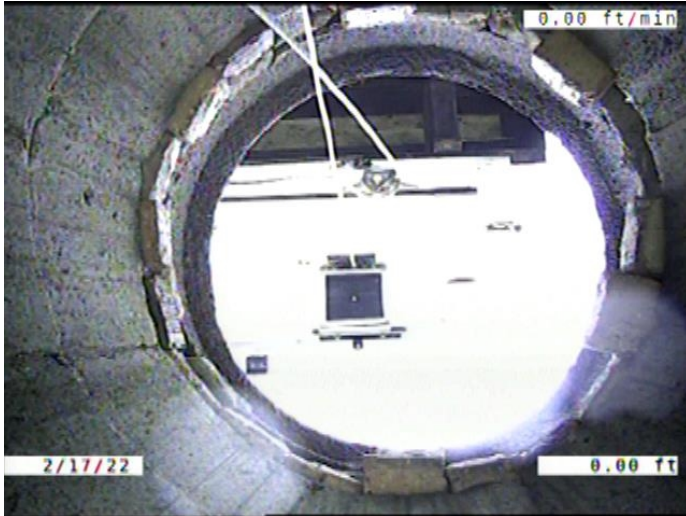
Code: **AMH**
Description: **Manhole**

Distance (ft): **.0**
Structural Grade: **0**
O&M Grade: **0**
Clock Start/From:
Clock To:
1st Value:
2nd Value:
Value Percent:
Continuous Index:
Within 8" of Joint: **NO**
Remarks: **M-707-064**

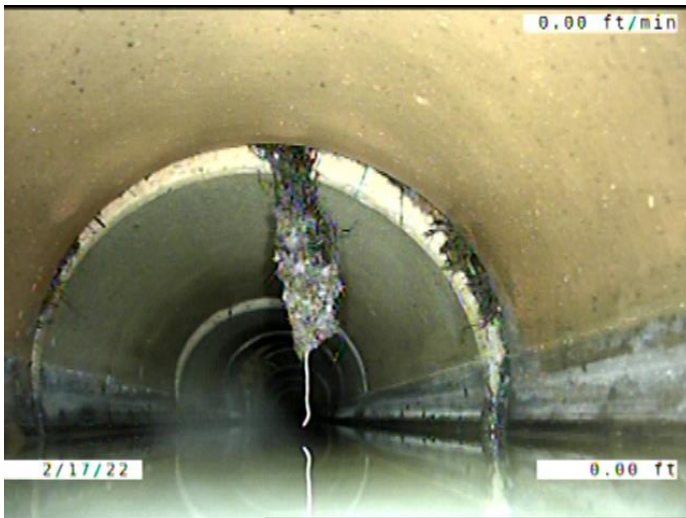
Code: **MWL**
Description: **Miscellaneous Water Level**

Distance (ft): **.0**
Structural Grade: **0**
O&M Grade: **0**
Clock Start/From:
Clock To:
1st Value:
2nd Value:
Value Percent: **20.000**
Continuous Index:
Within 8" of Joint: **NO**
Remarks:

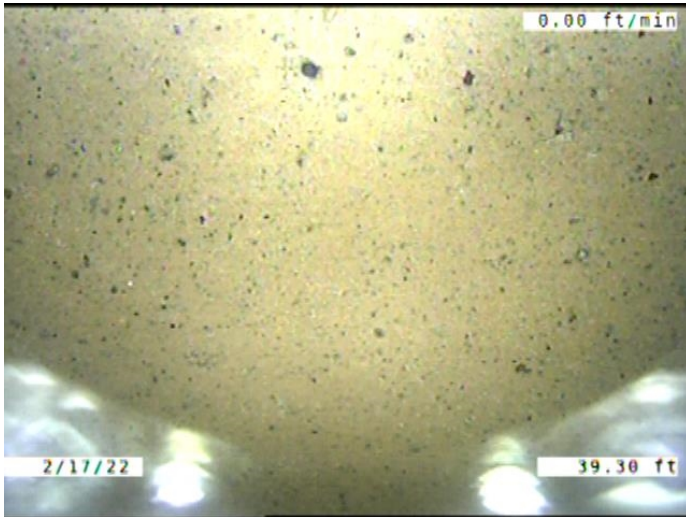
Code: **MWL**
 Description: **Miscellaneous Water Level**

Distance (ft): **39.3**
 Structural Grade: **0**
 O&M Grade: **0**
 Clock Start/From:
 Clock To:
 1st Value:
 2nd Value:
 Value Percent: **50.000**
 Continuous Index:
 Within 8" of Joint: **NO**
 Remarks:

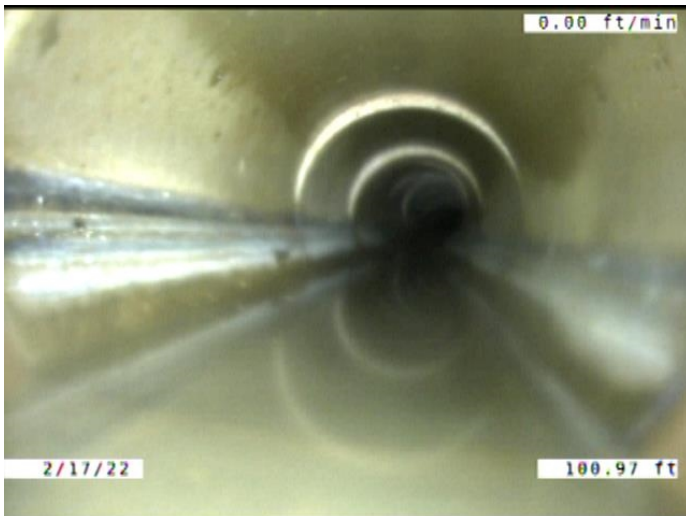
Code: **MWL**
 Description: **Miscellaneous Water Level**

Distance (ft): **101.0**
 Structural Grade: **0**
 O&M Grade: **0**
 Clock Start/From:
 Clock To:
 1st Value:
 2nd Value:
 Value Percent: **10.000**
 Continuous Index:
 Within 8" of Joint: **NO**
 Remarks:

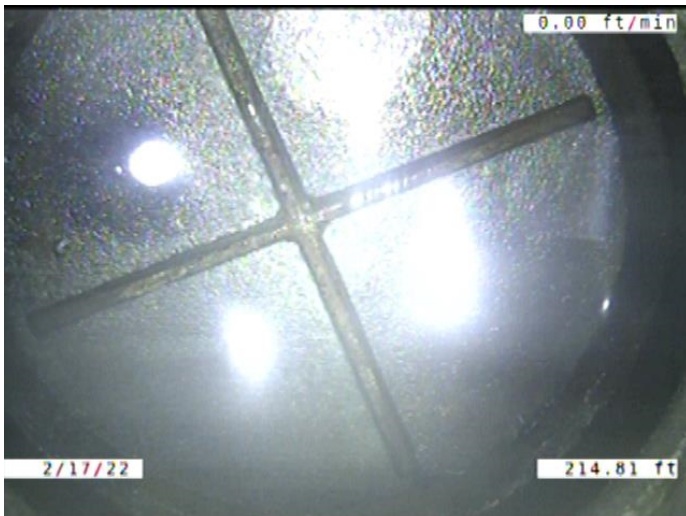
Code: **AMH**
 Description: **Manhole**

Distance (ft): **214.9**
 Structural Grade: **0**
 O&M Grade: **0**
 Clock Start/From:
 Clock To:
 1st Value:
 2nd Value:
 Value Percent:
 Continuous Index:
 Within 8" of Joint: **NO**
 Remarks: **M-707-071**
