Profile/Photo Observation Report

| Street: | East 11th Place | Flow Control: | Not Controlled |
| Purpose: | Routine Assessment | Dia/Height: | 10" |
| US MH: | M-707-072 | DS MH: | M-707-071 |

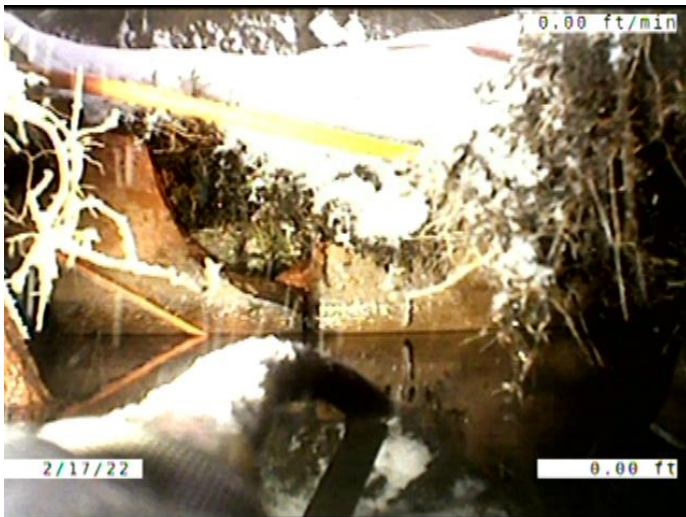
Code: **AMH**
Description: **Manhole**

Distance (ft): **.0**
Structural Grade: **0**
O&M Grade: **0**
Clock Start/From:
Clock To:
1st Value:
2nd Value:
Value Percent:
Continuous Index:
Within 8" of Joint: **NO**
Remarks: **M-707-071**

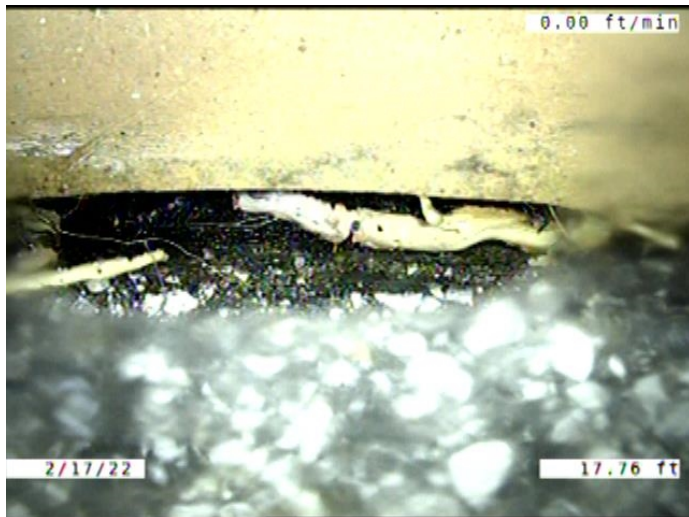
Code: **MMC**
 Description: **Miscellaneous Material Change**

Distance (ft): **17.8**
 Structural Grade: **0**
 O&M Grade: **0**
 Clock Start/From:
 Clock To:
 1st Value:
 2nd Value:
 Value Percent:
 Continuous Index:
 Within 8" of Joint: **NO**
 Remarks: **VCP TO CONCRETE**

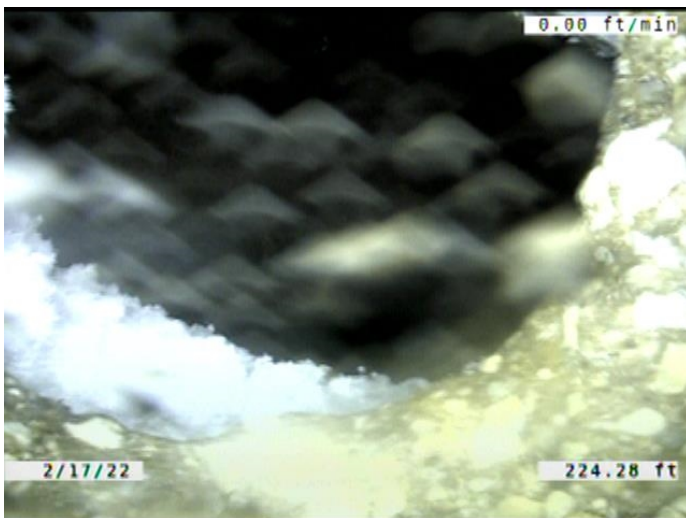
Code: **AMH**
 Description: **Manhole**

Distance (ft): **224.3**
 Structural Grade: **0**
 O&M Grade: **0**
 Clock Start/From:
 Clock To:
 1st Value:
 2nd Value:
 Value Percent:
 Continuous Index:
 Within 8" of Joint: **NO**
 Remarks: **M-707-072**
