Profile/Photo Observation Report

Date:	04/11/2018	Weather:		Coding:	PACP 6.0
Pipe Length (ft):	357.8	Owner:	NA	Pre Clean:	Not Known
P.O.#:		Surveyor:	Jen Costello	PSR:	P-707-081-076
Customer:		Clean Date:	01/01/1900	Shape:	C

Street:	Capitol	Flow Control:	Not Controlled
City:	Hobart, IN	Year Renewed:	
Location:	Light Highway	Tape/Media #:	
Purpose:	Maintenance Related	Dia/Height:	12"
Use:	Sanitary	Material:	PVC
Drain Area:	NA	Lining:	Cured in Place
Category:	NA		
Comment:	heavy soft debris at 203'.-flow incorrect.		
Location Details:		Direction of Survey:	Downstream
US MH:	M-707-076	DS MH:	M-707-081
		Total Length Surveyed (ft):	202.9

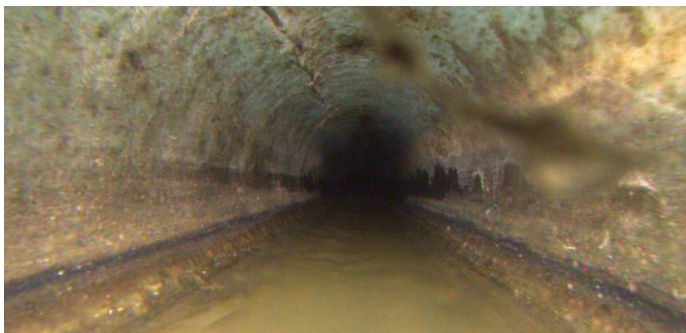
Code: **AMH**
Description: **Manhole**

Distance (ft): **.0**
Structural Grade: **0**
O&M Grade: **0**
Clock Start/From:
Clock To:
1st Value:
2nd Value:
Value Percent:
Continuous Index:
Within 8" of Joint: **NO**
Remarks: **M-707-076**
