Profile/Photo Observation Report

Date:	04/11/2018	Weather:		Coding:	PACP 6.0
Pipe Length (ft):	357.8	Owner:	NA	Pre Clean:	Not Known
P.O.#:		Surveyor:	Jen Costello	PSR:	P-707-081-076
Customer:		Clean Date:	01/01/1900	Shape:	C

Street:	STATE ST	Flow Control:	Not Controlled
City:	Hobart, IN	Year Renewed:	
Location:	Light Highway	Tape/Media #:	
Purpose:	Maintenance Related	Dia/Height:	12"
Use:	Sanitary	Material:	PVC
Drain Area:	NA	Lining:	Cured in Place
Category:	NA		
Comment:	Reverse setup.blk silt at 79'.-flow incorrect.		
Location Details:		Direction of Survey:	Upstream
US MH:	M-707-076	DS MH:	M-707-081
		Total Length Surveyed (ft):	80.2

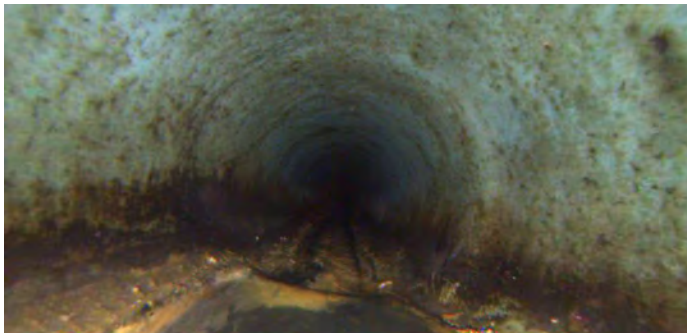
Code:	MWL
Description:	Water Level

Distance (ft):	.0
Structural Grade:	0
O&M Grade:	0
Clock Start/From:	
Clock To:	
1st Value:	
2nd Value:	
Value Percent:	5.000
Continuous Index:	
Within 8" of Joint:	NO
Remarks:
