Profile/Photo Observation Report

Date:	02/09/2022	Weather:		Coding:	PACP 7.0
Pipe Length (ft):	357.4	Owner:	City of Hobart	Pre Clean:	Heavy Cleaning
P.O.#:	YES502259	Surveyor:	S. Bucklin	PSR:	P-707-081-076
Customer:	City of Hobart	Clean Date:	02/08/2022	Shape:	C

Street:	South State Street	Flow Control:	Not Controlled
City:	Hobart, IN	Year Renewed:	
Location:	Local rural streets with light traffic, t	Tape/Media #:	
Purpose:	Routine Assessment	Dia/Height:	12"
Use:	Sanitary Sewage Pipe	Material:	VCP
Drain Area:		Lining:	Not Known
Category:	NA		
Comment:			
Location Details:		Direction of Survey:	Downstream
US MH:	M-707-076	DS MH:	M-707-081
		Total Length Surveyed (ft):	357.4

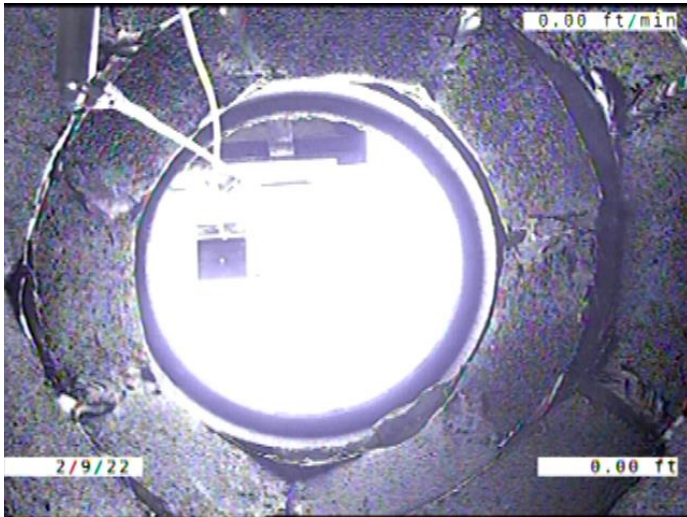
Code: **AMH**
Description: **Manhole**

Distance (ft): **.0**
Structural Grade: **0**
O&M Grade: **0**
Clock Start/From:
Clock To:
1st Value:
2nd Value:
Value Percent:
Continuous Index:
Within 8" of Joint: **NO**
Remarks: **M-707-076**

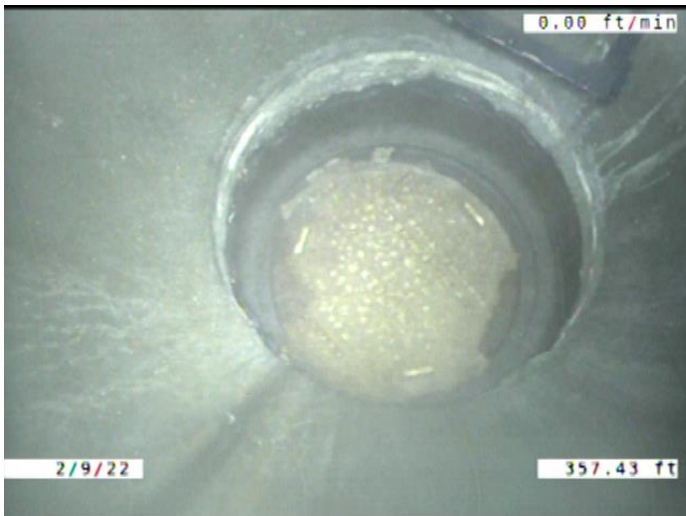
Code: **AMH**
 Description: **Manhole**

Distance (ft): **357.4**
 Structural Grade: **0**
 O&M Grade: **0**
 Clock Start/From:
 Clock To:
 1st Value:
 2nd Value:
 Value Percent:
 Continuous Index:
 Within 8" of Joint: **NO**
 Remarks: **M-707-081**
