Profile/Photo Observation Report

Date:	02/13/2022	Weather:		Coding:	PACP 7.0
Pipe Length (ft):	125.8	Owner:	City of Hobart	Pre Clean:	Heavy Cleaning
P.O.#:	YES502259	Surveyor:	S. Bucklin	PSR:	P-707-042-078
Customer:	City of Hobart	Clean Date:	02/09/2022	Shape:	C

Street:	East 13th Street	Flow Control:	Not Controlled
City:	Hobart, IN	Year Renewed:	
Location:	Local rural streets with light traffic, t	Tape/Media #:	
Purpose:	Routine Assessment	Dia/Height:	12"
Use:	Sanitary Sewage Pipe	Material:	CP
Drain Area:		Lining:	None
Category:	NA		
Comment:			
Location Details:		Direction of Survey:	Downstream
US MH:	M-707-078	DS MH:	M-707-042
		Total Length Surveyed (ft):	125.8

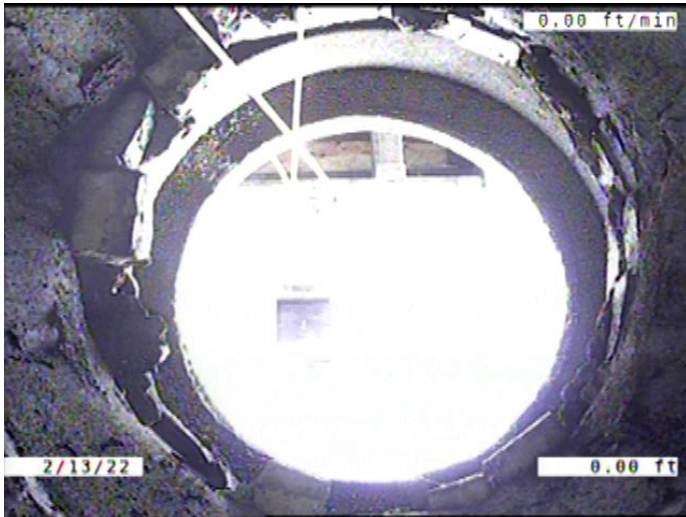
Code: **AMH**
Description: **Manhole**

Distance (ft): **.0**
Structural Grade: **0**
O&M Grade: **0**
Clock Start/From:
Clock To:
1st Value:
2nd Value:
Value Percent:
Continuous Index:
Within 8" of Joint: **NO**
Remarks: **M-707-078**

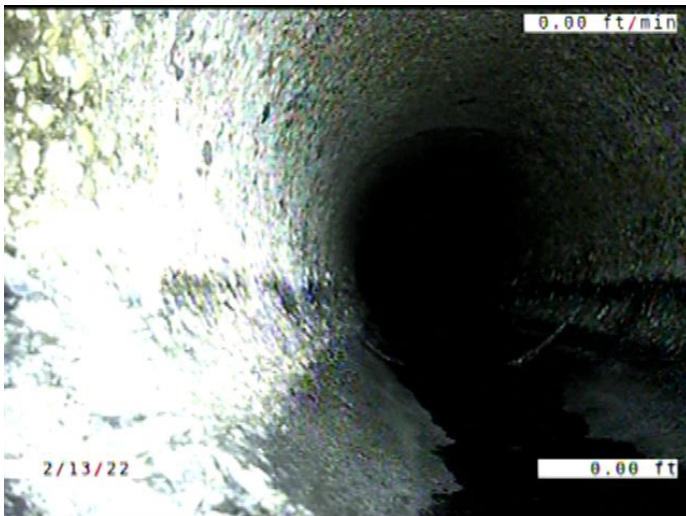
Code: **MWL**
Description: **Miscellaneous Water Level**

Distance (ft): **.0**
Structural Grade: **0**
O&M Grade: **0**
Clock Start/From:
Clock To:
1st Value:
2nd Value:
Value Percent: **5.000**
Continuous Index:
Within 8" of Joint: **NO**
Remarks:

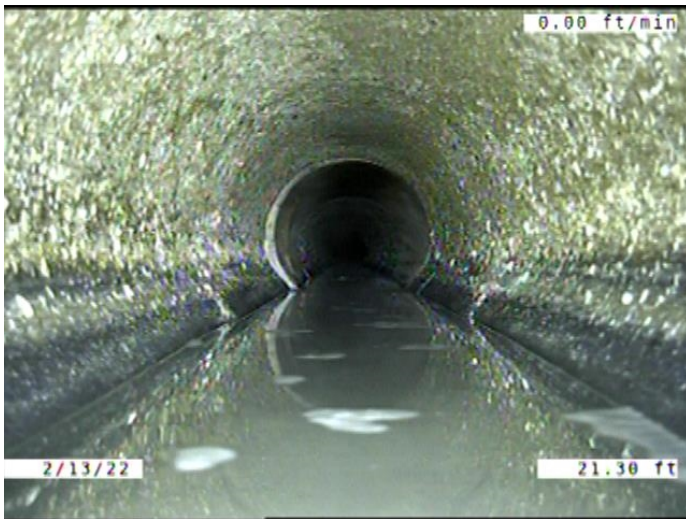
Code:	MWL
Description:	Miscellaneous Water Level
Distance (ft):	21.3
Structural Grade:	0
O&M Grade:	0
Clock Start/From:	
Clock To:	
1st Value:	
2nd Value:	
Value Percent:	15.000
Continuous Index:	
Within 8" of Joint:	NO
Remarks:

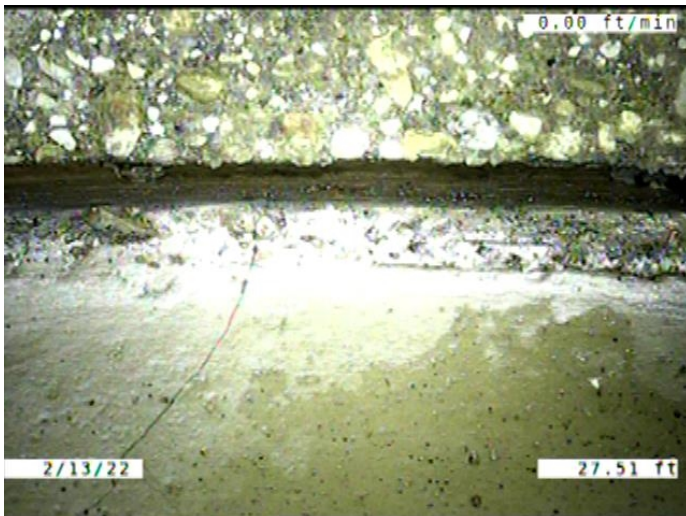
Code: **MMC**
Description: **Miscellaneous Material Change**

Distance (ft): **27.5**
Structural Grade: **0**
O&M Grade: **0**
Clock Start/From:
Clock To:
1st Value:
2nd Value:
Value Percent:
Continuous Index:
Within 8" of Joint: **NO**
Remarks: **CONCRETE TO VCP**

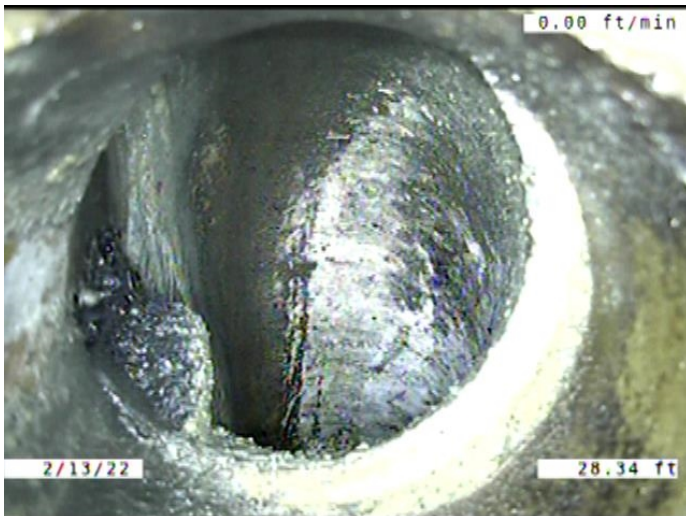
Code: **TF**
 Description: **Tap Factory**

Distance (ft): **28.3**
 Structural Grade: **0**
 O&M Grade: **0**
 Clock Start/From: **9**
 Clock To:
 1st Value: **6.000**
 2nd Value:
 Value Percent:
 Continuous Index:
 Within 8" of Joint: **YES**
 Remarks:

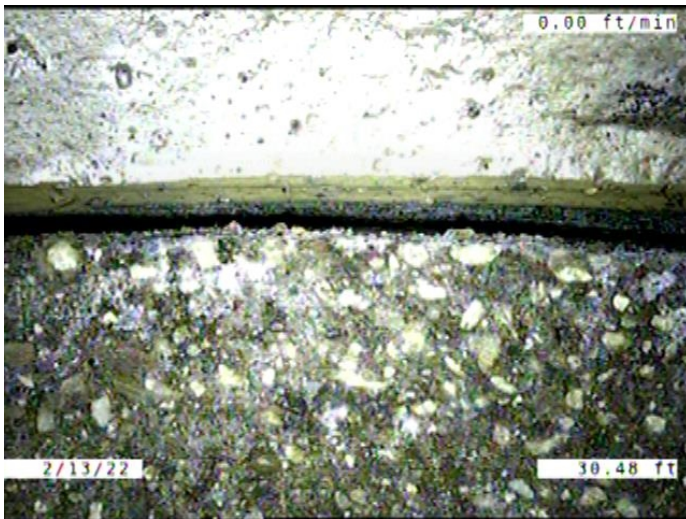
Code: **MMC**
Description: **Miscellaneous Material Change**

Distance (ft): **30.5**
Structural Grade: **0**
O&M Grade: **0**
Clock Start/From:
Clock To:
1st Value:
2nd Value:
Value Percent:
Continuous Index:
Within 8" of Joint: **NO**
Remarks: **VCP TO CONCRETE**

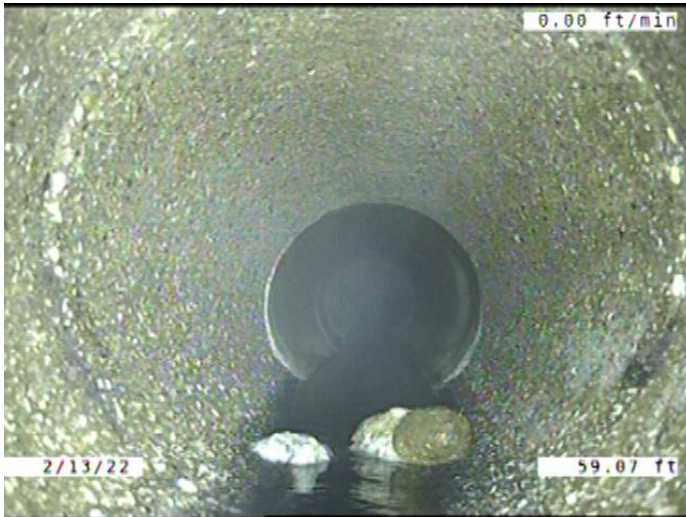
Code: **MWL**
 Description: **Miscellaneous Water Level**

Distance (ft): **59.1**
 Structural Grade: **0**
 O&M Grade: **0**
 Clock Start/From:
 Clock To:
 1st Value:
 2nd Value:
 Value Percent: **5.000**
 Continuous Index:
 Within 8" of Joint: **NO**
 Remarks:

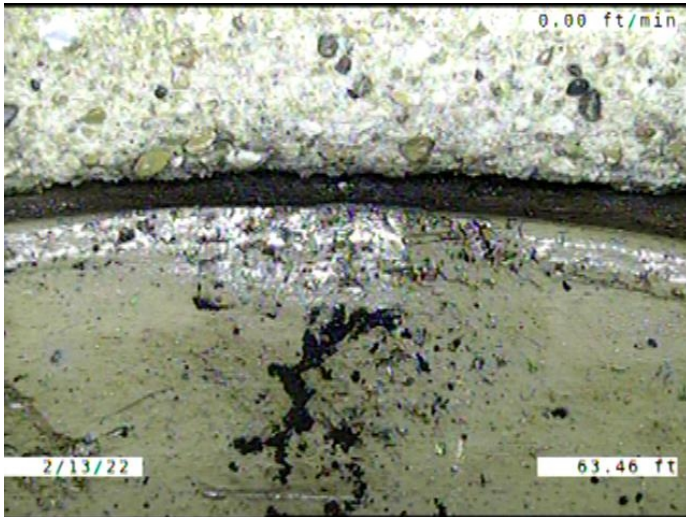
Code: **MMC**
Description: **Miscellaneous Material Change**

Distance (ft): **63.5**
Structural Grade: **0**
O&M Grade: **0**
Clock Start/From:
Clock To:
1st Value:
2nd Value:
Value Percent:
Continuous Index:
Within 8" of Joint: **NO**
Remarks: **CONCRETE TO VCP**

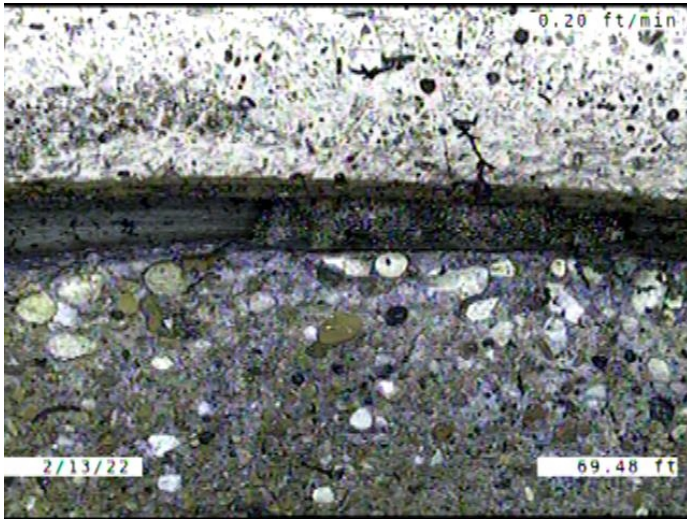
Code:	MMC
Description:	Miscellaneous Material Change
Distance (ft):	69.5
Structural Grade:	0
O&M Grade:	0
Clock Start/From:	
Clock To:	
1st Value:	
2nd Value:	
Value Percent:	
Continuous Index:	
Within 8" of Joint:	NO
Remarks:	VCP TO CONCRETE

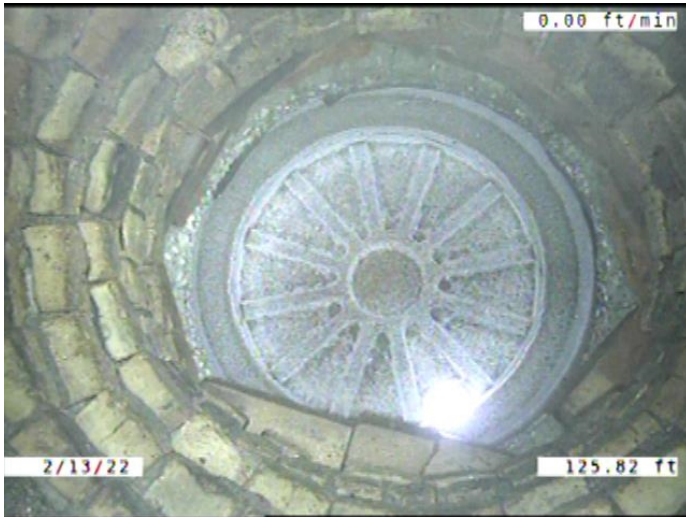
Code:	AMH
Description:	Manhole
Distance (ft):	125.8
Structural Grade:	0
O&M Grade:	0
Clock Start/From:	
Clock To:	
1st Value:	
2nd Value:	
Value Percent:	
Continuous Index:	
Within 8" of Joint:	NO
Remarks:	M-707-042
