# Profile/Photo Observation Report

Date:	<b>10/12/2018</b>	Weather:		Coding:	<b>PACP 6.0</b>
Pipe Length (ft):	<b>82.6</b>	Owner:	<b>NA</b>	Pre Clean:	<b>Not Known</b>
P.O.#:		Surveyor:	<b>Selasie Honu</b>	PSR:	<b>P-708-021-022</b>
Customer:		Clean Date:	<b>01/01/1900</b>	Shape:	<b>C</b>

Street:	<b>OFF S LAKE PARK AVE</b>	Flow Control:	<b>Not Controlled</b>
City:	<b>Hobart, IN</b>	Year Renewed:	
Location:	<b>Light Highway</b>	Tape/Media #:	
Purpose:	<b>Routine Assessment</b>	Dia/Height:	<b>8"</b>
Use:	<b>Sanitary</b>	Material:	<b>PVC</b>
Drain Area:	<b>NA</b>	Lining:	
Category:	<b>NA</b>		
Comment:			
Location Details:		Direction of Survey:	<b>Upstream</b>
US MH:	<b>M-708-021</b>	DS MH:	<b>M-708-022</b>
		Total Length Surveyed (ft):	<b>79.3</b>

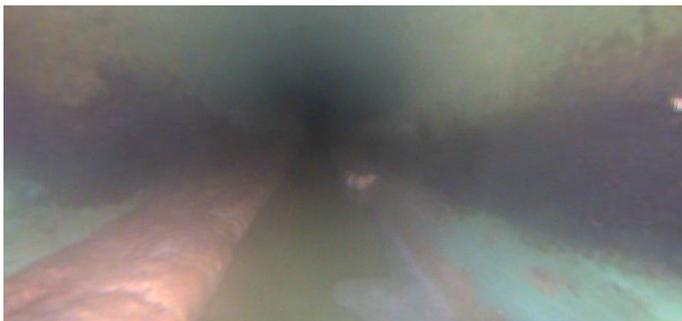
Code: **AMH**  
Description: **Manhole**

Distance (ft): **.0**  
Structural Grade: **0**  
O&M Grade: **0**  
Clock Start/From:  
Clock To:  
1st Value:  
2nd Value:  
Value Percent:  
Continuous Index:  
Within 8" of Joint: **NO**  
Remarks: **M-708-022**

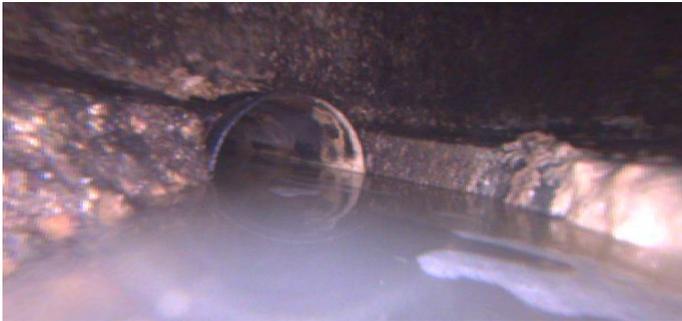
Code: **AMH**  
Description: **Manhole**

Distance (ft): **79.3**  
Structural Grade: **0**  
O&M Grade: **0**  
Clock Start/From:  
Clock To:  
1st Value:  
2nd Value:  
Value Percent:  
Continuous Index:  
Within 8" of Joint: **NO**  
Remarks: **M-708-021**
