Profile/Photo Observation Report

Date:	03/20/2018	Weather:		Coding:	PACP 6.0
Pipe Length (ft):	170.8	Owner:	NA	Pre Clean:	Not Known
P.O.#:		Surveyor:	John Kuglmaier	PSR:	P-709-029-012
Customer:		Clean Date:	01/01/1900	Shape:	C

Street:	AVOCET CIR & DUNLIN CT	Flow Control:	Not Controlled
City:	Hobart, IN	Year Renewed:	
Location:	Yard	Tape/Media #:	
Purpose:	Maintenance Related	Dia/Height:	8"
Use:	Sanitary	Material:	PVC
Drain Area:	NA	Lining:	
Category:	NA		
Comment:	2nd attempt. mh at 168', broke up clay mound.		
Location Details:		Direction of Survey:	Upstream
US MH:	M-709-012	DS MH:	M-709-029
		Total Length Surveyed (ft):	169.7

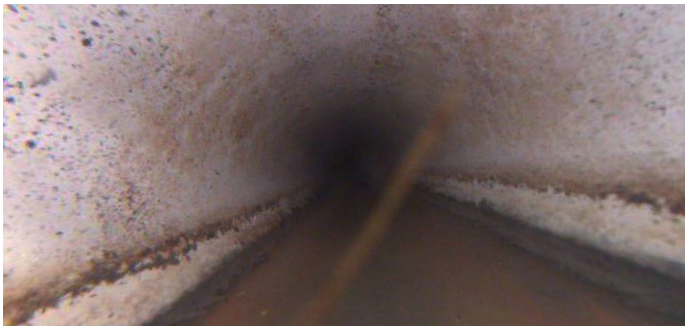
Code: **AMH**
Description: **Manhole**

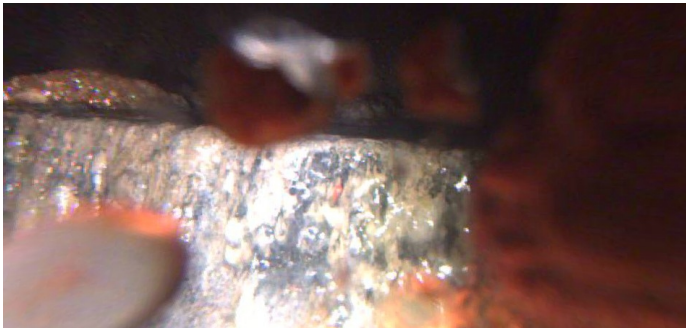
Code: **AMH**
Description: **Manhole**

Distance (ft): **169.7**
Structural Grade: **0**
O&M Grade: **0**
Clock Start/From:
Clock To:
1st Value:
2nd Value:
Value Percent:
Continuous Index:
Within 8" of Joint: **NO**
Remarks: **M-709-012**
