Profile/Photo Observation Report

Date:	03/19/2018	Weather:		Coding:	PACP 6.0
Pipe Length (ft):	114.5	Owner:	NA	Pre Clean:	Not Known
P.O.#:		Surveyor:	John Kuglmaier	PSR:	P-709-032-031
Customer:		Clean Date:	01/01/1900	Shape:	C

Street:	Oak	Flow Control:	Not Controlled
City:	Hobart, IN	Year Renewed:	
Location:	Yard	Tape/Media #:	
Purpose:	Maintenance Related	Dia/Height:	8"
Use:	Sanitary	Material:	PVC
Drain Area:	NA	Lining:	
Category:	NA		
Comment:

Location Details:		Direction of Survey:	Upstream
US MH:	M-709-032	DS MH:	M-709-031
		Total Length Surveyed (ft):	113.0

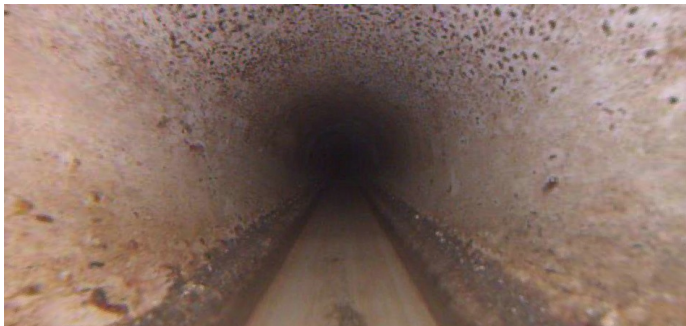
Code: **AMH**
Description: **Manhole**

Distance (ft): **.0**
Structural Grade: **0**
O&M Grade: **0**
Clock Start/From:
Clock To:
1st Value:
2nd Value:
Value Percent:
Continuous Index:
Within 8" of Joint: **NO**
Remarks: **M-709-031**

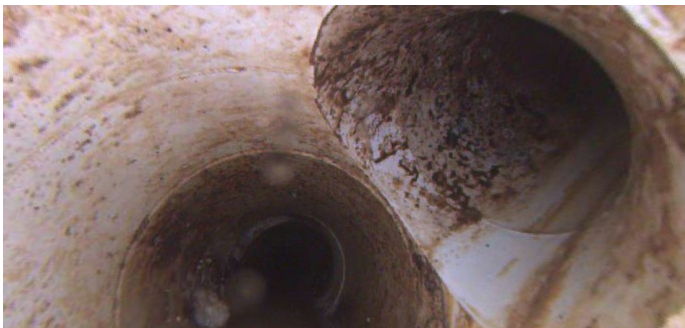
Code: **TF**
Description: **Tap Factory**

Distance (ft): **23.8**
Structural Grade: **0**
O&M Grade: **0**
Clock Start/From: **2**
Clock To:
1st Value: **4.000**
2nd Value:
Value Percent:
Continuous Index:
Within 8" of Joint:
Remarks:

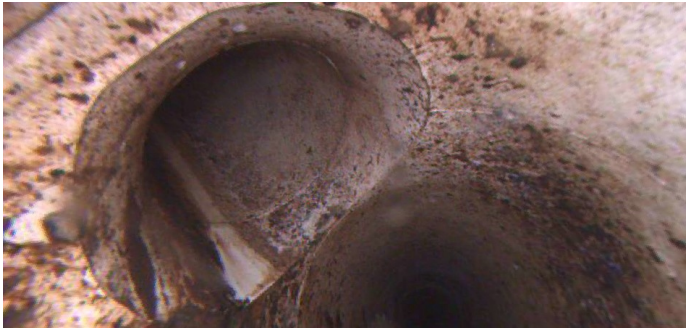
Code: **TF**
Description: **Tap Factory**

Distance (ft): **25.5**
Structural Grade: **0**
O&M Grade: **0**
Clock Start/From: **10**
Clock To:
1st Value: **4.000**
2nd Value:
Value Percent:
Continuous Index:
Within 8" of Joint:
Remarks:

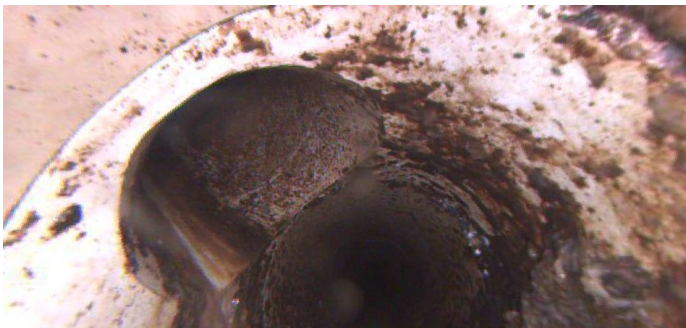
Code: **TF**
Description: **Tap Factory**

Distance (ft): **66.9**
Structural Grade: **0**
O&M Grade: **0**
Clock Start/From: **10**
Clock To:
1st Value: **4.000**
2nd Value:
Value Percent:
Continuous Index:
Within 8" of Joint:
Remarks:

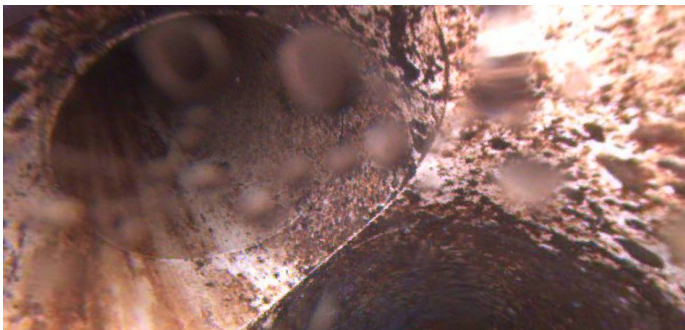
Code: **TF**
Description: **Tap Factory**

Distance (ft): **102.9**
Structural Grade: **0**
O&M Grade: **0**
Clock Start/From: **10**
Clock To:
1st Value: **4.000**
2nd Value:
Value Percent:
Continuous Index:
Within 8" of Joint:
Remarks:

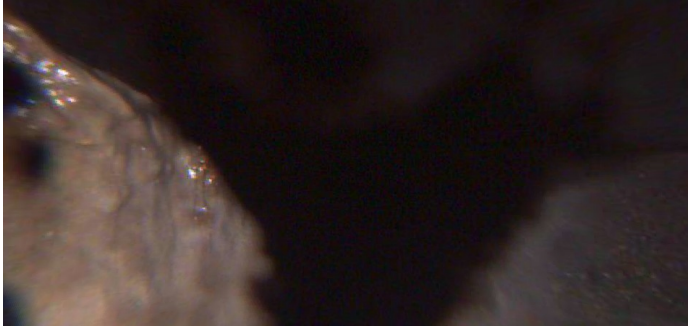
Code:	AMH
Description:	Manhole
Distance (ft):	113.0
Structural Grade:	0
O&M Grade:	0
Clock Start/From:	
Clock To:	
1st Value:	
2nd Value:	
Value Percent:	
Continuous Index:	
Within 8" of Joint:	NO
Remarks:	M-709-032
