Profile/Photo Observation Report

Street:	OFF N HOBART RD	Flow Control:	Not Controlled
City:	Hobart, IN	Year Renewed:	
Location:	Main Highway - Suburban/Rural	Tape/Media #:	
Purpose:	Resurvey	Dia/Height:	8"
Use:	Sanitary	Material:	PVC
Drain Area:	NA	Lining:	
Category:	NA		
Comment:

Location Details:		Direction of Survey:	Upstream
US MH:	M-802-016	DS MH:	M-802-014
		Total Length Surveyed (ft):	152.7

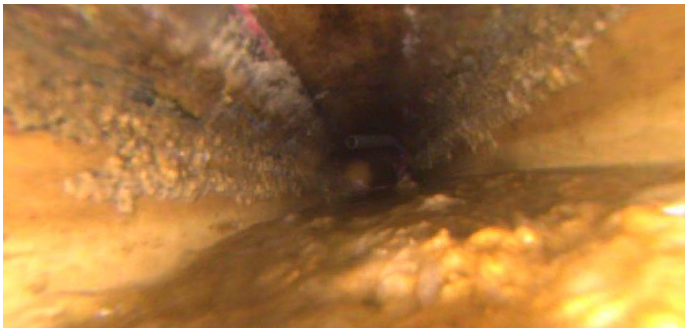
Code:	MGO
Description:	General Observation

Distance (ft):	2.8
Structural Grade:	0
O&M Grade:	0
Clock Start/From:	
Clock To:	
1st Value:	
2nd Value:	
Value Percent:	
Continuous Index:	
Within 8" of Joint:	NO
Remarks:	Switching to rear camera

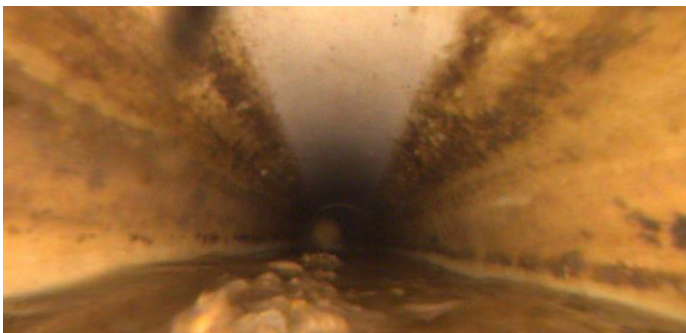
Code: **MGO**
Description: **General Observation**

Distance (ft): **20.8**
Structural Grade: **0**
O&M Grade: **0**
Clock Start/From:
Clock To:
1st Value:
2nd Value:
Value Percent:
Continuous Index:
Within 8" of Joint: **NO**
Remarks: **rear camera**

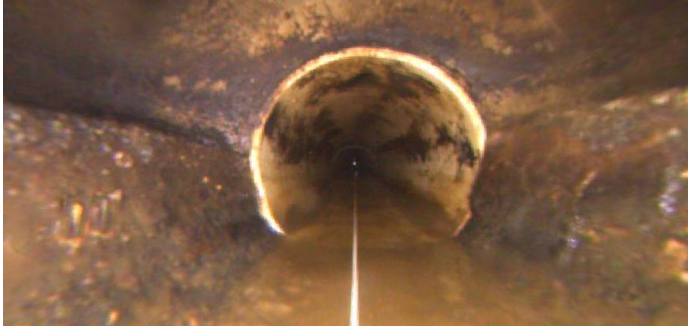
Code:	AMH
Description:	Manhole
Distance (ft):	151.0
Structural Grade:	0
O&M Grade:	0
Clock Start/From:	
Clock To:	
1st Value:	
2nd Value:	
Value Percent:	
Continuous Index:	
Within 8" of Joint:	NO
Remarks:	M-802-016
