Profile/Photo Observation Report

Date:	03/29/2018	Weather:		Coding:	PACP 6.0
Pipe Length (ft):	130.9	Owner:	NA	Pre Clean:	Not Known
P.O.#:		Surveyor:	Jen Costello	PSR:	P-803-003-002
Customer:		Clean Date:	01/01/1900	Shape:	C

Street:	HIGH ST	Flow Control:	Not Controlled
City:	Hobart, IN	Year Renewed:	
Location:	Other	Tape/Media #:	
Purpose:	Not Known	Dia/Height:	10"
Use:	Sanitary	Material:	VCP
Drain Area:	NA	Lining:	
Category:	NA		
Comment:

Location Details:		Direction of Survey:	Upstream
US MH:	M-803-003	DS MH:	M-803-002
		Total Length Surveyed (ft):	28.9

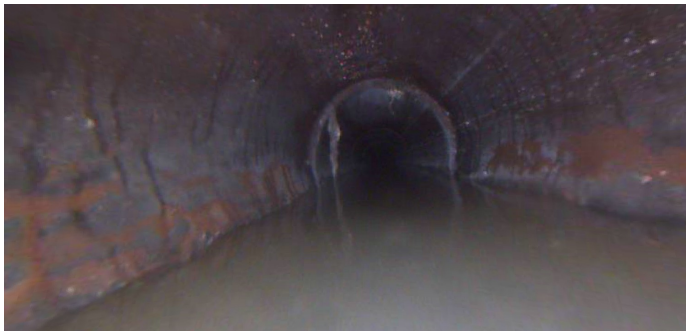
Code:	MWL
Description:	Water Level

Distance (ft):	.0
Structural Grade:	0
O&M Grade:	0
Clock Start/From:	
Clock To:	
1st Value:	
2nd Value:	
Value Percent:	30.000
Continuous Index:	
Within 8" of Joint:	NO
Remarks:
