## Profile/Photo Observation Report

Street:	<b>E 40TH AVE &amp; N JOLIET ST</b>	Flow Control:	<b>Not Controlled</b>
City:	<b>Hobart, IN</b>	Year Renewed:	
Location:	<b>Other</b>	Tape/Media #:	
Purpose:	<b>Not Known</b>	Dia/Height:	<b>10"</b>
Use:	<b>Sanitary</b>	Material:	<b>VCP</b>
Drain Area:	<b>NA</b>	Lining:	
Category:	<b>NA</b>		
Comment:

Location Details:		Direction of Survey:	<b>Upstream</b>
US MH:	<b>M-803-021</b>	DS MH:	<b>M-803-023</b>
		Total Length Surveyed (ft):	<b>155.6</b>

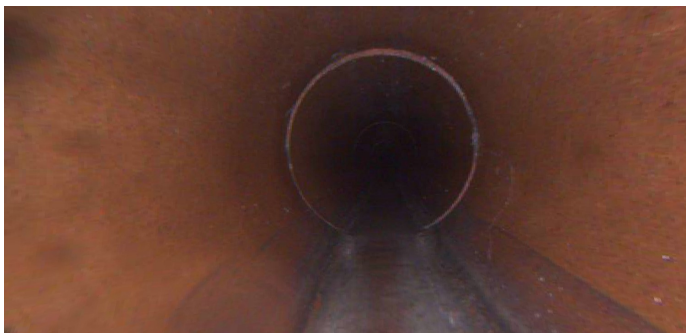
Code: **AMH**  
Description: **Manhole**

Distance (ft): **.0**  
Structural Grade: **0**  
O&M Grade: **0**  
Clock Start/From:  
Clock To:  
1st Value:  
2nd Value:  
Value Percent:  
Continuous Index:  
Within 8" of Joint: **NO**  
Remarks: **M-803-023**

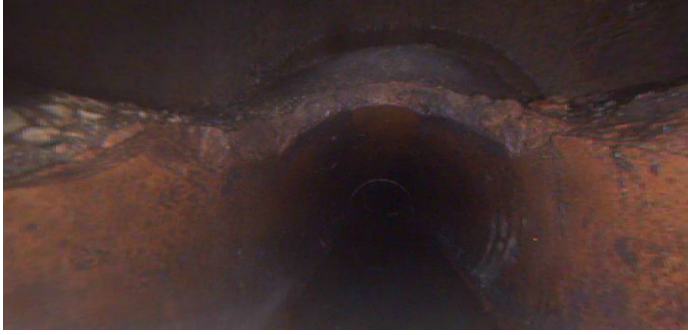
Code:	<b>AMH</b>
Description:	<b>Manhole</b>
Distance (ft):	<b>155.6</b>
Structural Grade:	<b>0</b>
O&M Grade:	<b>0</b>
Clock Start/From:	
Clock To:	
1st Value:	
2nd Value:	
Value Percent:	
Continuous Index:	
Within 8" of Joint:	<b>NO</b>
Remarks:	<b>M-803-021</b>
