Profile/Photo Observation Report

Street:	ALLEY BETWEEN N JOLIET ST & N OH	Flow Control:	Not Controlled
City:	Hobart, IN	Year Renewed:	
Location:	Light Highway	Tape/Media #:	
Purpose:	Routine Assessment	Dia/Height:	12"
Use:	Sanitary	Material:	VCP
Drain Area:	NA	Lining:	
Category:	NA		
Comment:

Location Details:		Direction of Survey:	Upstream
US MH:	M-803-024	DS MH:	M-803-025
		Total Length Surveyed (ft):	2.3

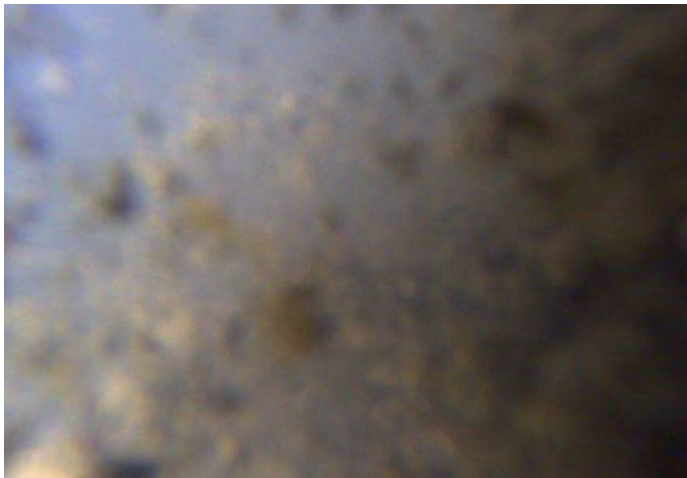
Position	Code	Observation	Video (sec)	Grade
.0	AMH	Manhole	10	NA
.0	MWL	Water Level	21	NA
1.9	MCU	Camera Underwater	36	M 4
2.3	MSA	Abandoned Survey	48	NA
