Profile/Photo Observation Report

Street:	Ohio St.	Flow Control:	Not Controlled
City:	Hobart, IN	Year Renewed:	
Location:	Light Highway	Tape/Media #:	
Purpose:	Routine Assessment	Dia/Height:	12"
Use:	Sanitary	Material:	VCP
Drain Area:	NA	Lining:	
Category:	NA		
Comment:

Location Details:		Direction of Survey:	Upstream
US MH:	M-803-024	DS MH:	M-803-025
		Total Length Surveyed (ft):	2.3

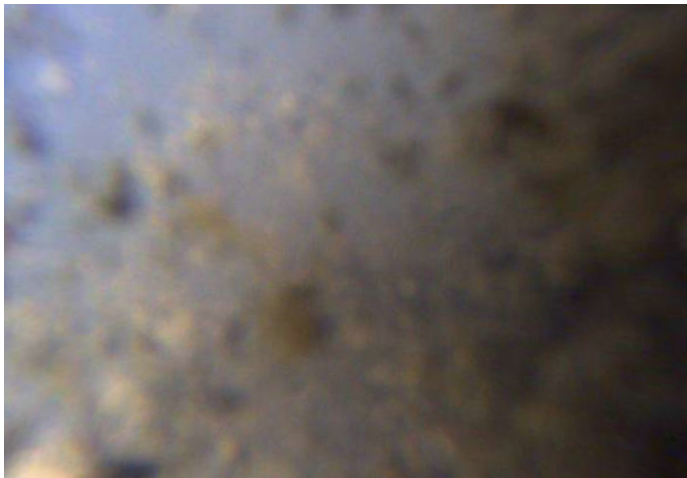
Position	Code	Observation	Video (sec)	Grade
.0	AMH	Manhole	10	NA
.0	MWL	Water Level	21	NA
1.9	MCU	Camera Underwater	36	M 4
2.3	MSA	Abandoned Survey	48	NA
