Profile/Photo Observation Report

Date:	10/02/2018	Weather:		Coding:	PACP 6.0
Pipe Length (ft):	273.0	Owner:	NA	Pre Clean:	Not Known
P.O.#:		Surveyor:	Justin Gonzales	PSR:	P-803-029-030
Customer:		Clean Date:	01/01/1900	Shape:	C

Street:	Rand St.	Flow Control:	Not Controlled
City:	Hobart, IN	Year Renewed:	
Location:	Light Highway	Tape/Media #:	
Purpose:	Routine Assessment	Dia/Height:	12"
Use:	Sanitary	Material:	VCP
Drain Area:	NA	Lining:	
Category:	NA		
Comment:

Location Details:		Direction of Survey:	Upstream
US MH:	M-803-029	DS MH:	M-803-030
		Total Length Surveyed (ft):	265.5

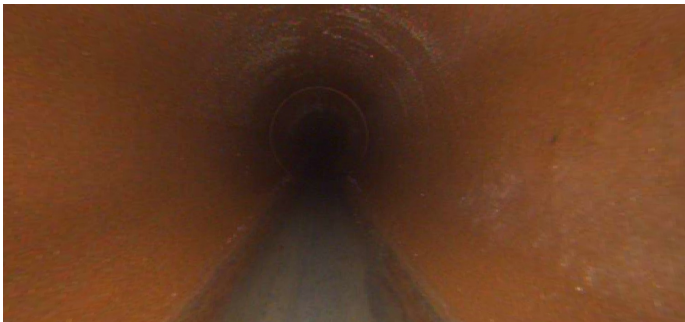
Code: **AMH**
Description: **Manhole**

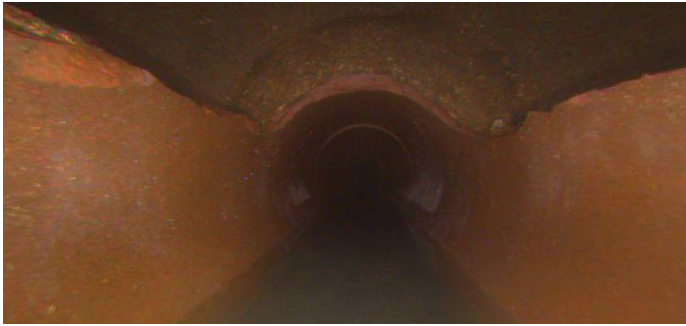
Code:	AMH
Description:	Manhole
Distance (ft):	265.5
Structural Grade:	0
O&M Grade:	0
Clock Start/From:	
Clock To:	
1st Value:	
2nd Value:	
Value Percent:	
Continuous Index:	
Within 8" of Joint:	NO
Remarks:	M-803-029
