Profile/Photo Observation Report

Date:	03/28/2018	Weather:		Coding:	PACP 6.0
Pipe Length (ft):	103.6	Owner:	NA	Pre Clean:	Not Known
P.O.#:		Surveyor:	Selasie Honu	PSR:	P-804-073-032
Customer:		Clean Date:	01/01/1900	Shape:	C

Street:	HIGH ST	Flow Control:	Not Controlled
City:	Hobart, IN	Year Renewed:	
Location:	Other	Tape/Media #:	
Purpose:	Not Known	Dia/Height:	10"
Use:	Sanitary	Material:	VCP
Drain Area:	NA	Lining:	
Category:	NA		
Comment:

Location Details:		Direction of Survey:	Upstream
US MH:	M-803-032	DS MH:	M-804-073
		Total Length Surveyed (ft):	94.4

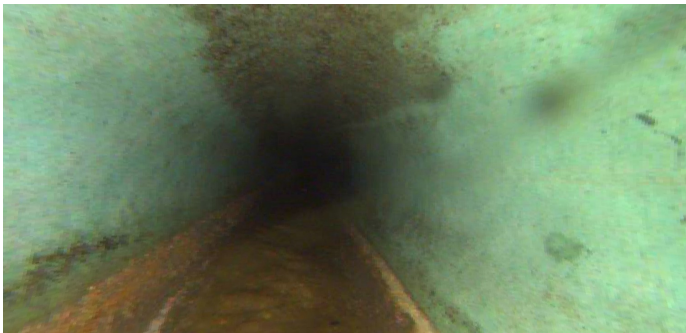
Code:	MWL
Description:	Water Level

Distance (ft):	.0
Structural Grade:	0
O&M Grade:	0
Clock Start/From:	
Clock To:	
1st Value:	
2nd Value:	
Value Percent:	5.000
Continuous Index:	
Within 8" of Joint:	NO
Remarks:
