Profile/Photo Observation Report

Street:	E RAND ST	Flow Control:	Not Controlled
City:	Hobart, IN	Year Renewed:	
Location:	Other	Tape/Media #:	
Purpose:	Not Known	Dia/Height:	10"
Use:	Sanitary	Material:	VCP
Drain Area:	NA	Lining:	
Category:	NA		
Comment:

Location Details:		Direction of Survey:	Downstream
US MH:	M-803-037	DS MH:	M-803-038
		Total Length Surveyed (ft):	158.7

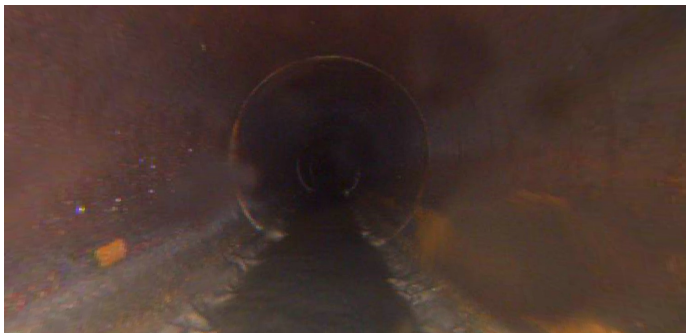
Code: **AMH**
Description: **Manhole**

Distance (ft): **.0**
Structural Grade: **0**
O&M Grade: **0**
Clock Start/From:
Clock To:
1st Value:
2nd Value:
Value Percent:
Continuous Index:
Within 8" of Joint: **NO**
Remarks: **M-803-037**

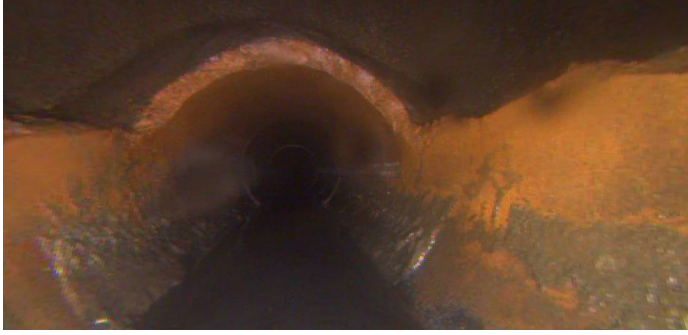
Code:	AMH
Description:	Manhole
Distance (ft):	158.7
Structural Grade:	0
O&M Grade:	0
Clock Start/From:	
Clock To:	
1st Value:	
2nd Value:	
Value Percent:	
Continuous Index:	
Within 8" of Joint:	NO
Remarks:	M-803-038
