Profile/Photo Observation Report

Date:	03/20/2018	Weather:		Coding:	PACP 6.0
Pipe Length (ft):	136.0	Owner:	NA	Pre Clean:	Not Known
P.O.#:		Surveyor:	Justin Gonzales	PSR:	P-803-060-061
Customer:		Clean Date:	01/01/1900	Shape:	C

Street:	OFF E 37TH AVE	Flow Control:	Not Controlled
City:	Hobart, IN	Year Renewed:	
Location:	Other	Tape/Media #:	
Purpose:	Not Known	Dia/Height:	10"
Use:	Sanitary	Material:	PVC
Drain Area:	NA	Lining:	
Category:	NA		
Comment:	REV - NULL - CNL MH-SNM-1702-012

Location Details:		Direction of Survey:	Upstream
US MH:	M-803-060	DS MH:	M-803-061
		Total Length Surveyed (ft):	131.5

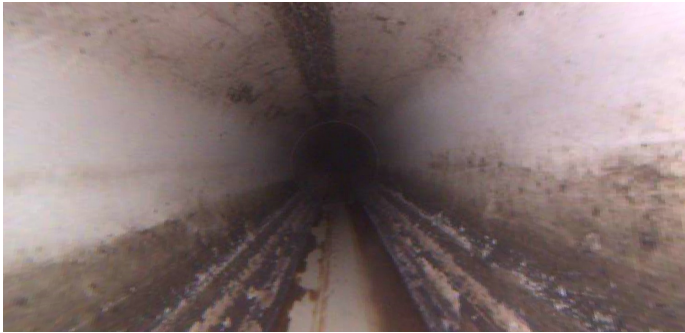
Code:	MWL
Description:	Water Level

Distance (ft):	.0
Structural Grade:	0
O&M Grade:	0
Clock Start/From:	
Clock To:	
1st Value:	
2nd Value:	
Value Percent:	5.000
Continuous Index:	
Within 8" of Joint:	NO
Remarks:

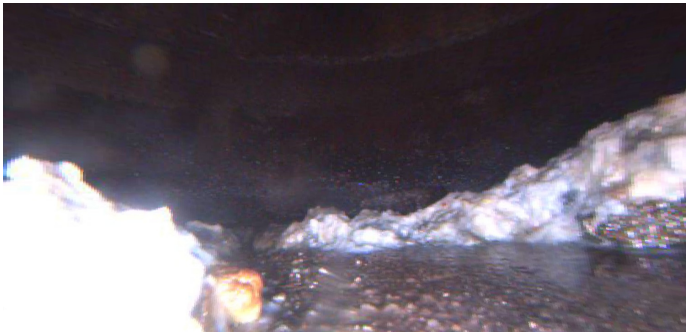
Code: **AMH**
Description: **Manhole**

Distance (ft): **131.5**
Structural Grade: **0**
O&M Grade: **0**
Clock Start/From:
Clock To:
1st Value:
2nd Value:
Value Percent:
Continuous Index:
Within 8" of Joint: **NO**
Remarks: **M-803-060**
